FIELDWORK ON THE SITE OF DUKESFIELD SMELTMILLS HEXHAMSHIRE

REPORT ON ARCHAEOLOGICAL EVALUATION
CARRIED OUT IN OCTOBER 2012

by
THE ARCHAEOLOGICAL PRACTICE LTD.

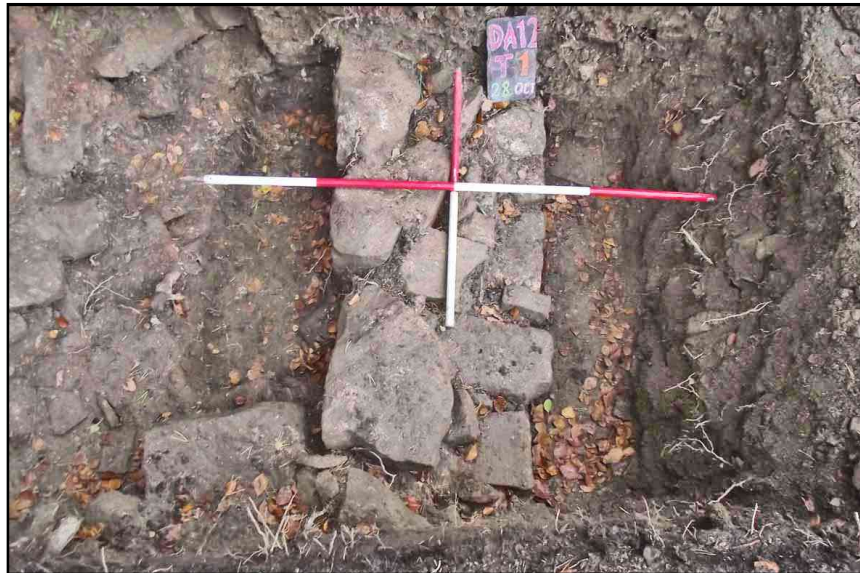
Illus. 29: View from the north of wall remains exposed in Trench 1.

The wall found at a depth of 0.65, continuing to at least 1.2 metres below current ground level (bgl), is wide enough to suggest that it once formed part of a substantial building. Its orientation, however, does not seem to tie in well to the known historic plans of the site, which show a building, or perhaps two overlapping buildings, orientated east-west and abutting the north side of the arches. The position of the wall uncovered in Trench 1 suggests that it must either have been an internal division of the structure(s) seen on historic plans, or, perhaps more likely, the remains of an earlier phase of building on the site. It might

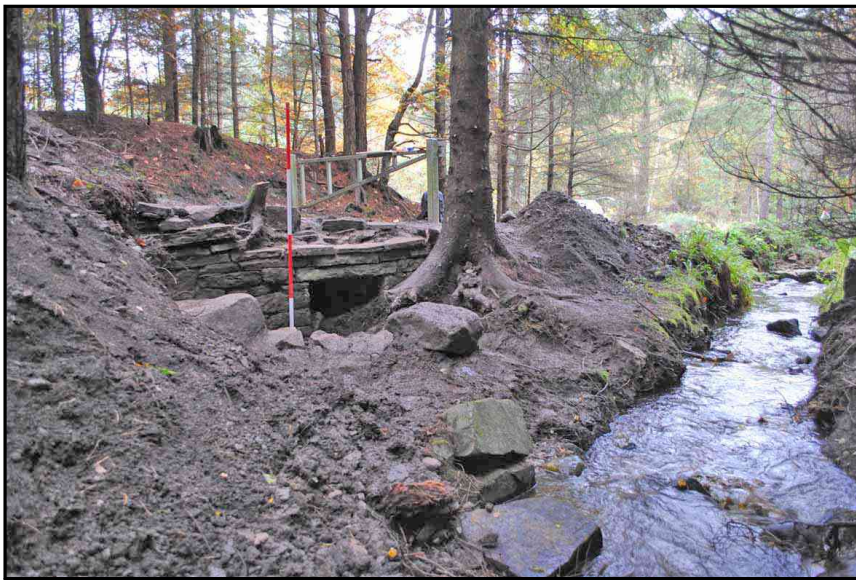
Illus. 34: View looking north-west towards culvert entrance to the Hall burn in Trench 2.

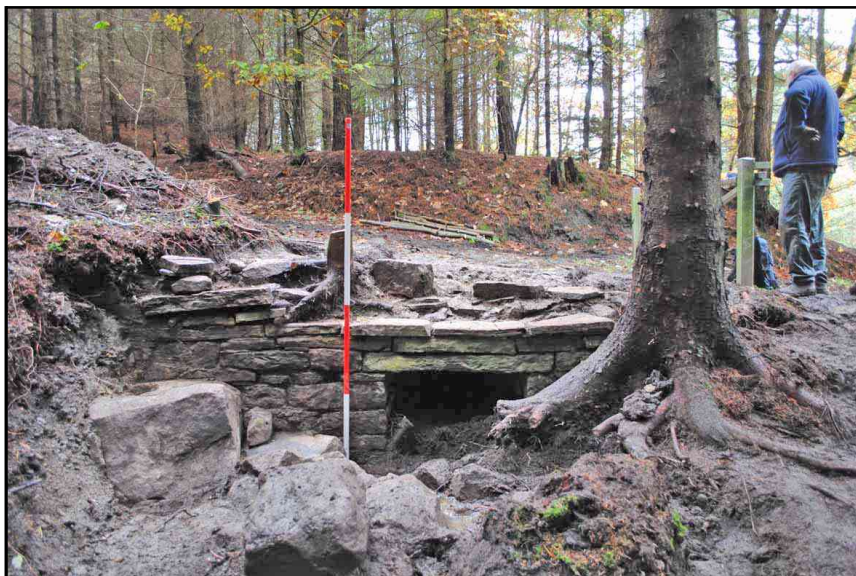
Illus. 36: View of the east-facing culvert entrance exposed in Trench 2.

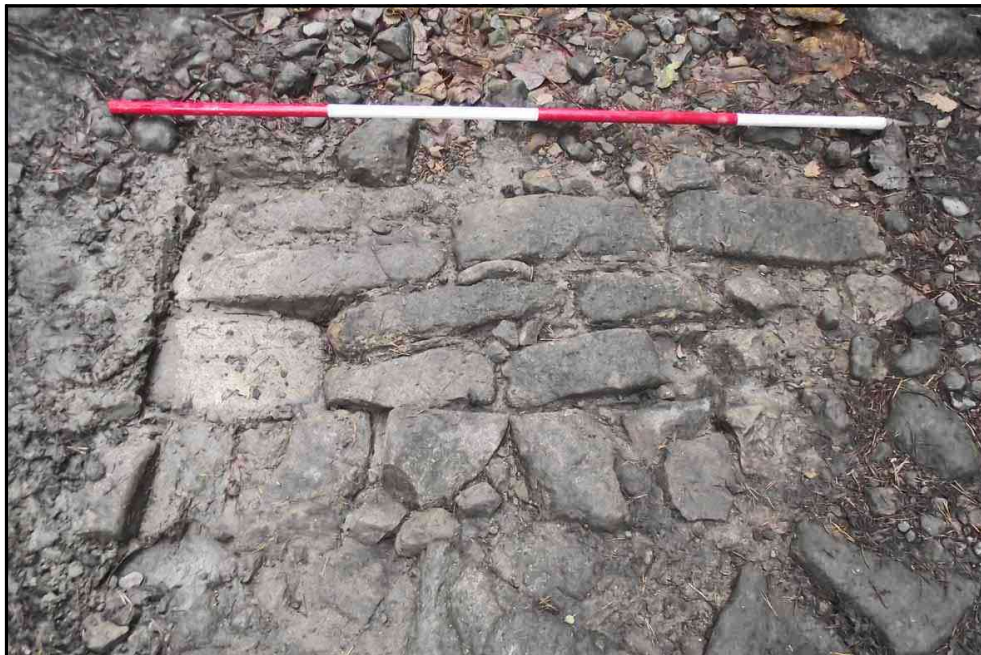
Illus. 39: View northwards of an exposed section of culvert roof exposed in Trench 2 (see above).

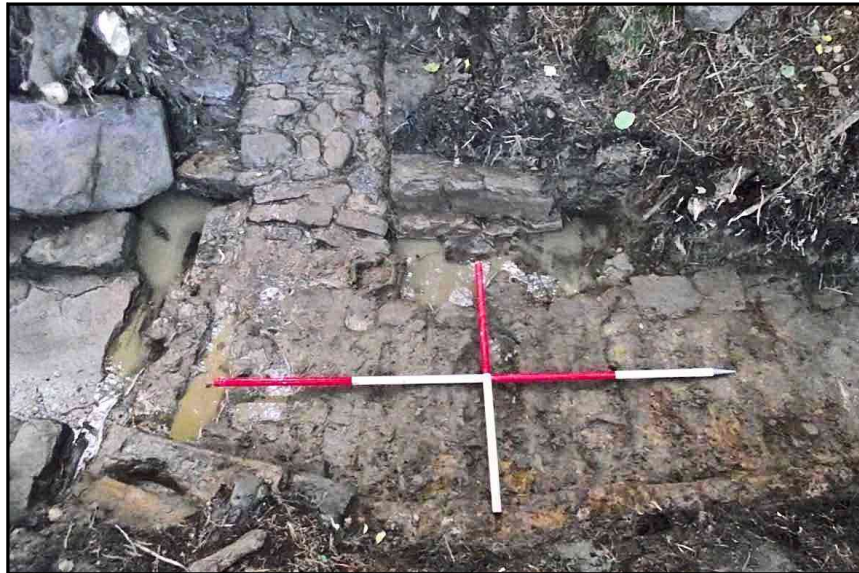
Illus. 52: East end of the hearthstone-lined leat revealed in Trench 3, with 'ramp' to the south and flagging to the east.

The section of leat with flagged floor east of the 'ramp' feature was bounded on either side by a lining of stonework, backed on the north side by a bank or dry-stone wall of similar construction to that noted at the west end of the trench. The stone lining tied in with the west-facing stonework of the arched entrance to the culvert, a straight-sided channel of coursed sandstone masonry, with corbelled roof set on a springer-course. On the north side of the culvert entrance, within the west-facing supporting wall of the springer-course, was a slot some 0.12 metres long and 0.08 metres high, with a depth of c0.10 metres. A second, larger and deeper slot, measuring some 0.30m long by 0.16 metres deep and at least 0.40 metres deep was observed in the south-facing wall of the culvert close to its entrance, just above floor level.

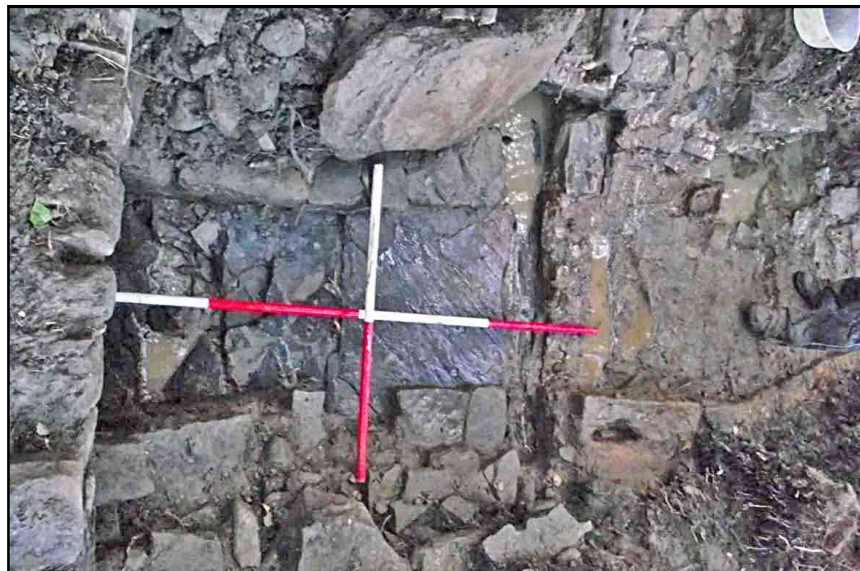
Illus. 53: Vertical view of flag-floored culvert entrance at the east end of Trench 3, with wood-lined slot between flagged- and hearthstone-lined sections of floor.

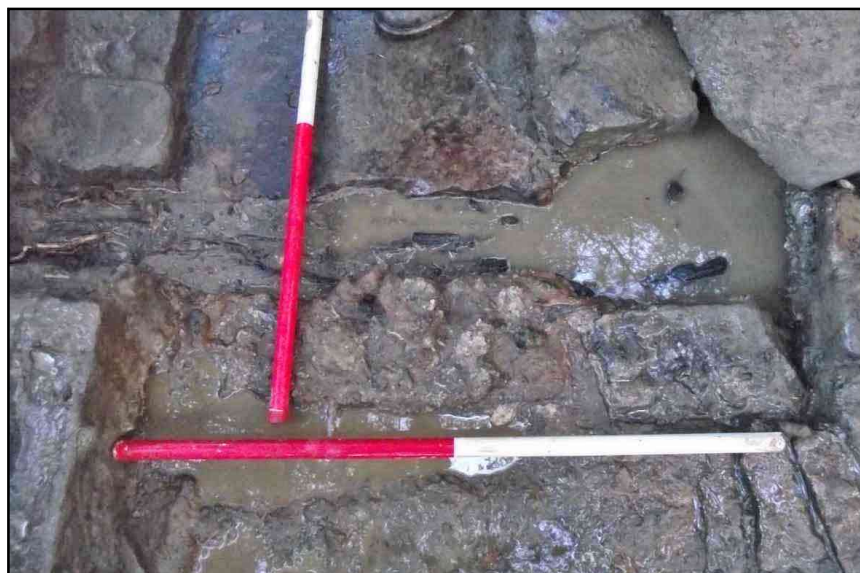
Illus. 54: Detail of preserved timber and iron fittings in socket marking the position of a former sluice gate at the east end of Trench 3.

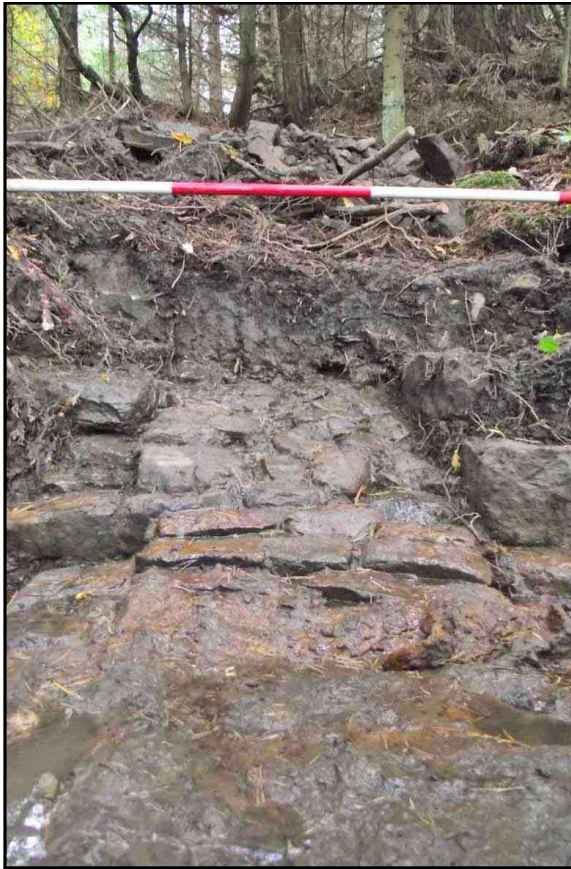
Illus. 55: View from the north of a cobbled feature - presumably a former water-course or access ramp - running into the south side of the leat exposed in Trench 3.

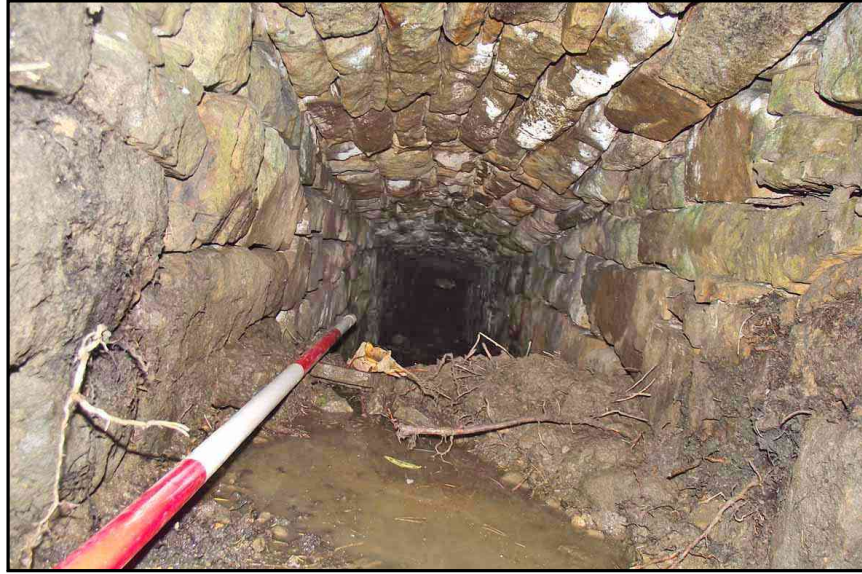
Illus. 58: View looking east along the interior of the culverted leat from the east end of Trench 3.

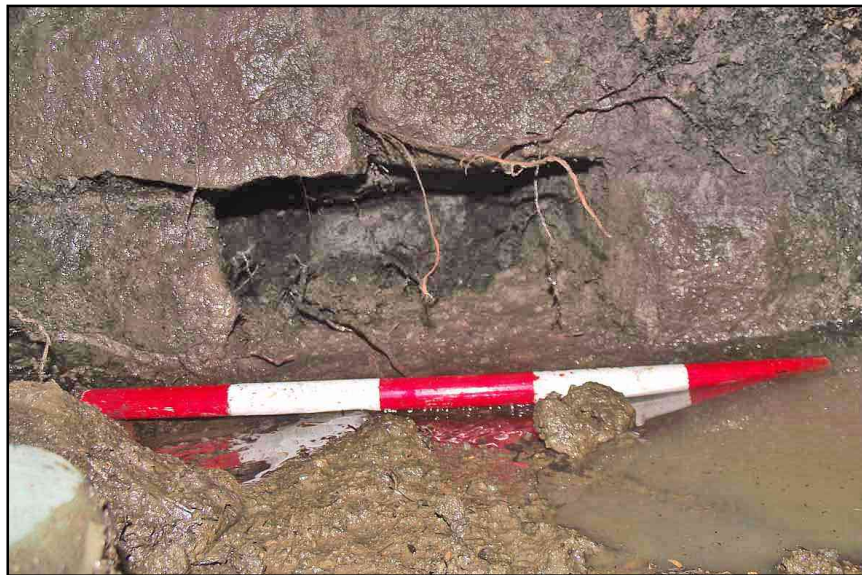
Illus. 59: View of a deep socket in the south-facing interior wall of the culvert, just above floor level, close to its west end, as revealed in Trench 3.

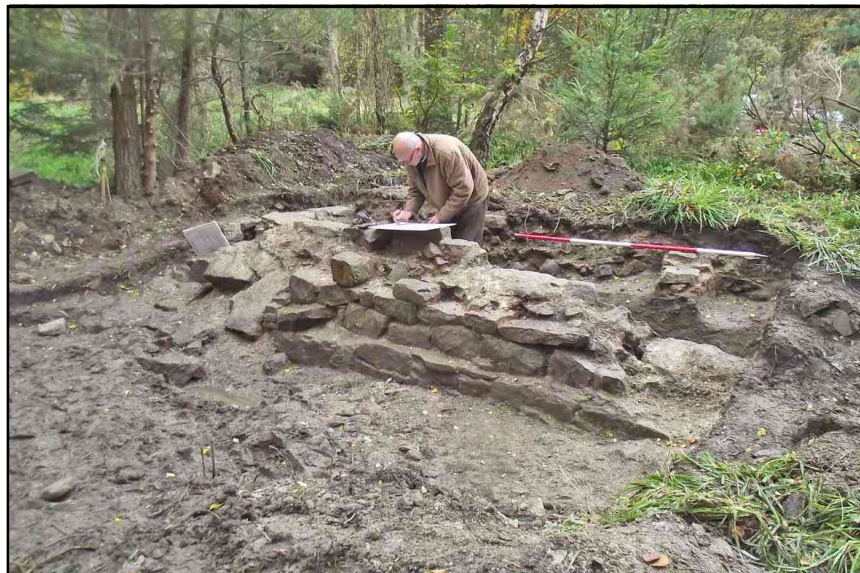
Illus. 64: View during the excavation of Trench 4, looking south at structural remains of a wall with cobbled floor in front.

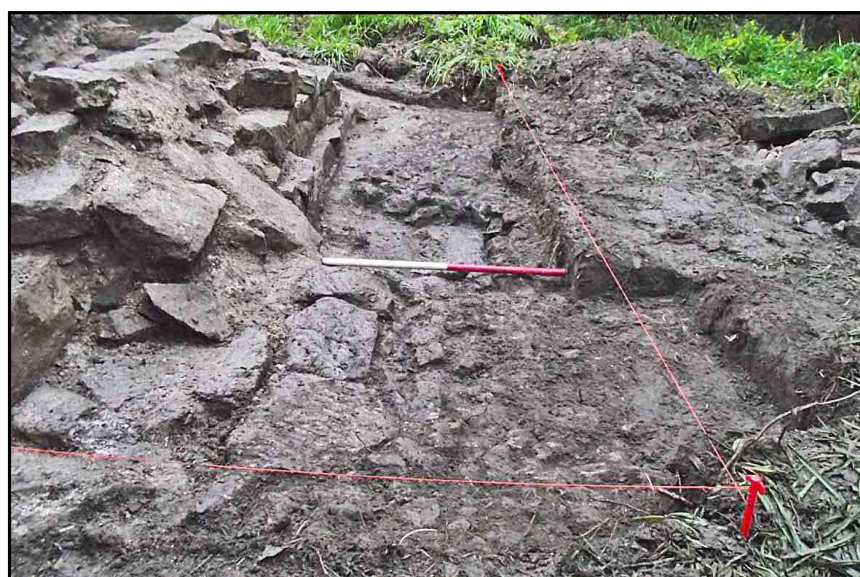
Illus. 66: View looking west along a wall face (above) fronted by cobbling in Trench 4.

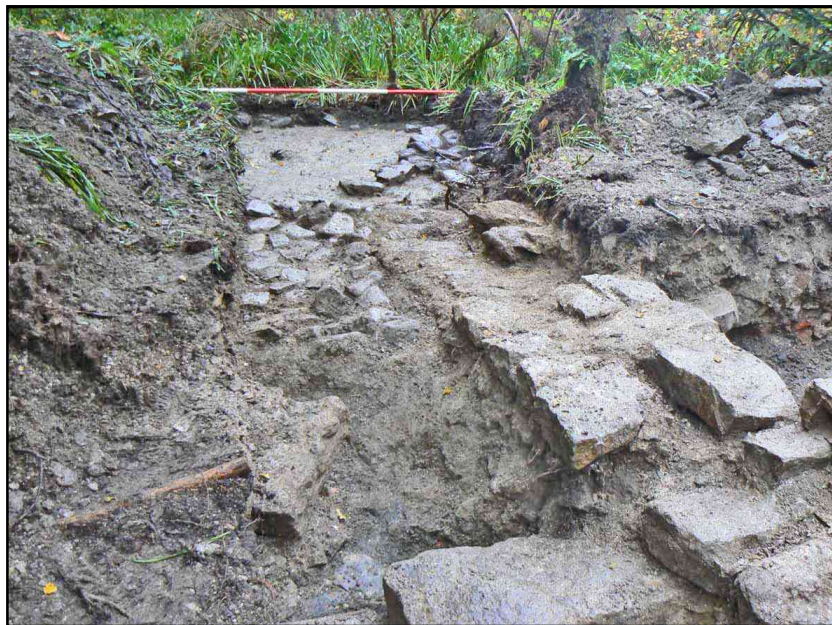
Illus. 70: View southwards of the remains of a N-S wall footings and cobbling in the south-east part of Trench 4.

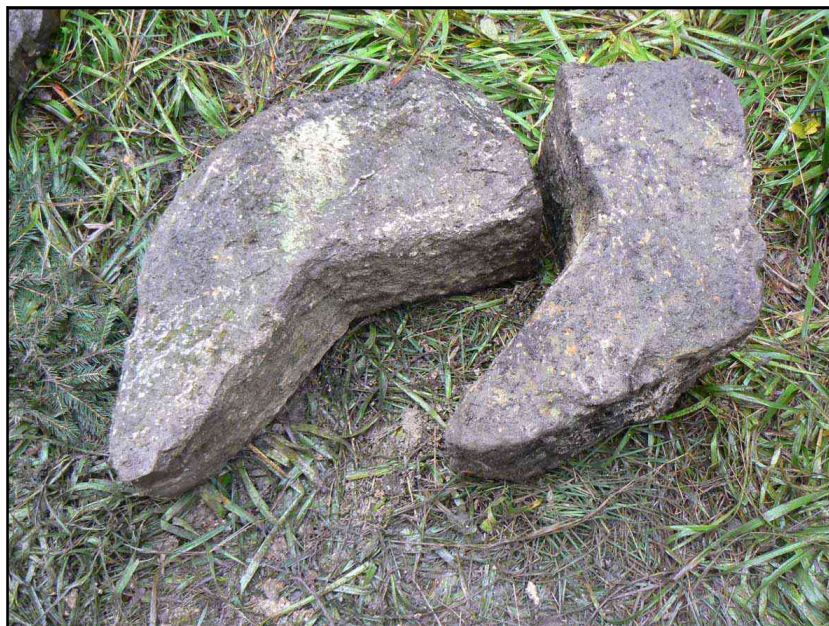
Illus. 72: Detail of shaped building stones uncovered in Trench 4.

Other than worked stone, including two apparent kneeler stones for supporting inclined coping on the slope of a gable, and fragments of sandstone roof tile, no significant artifactual discoveries were made during the excavation of Trench 4, but some large pieces of slag – including one of crucible form – were recovered from secondary contexts, where they appear to have been used to infill construction trenches or support building foundations and floors. The initial examination of the slag by nationally-renowned specialists, including David Cranstone and Dr Tim Young suggested that this slag may result from ironworking rather than lead smelting; further testing is proposed in order to resolve this.

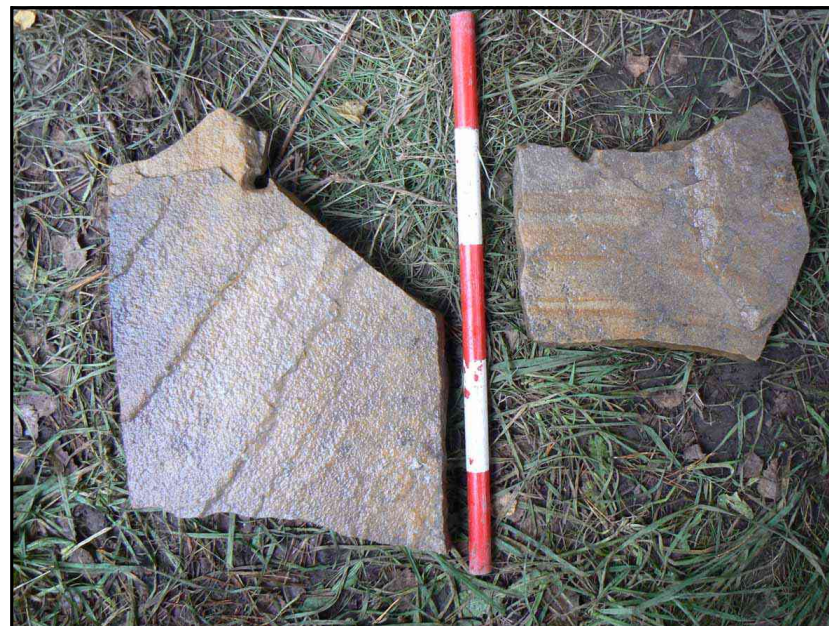
Illus. 73: Detail of sandstone roof tile fragments from Trench 4.
