ALTOGETHER ARCHAEOLOGY
MODULE 4:
THE MAIDEN WAY ROMAN ROAD,
WHITLEY CASTLE, TYNEDALE,
NORTHUMBERLAND

TRIAL TRENCH
EVALUATION REPORT
CP01413
FOR THE NORTH PENNINES
AONB PARTNERSHIP
23/01/2012

DOCUMENT TITLE: The Maiden Way Roman Road at Whitley Castle,
Tynedale, Northumberland

DOCUMENT TYPE: Trial Trench Evaluation Report

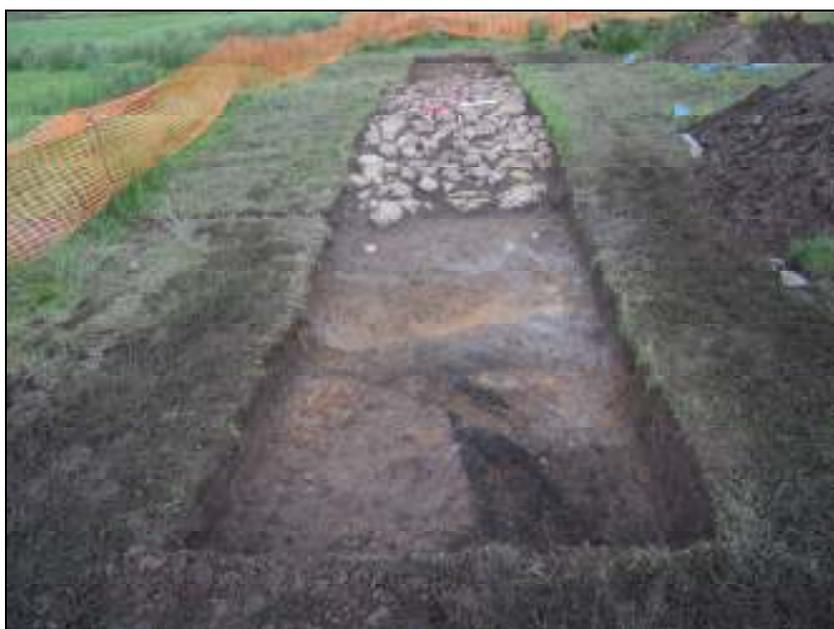
4.2.1 *Trench 1:* Trench 1 measured 15.40m in length and 2.00m in width. It was located north-west of the conserved bastle house at Whitlow Farm (Figure 2). The trench was orientated east to west across a stretch of the Maiden Way road running between Castle Nook Farm and Whitlow Farm. It had a slight fall in gradient from west to east and was excavated to a maximum depth of 0.48m revealing a soft, mottled grey/orange, sandy natural substrate (**104**) below c.0.10m of light brown, silty subsoil (**101**) and c.0.06m of dark brown, silty topsoil (**100**). At the western end of the trench a layer of mottled grey/orange, silty/clay hill wash (**108**) measuring c.3.80m in length and c.0.16m in depth sealed the natural substrate (**104**) (Figure 3).

Plate 1: Trench 1 after excavation (facing east)

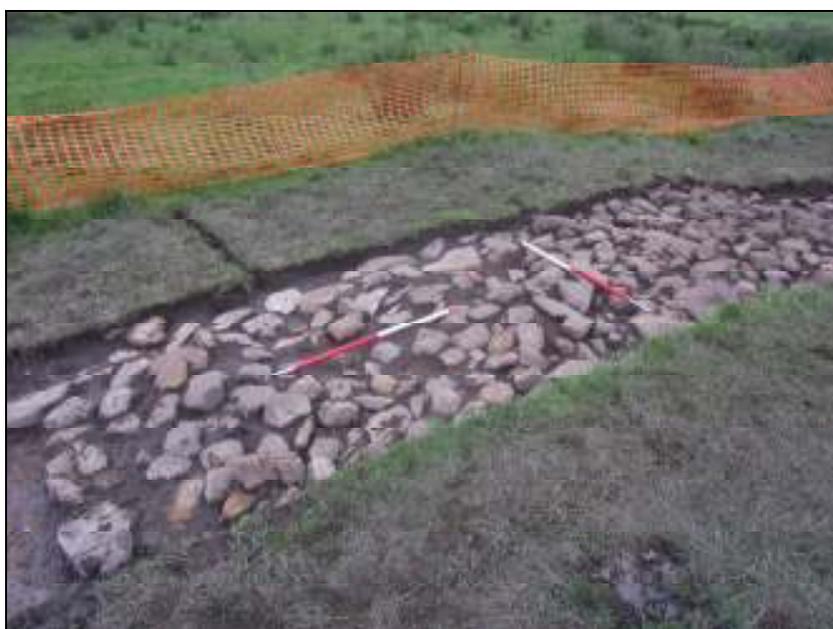
4.2.2 Excavation revealed at the centre of the trench a substantial, cambered, stone road surface (107) with a width of c.5.80m and having an average depth of c.0.20m (Figure 3; Plates 1 and 2). The metalling consisted mainly (c.75%) of orange/grey, flat, sub-angular pieces of sandstone with an average size of 0.25m x 0.15m x 0.12m. However c.25% of the stones were considerably larger with an average size of 0.50m x 0.30m x 0.20m and not particularly flat. On the eastern edge of the road, the downslope side, was an area of road tumble (111). A slot, excavated through the road surface to a depth of c.0.48m below ground level, revealed only one phase of construction. The metalling (107) was laid on a raised mound, measuring 0.25m in height, of redeposited natural material (112) (Figure 3).

Plate 2: Trench 1 showing cambered road surface (107) (facing north-east)

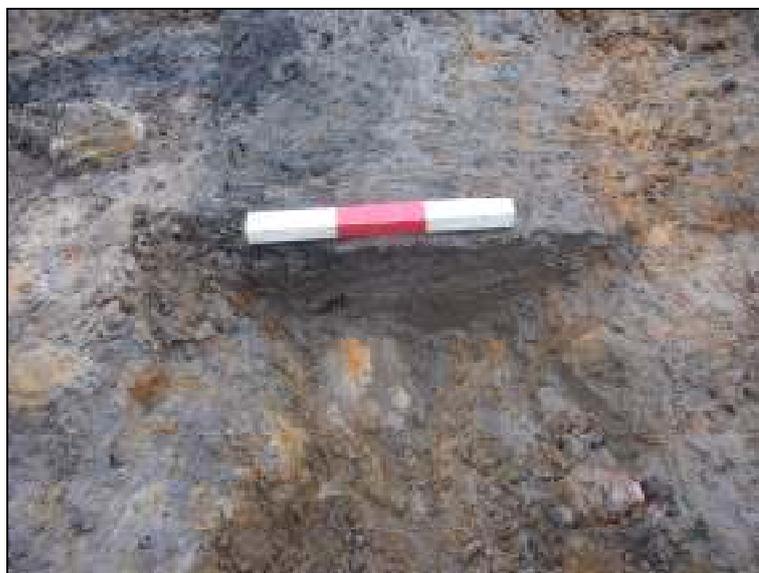
4.2.3 On the western side of the road and running parallel with it, was a roadside ditch [102] measuring c.0.55m in width and c.0.18m in depth. This contained a single fill of grey, silty/clay (103) (Figure 3; Plate 3). On the eastern side of the road, again running parallel, was a very shallow ditch feature [109] measuring c.0.60m in width and c.0.06m in depth. Containing a single mottled grey/ orange, silty/clay fill (110) it was probably a result of the agger construction rather than a deliberately excavated roadside ditch. It seems likely that it was only considered necessary to excavate a roadside ditch on the uphill side of the road as on the downhill side any water would naturally drain away.

Plate 3: Trench 1, slot through western roadside ditch [102], (103) (facing north)

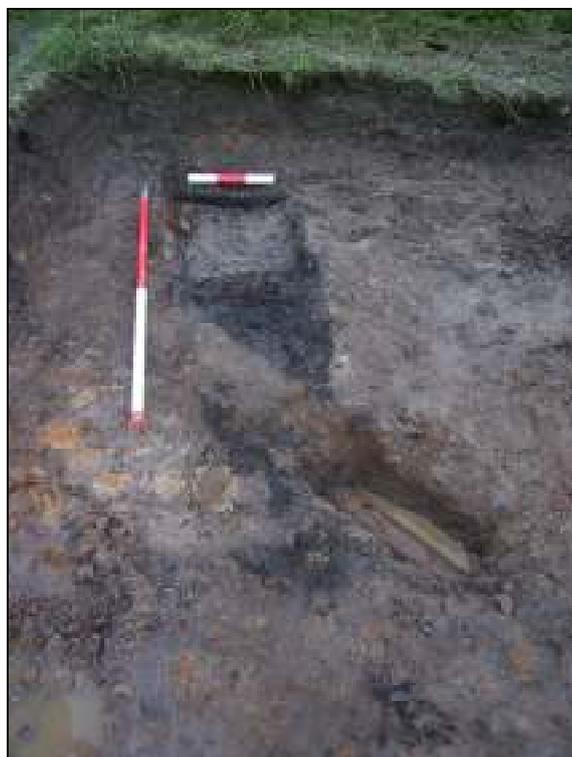
4.2.4 At the western end of the trench a linear feature [105] measuring c.0.48m in width and c.0.09m in depth and containing a single fill of black industrial slag (106), cut the western roadside ditch [102], (103). The linear feature [105] was in turn cut by a modern ceramic land drain (Figure 3; Plate 4).

Plate 4: Trench 1, slots through linear feature [105], (106) and modern land drain (facing west)

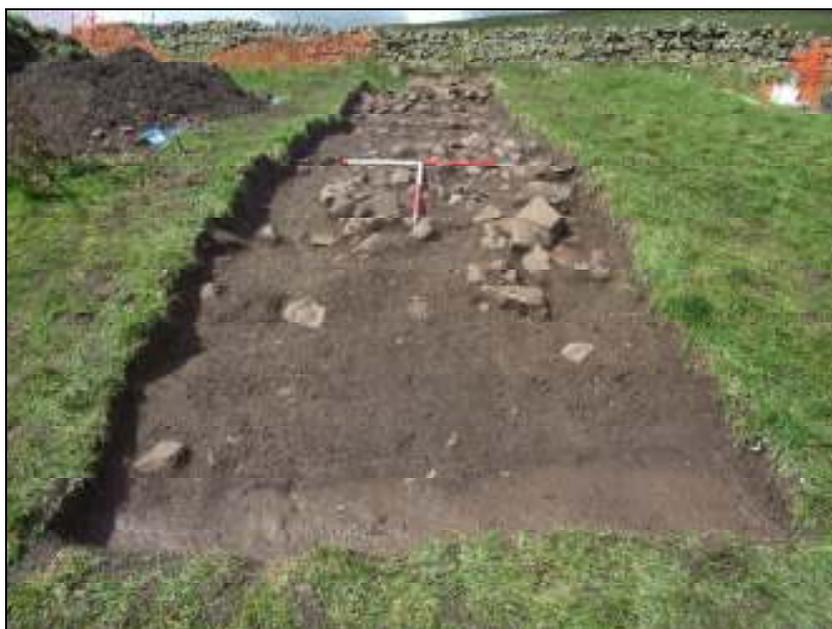
- 4.2.5 **Trench 2:** Trench 2 measured 14.70m in length and had a maximum width of 4.00m. It was located to the south-west of the conserved bastle house at Whitlow Farm (Figure 2). The trench was orientated from east to west and sloped downwards from west to east. It was targeted on a section of the Maiden Way that had a pronounced bank and ditch on its western edge.
- 4.2.6 The trench was excavated to a maximum depth of 0.93m revealing a hard, black, shale natural substrate **(208)** below c.0.12m of mid brown, silty subsoil **(201)** and c.0.13m of dark brown, silty topsoil **(200)** (Plate 5).

Plate 5: Trench 2 after excavation (facing west)

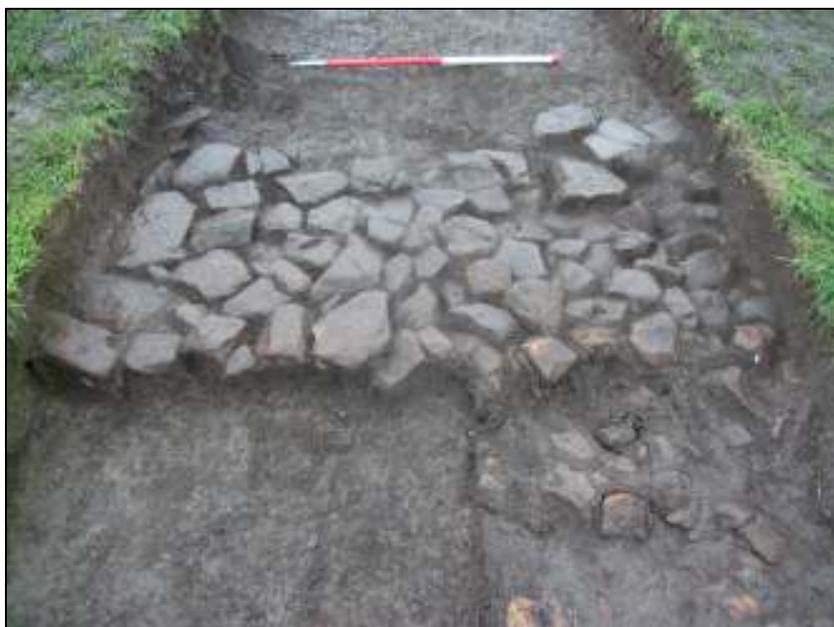
- 4.2.7 Excavation revealed at the centre of the trench the remains of a substantial metalled road surface. A 1.80m wide section of well preserved road metalling **(203)**, cut into the sloping ground **[214]**, was uncovered on the western edge of the road. The stones were relatively flat and had an average size of 0.30m x 0.15m x 0.08m (Figure 4; Plate 6). The eastern and greater part (c.4.20m) of the road **(204)** was less well preserved, probably having been subject to stone robbing (Figure 4; Plate 5). The original width of the road was difficult to ascertain due to the lack of kerbstones and some down slope tumble of the metalling. However the combined width of the two surfaces **(203)**, **(204)** was c.6.00m.

Plate 6: Trench 2, the well preserved road metalling (203) (top) contrasts with the robbed area (204) (bottom right). The excavated slot (bottom left) shows the shale natural substrate (208) on which the road was laid (facing west)

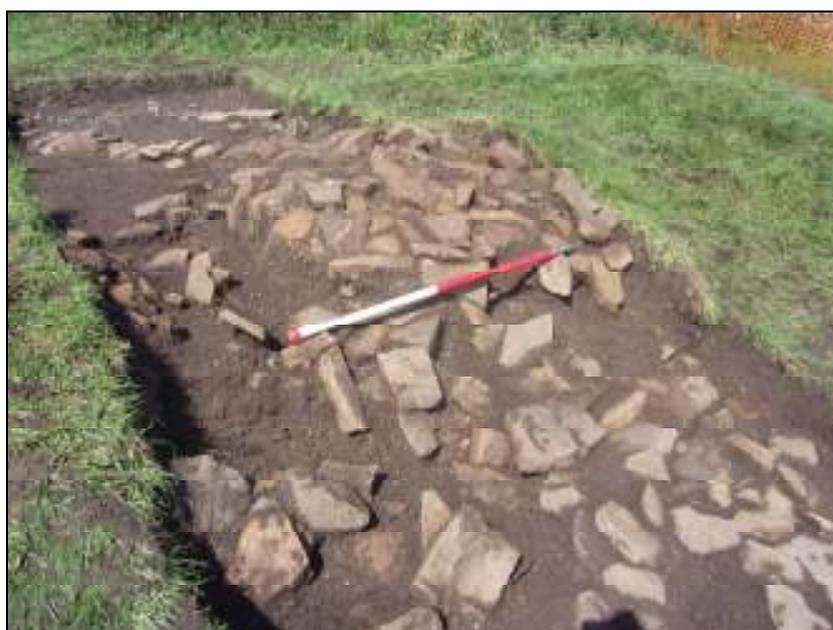
- 4.2.8 Running parallel with the western edge of the road measuring 0.30m in height was the slumped remains of a low soil bank **(207)** capped with stones **(202)** (Figure 4; Plate 7). Immediately to the west of the bank, running parallel with it, was a large ditch **[210]** which extended outside the evaluation trench. The total width of it measured in excess of 4.50m. The

Plate 7: Trench 2, low earth bank (207) with capping stones (202) (facing north-west)

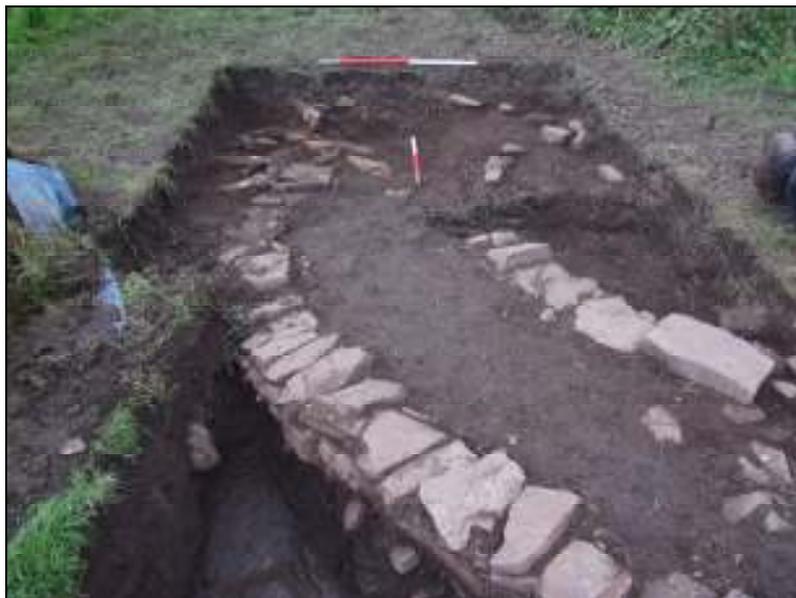
4.2.9 Crossing the ditch from south-west to north-east was a causeway measuring c.1.30m wide (Figure 4; Plate 8). This appeared to cut through the low bank (202), (207). The causeway consisted of a fill (209) that had been inserted into the ditch [210] over the primary fill (212). Two rows of stones with an average size of 0.25m x 0.14m x 0.06m (205), (206) delineated the causeway route. A similar line of stones (213) ran due north from the causeway. The function of these was not ascertained (Figure 4).

Plate 8: Trench 2, causeway fill (209) and delineating walls (205), (206) across the ditch [210] (facing west)

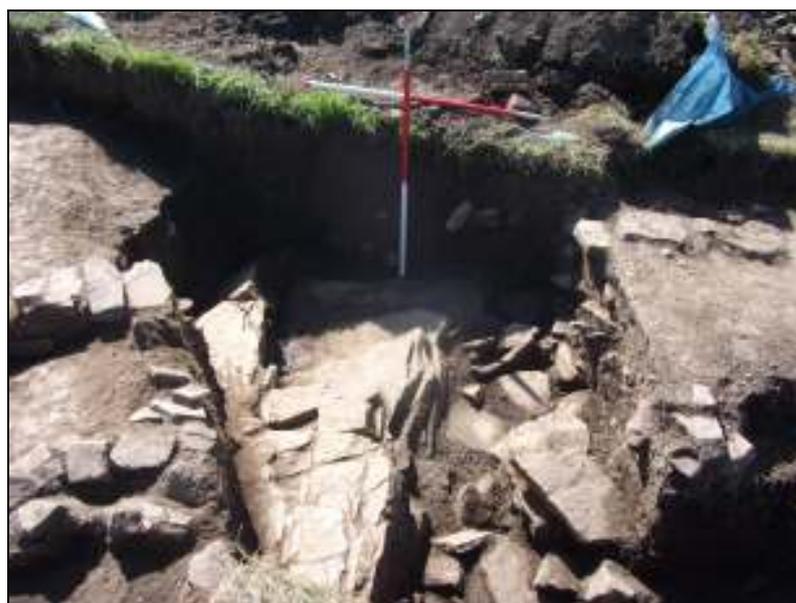
base of the ditch had been excavated down to the yellow sandstone bedrock (215) (Figure 4; Plate 9). The ditch contained two fills, a primary of dark brown, silt (212) measured 0.20m in depth and a secondary of medium brown silt (211) measured 0.50m in depth (Figure 4).

Plate 9: Trench 2, excavated slot through the causeway (209) showing the bedrock base (215) of the ditch [210] (facing south)

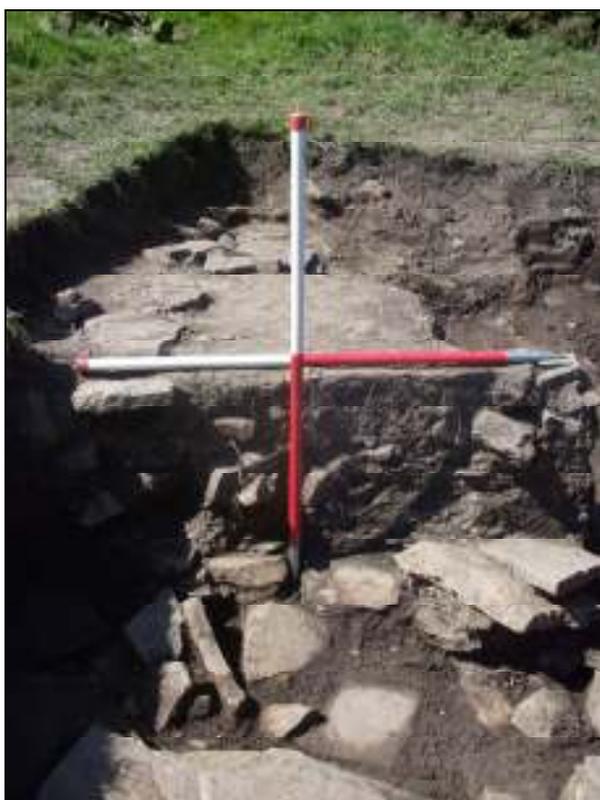
Plate 10: Trench 2, section through the causeway fill (209), ditch primary fill (212) and delineating walls (205), (206) (facing south-west)

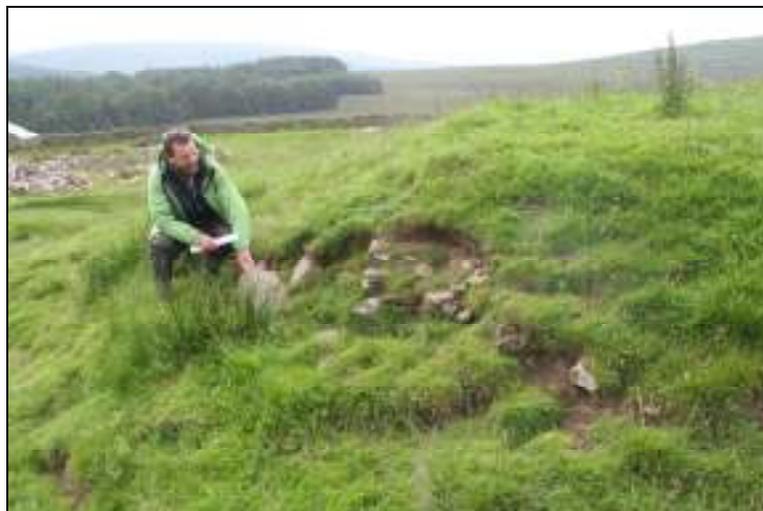
4.2.10 **Trench 3:** Trench 3 measured 5.20m in length and 2.20m in width. It was again located to the south-west of the conserved bastle house at Whitlow Farm (Figure 2). The trench was orientated east to west with a steep drop of slope on the northern edge leading down to a small stream. Targeted on exposed stone at the top of the bank it was suspected that it may have once been the site of a possible bridge abutment (Plate 10).

Plate 10: Site of Trench 3 prior to excavation showing exposed stonework (facing south-east)

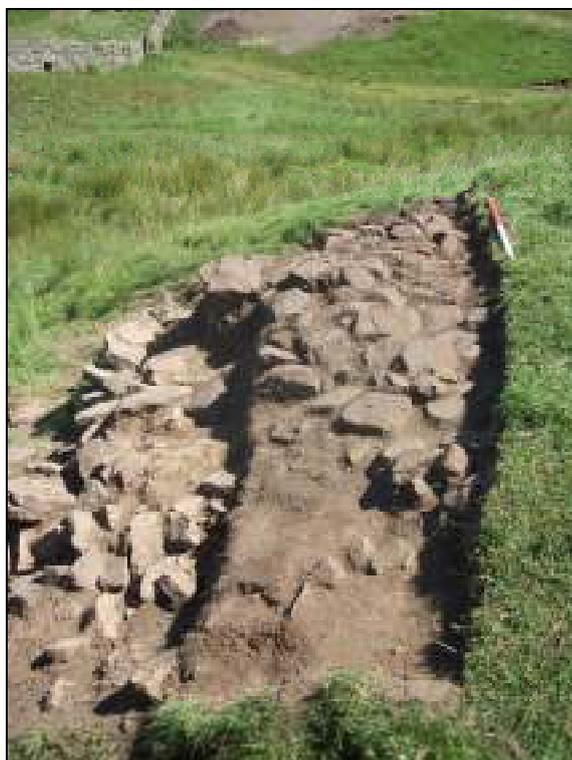
4.2.11 The trench was excavated to a maximum depth of 0.20m revealing, on the northern side of the trench, a light brown, silty, natural substrate (303) below an area of large stone tumble (302) and mid brown, silty, topsoil (300) (Figure 5; Plate 11).

4.2.12 On the southern edge of the trench, just below the topsoil were the remains of a metalled road surface (301) similar to the surface (203) observed in Trench 2. The metalling (301) consisted of flat, sub rectangular pieces of orangy/brown sandstone with an average size of 0.30m x 0.15m x 0.06m forming a relatively neat and compact surface (Figure 5; Plate 11). The width of the metalling here was only 4.80m, this being attributed to the erosion and slump of the ground on the edge of the slope. Average depth of the

metalling was 0.12m. The larger stones of the tumble (302) had an average size of 0.35m x 0.20m x 0.15m. Whether these were the remains of the core of a bridge abutment or the result of casual stone clearance is difficult to say. Certainly no squared off or worked stone was observed in the excavated area.

Plate 12: Trench 3, metalled road surface (301) on right and tumble (302) on left (facing east)

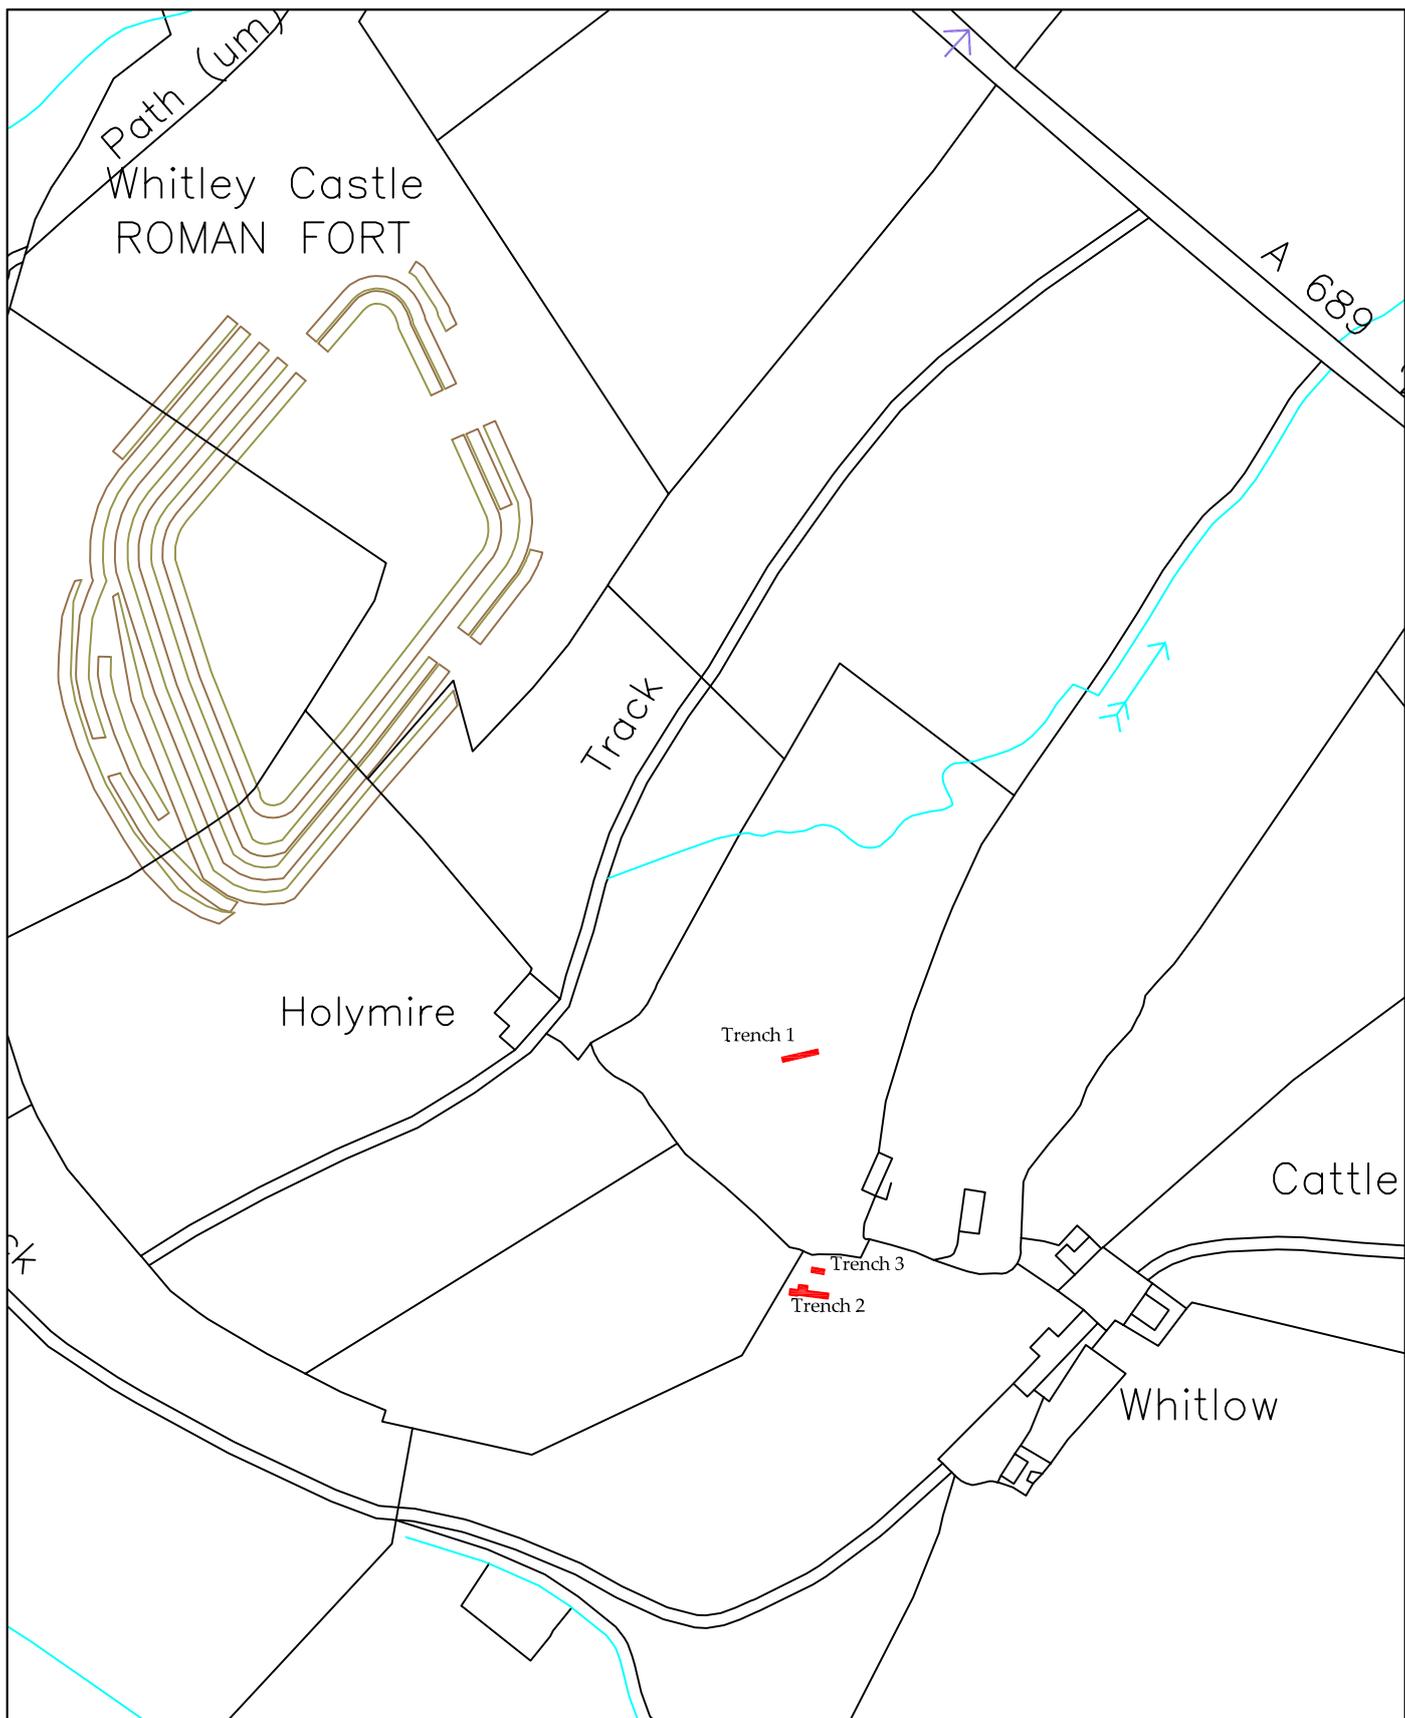
Figure 2 : Trench Locations

4.1.1 The evaluation consisted of the excavation of 3 trenches, crossing the line of the Maiden Way Roman Road and covering a total evaluated area of 81m² (Figure 2). The work was carried out in order to investigate the nature and current condition of the surviving road. Trenches 1 and 2 were located so as to evaluate two sections of the road which were suspected of having different constructional forms and Trench 3 was located at a possible bridge abutment site. All the trenches were excavated by hand.

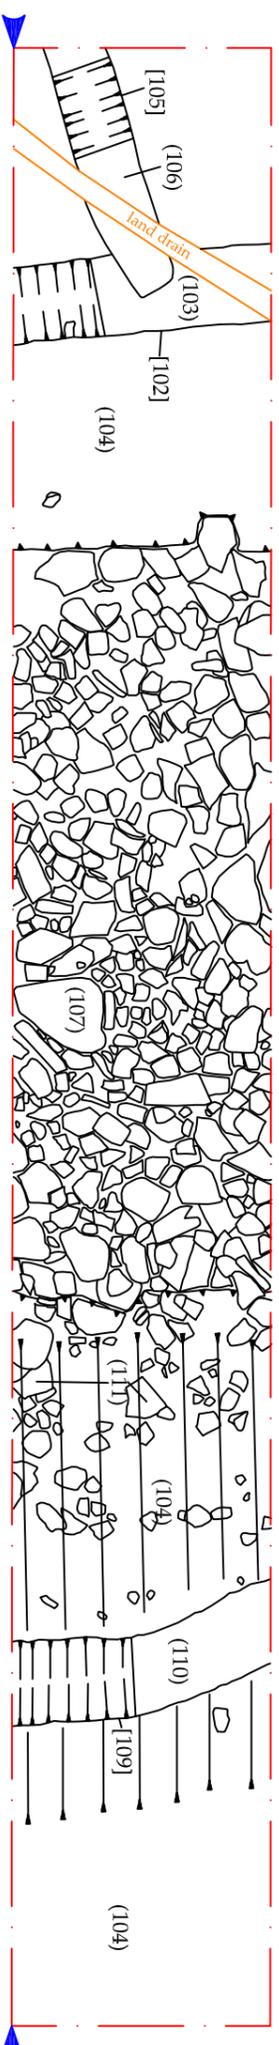
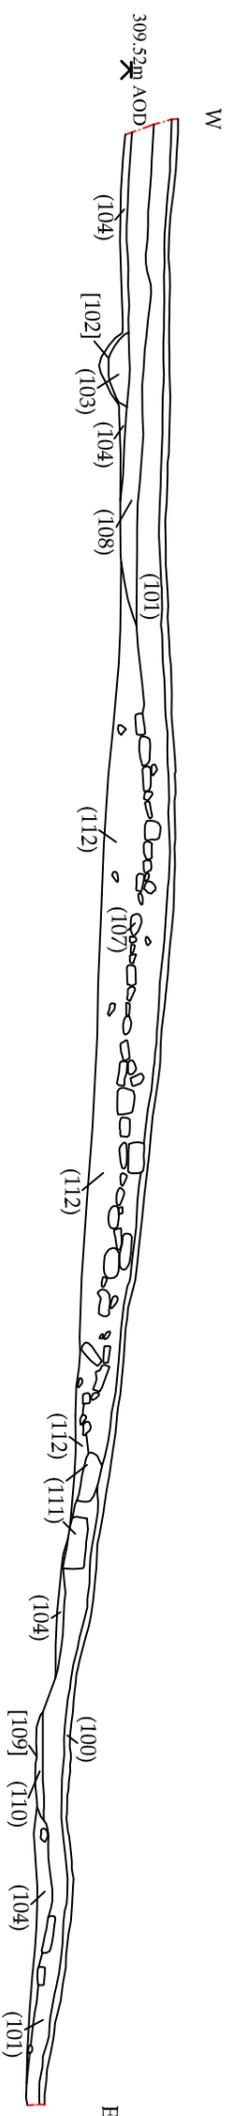
Figure 3: Plan and Section of Trench 1

Plan of Trench 1

Section of Trench 1

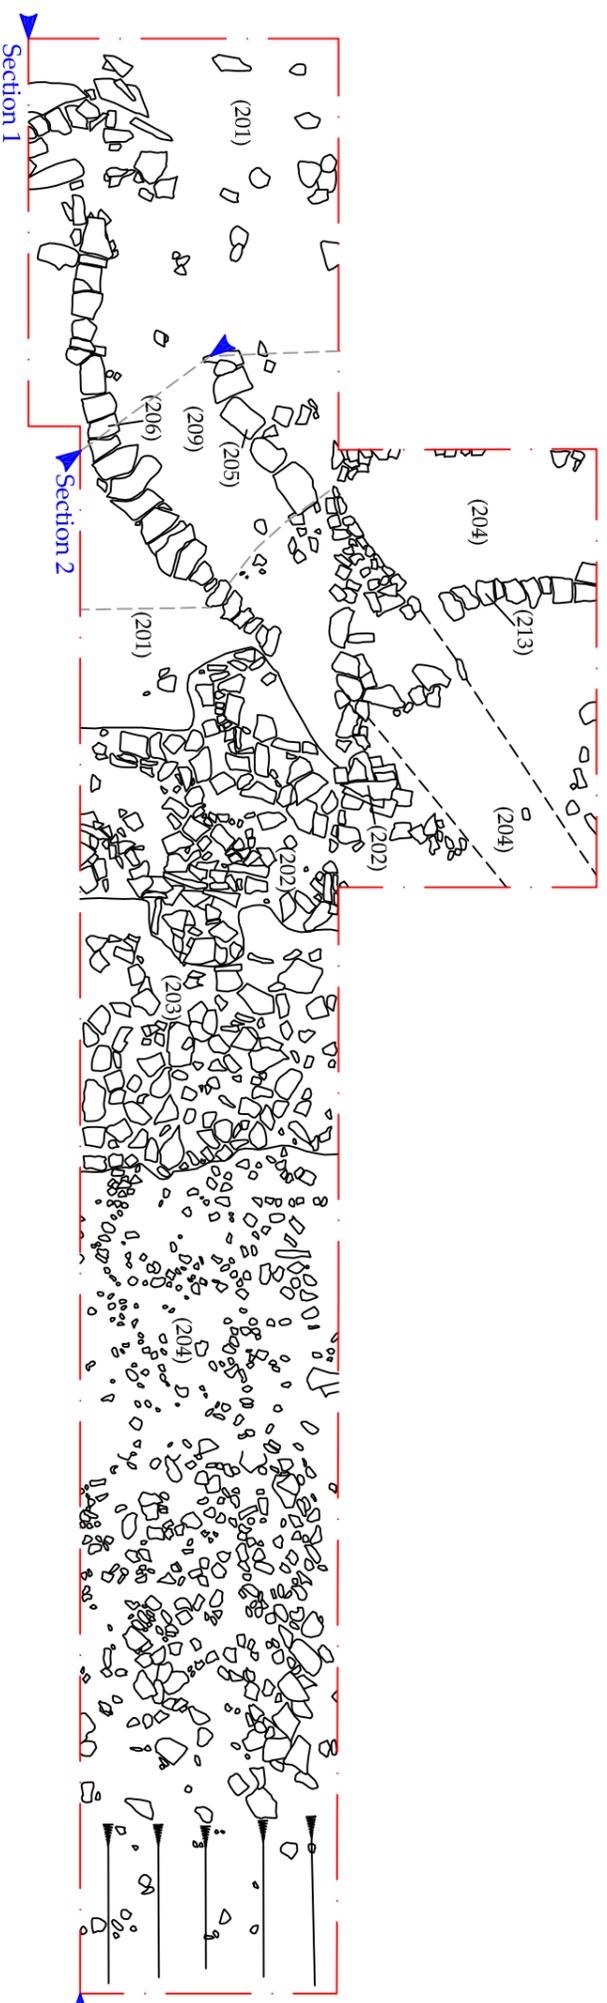
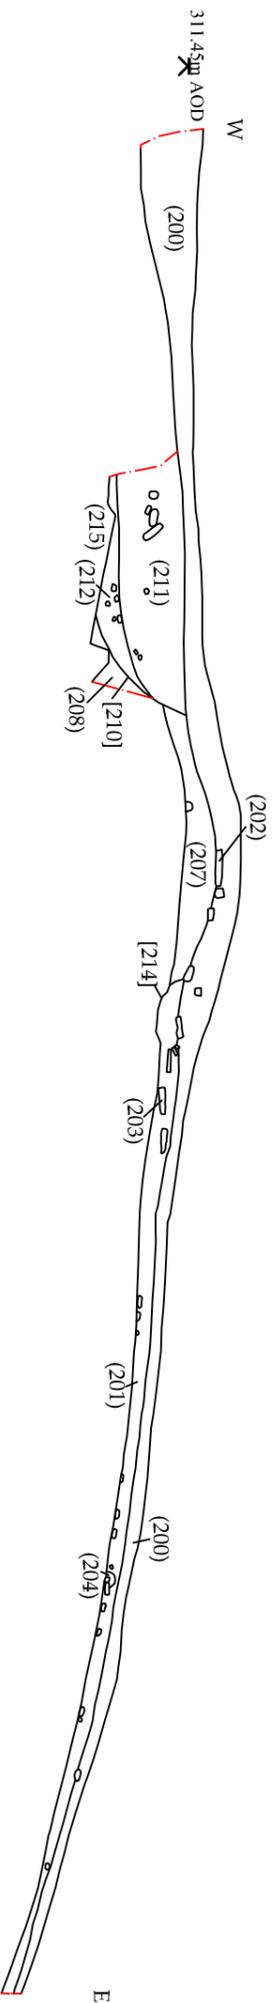
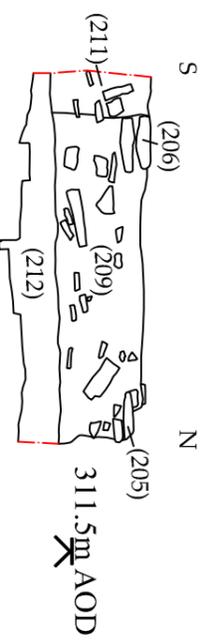
Plan of Trench 2

Section 1 in Trench 2

Section 2 in Trench 2
