# WELL HEAD DESERTED SETTLEMENT Holwick, Teesdale

*Project Design for 2018 (2nd season) Excavation  
and Interim Report on 2017 Excavation*

Version 1.2 (11 April 2018)

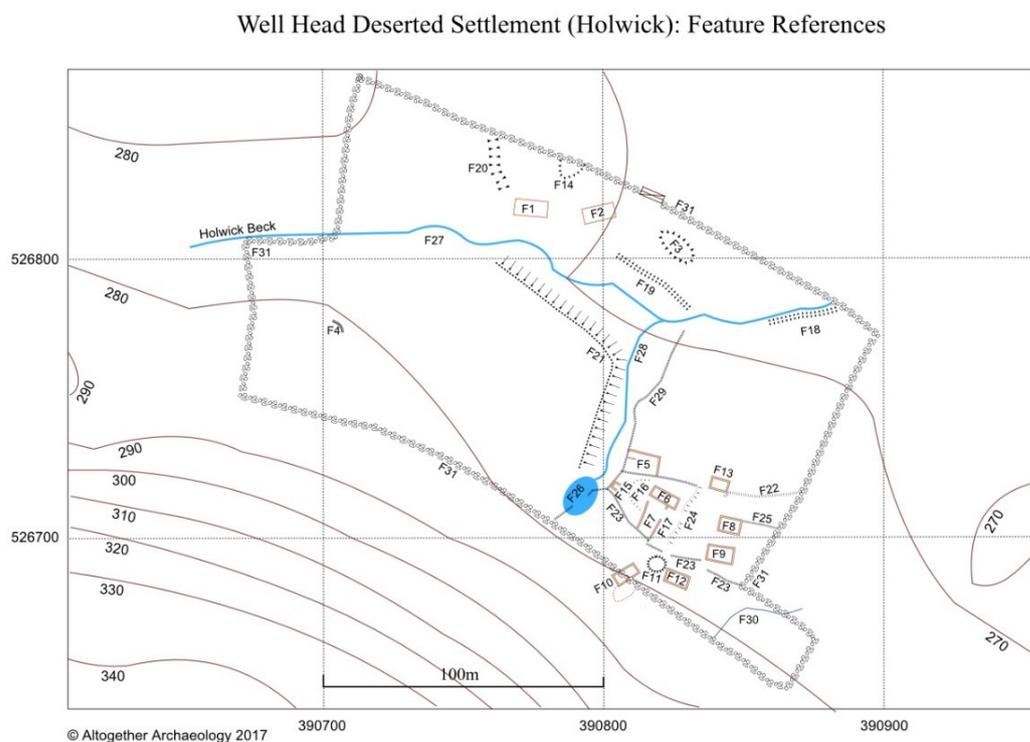
**Figure 2: Hand-held GPS survey of Well Head, showing feature numbers (from Well Head Survey Report).**

In the centre of the settlement, at the summit of a hillock beside a large spring, are two single-celled rectangular structures at right angles to each other (F6, F7), overlain by old tumbled field walls and rubble. To the NW of F7 are two platforms lower on the slope (F15, F16). To the southeast of F7 is a rectangular platform (F17). **See Figures 3 and 4 for plans of this core area.**

Around this central core are six rectangular buildings (F5, F8, F9, F10, F12, F13), all (except F10) roughly sharing the orientation of F6. Some are single-celled. However, F9 and F12 may be two-celled. The western end of F13 has been lost in debris from a steep earth slope. Only F6, F7, and F8 have clear entrances: these are in their long sides. F10 has an attached yard to its east. F5 has a flat platform attached to its north side, possibly a yard.

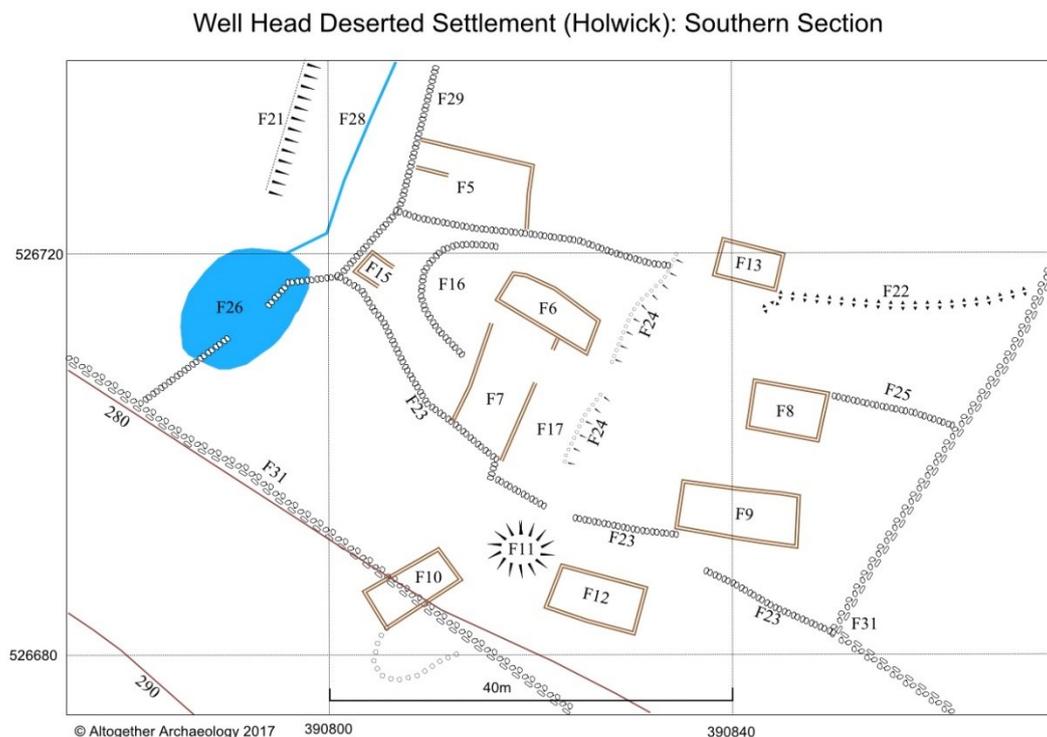
**Figure 3: Hand-held GPS survey of core area of the Well Head settlement (from Well Head Survey Report).**

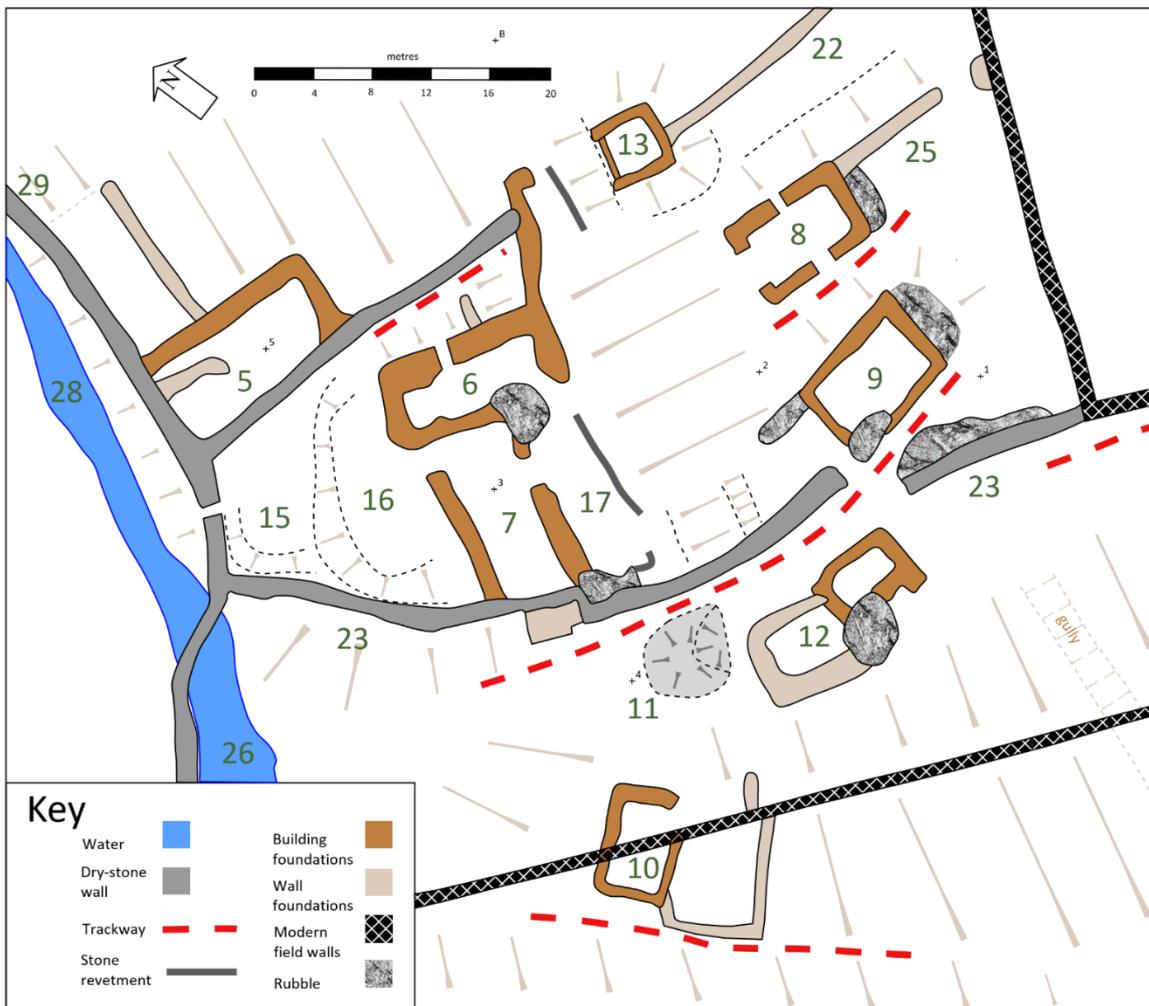
**Figure 4: Theodolite-with-disto survey of core area of the Well Head settlement**  
*(from Well Head Survey Report)*

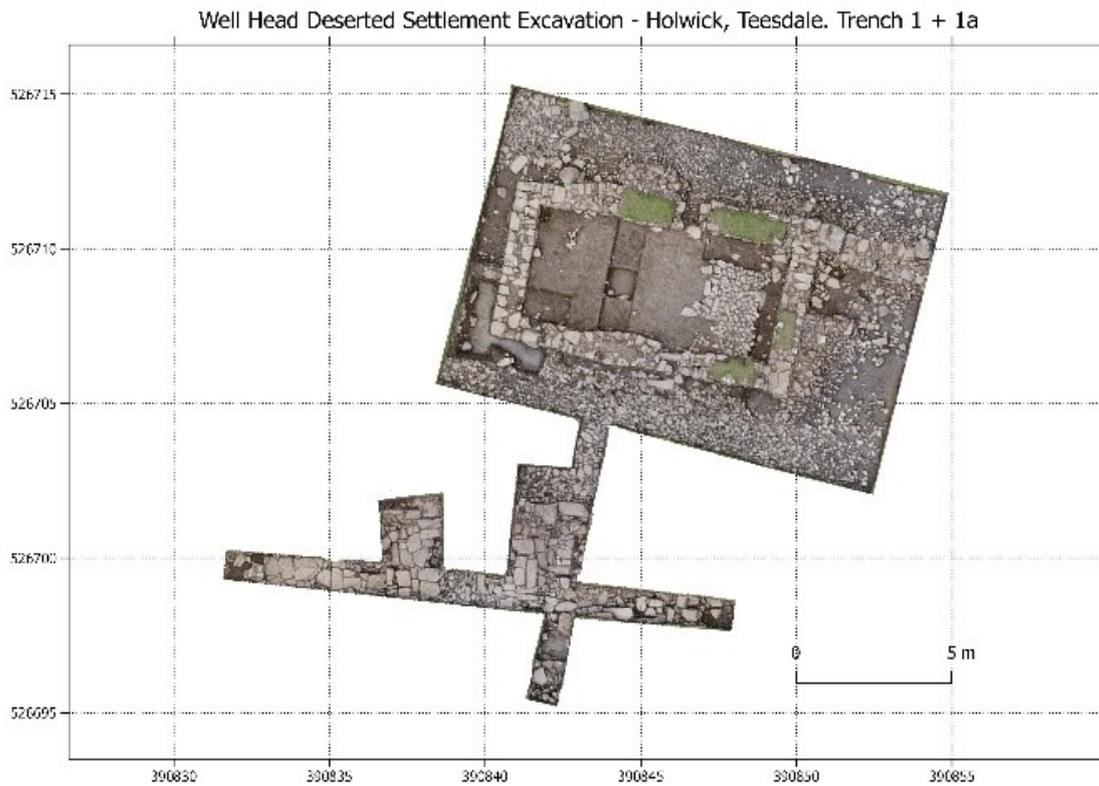
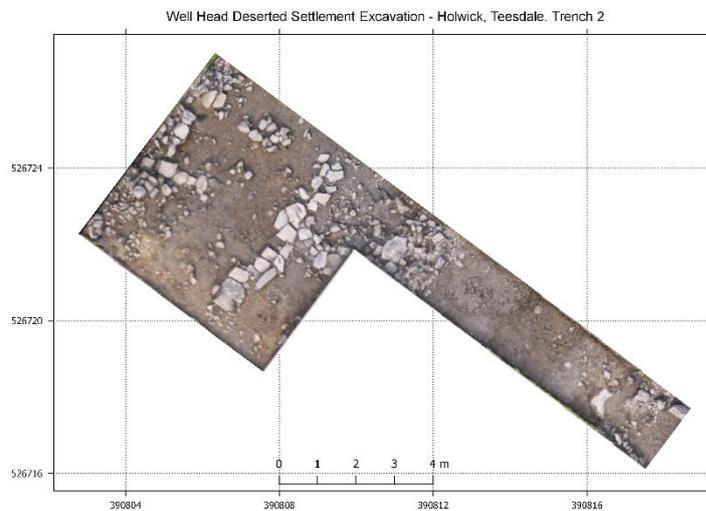
**Figure 5: 2017 trench locations on OS grid (Stephen Eastmead)**

Excavation of three trenches was carried out by AA members under the guidance of Paul Frodsham during two weeks in September 2017. After recording, the trenches were back-filled and re-turfed. See Figure 11 for a plan of trench positions in the settlement.

**Trench 1**, 10m x 14.3m, examined the rectangular structure F8 which was fully excavated, except that the stone wall-bases were not dismantled.

**Trench 1a**, 1m wide along the centre of both axes of rectangular structure F7, with widening of the trenches in two places. The arm of the trench across the width of F7 was extended to join up with Trench 1, enabling examination of the surface between F7 and F8.

**Trench 2**, 16m x 2m widened to 6m x 6m at its lower (west) end, examined the west side of the central hillock in the settlement, from the side-wall of F7, a rectangular structure on the top of the hillock, down across two platforms, F15 and F16.

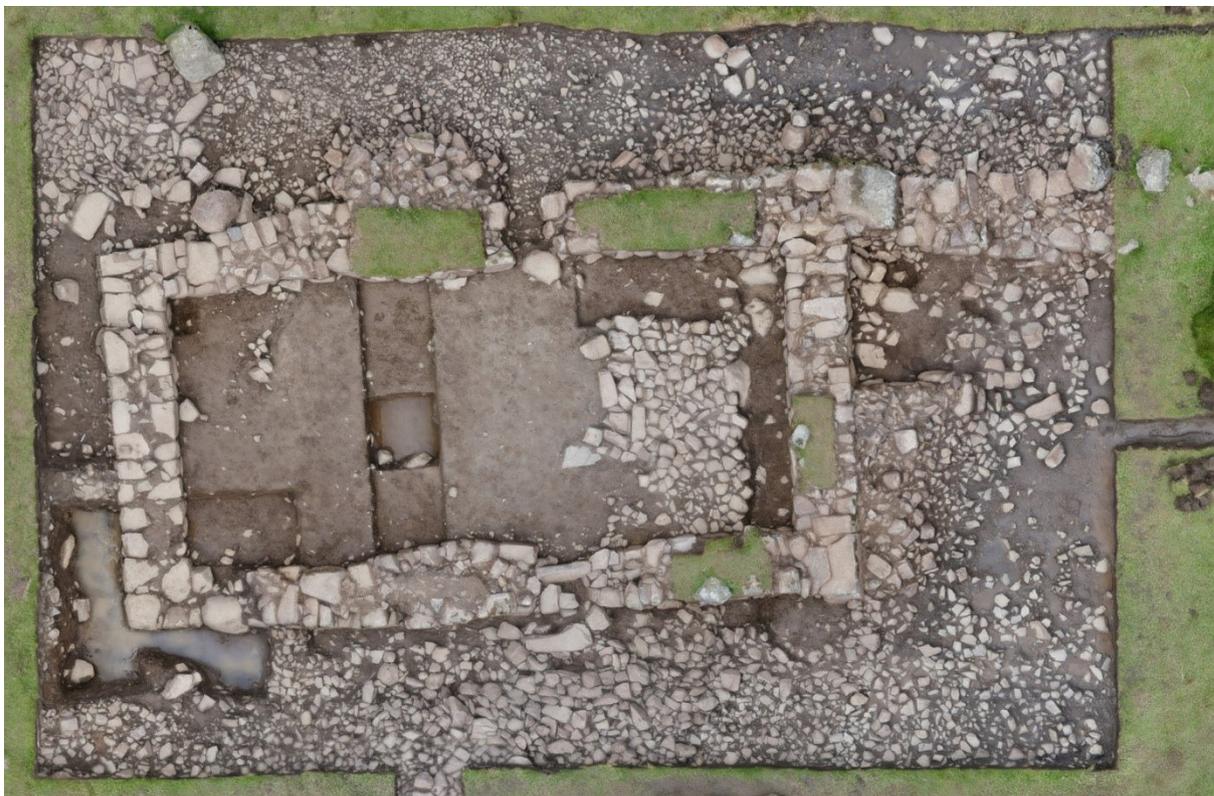
**Figure 6: Trench 1 vertical photogrammetry view. Building F8. The cobbled surface at the east end has been partly excavated in this view. (Stephen Eastmead)**

See below for a photogrammetric vertical view of this trench. The trench examined F8, a longhouse with entrances in middle of long sides. The walls are dwarf roughly-dressed stone structures with a rubble core. There is no mortar bonding.

There was a surface of worn cobbles in the downhill half (probably the part used to house livestock), but no drain was found. In the other (western) end of the house there was a surface of redeposited clay and subsoil. There were fragmentary remains of a robbed flagstone floor overlying this.

Outside the structure were cobbled surfaces: there was a good surface of small worn cobbles outside the north door, along most of the length of the north wall. On the south side of the structure was a surface of larger rougher cobbles with a drainage gully. This surface was continuous between F8 and the neighbouring structure F9 (examined by Trench 1a). To the northwest of F8 was a cobbled area edged with larger stones and overlying the cobbles outside the door.

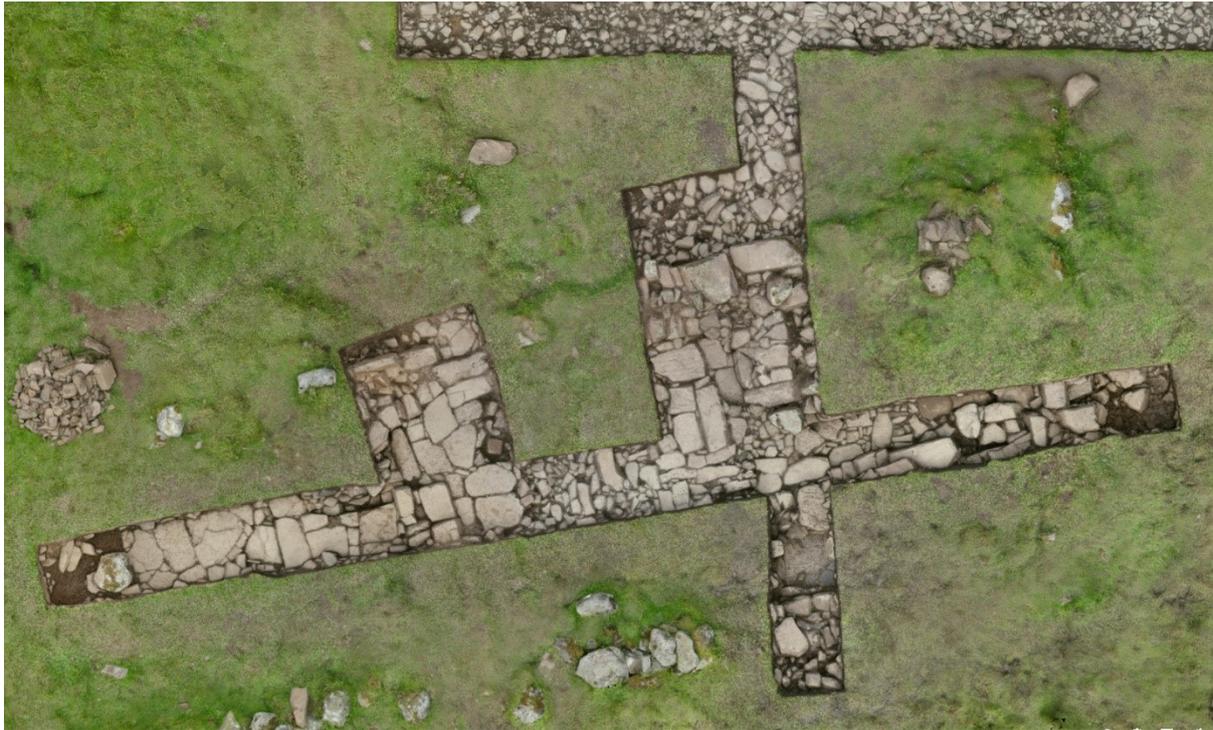
**Figure 7: Trench 1a vertical photogrammetry view. Structure F9. (Stephen Eastmead)**

This trench examined structure F9, a long-house type building about 5m south of and at a slightly different orientation to long-house F8. No attempt was made to fully excavate this; crossed 1m wide trenches were excavated centrally along the short and long axes of the structure and crossing the gap to Trench 1, enabling the surface between the structures to be examined. The intention was to enable an assessment of whether the two structures F8 and F9 were similar.

The cobbled surface stretched all way across the gap between structures F8 and F9. The walls of F9 were similar to those of F8: dwarf roughly-dressed stone walls, lacking mortar. The west end was not defined: there may be a cross wall or end wall two thirds of the way along the trench with the west end of the structure represented by the large stone and smaller stones. There was a short internal stub wall (143).

The interior of F9 was almost completely paved in a patchwork of areas of different size cobbles and flags. There were fragmentary remains of an upper flagged surface seen in the trench section. East of the house was a cobbled surface, similar to that between F8 and F9. Two threshold-stones/doorsteps were found in the NW corner of the trench, these may have been re-used for wall-building rather than being in situ.

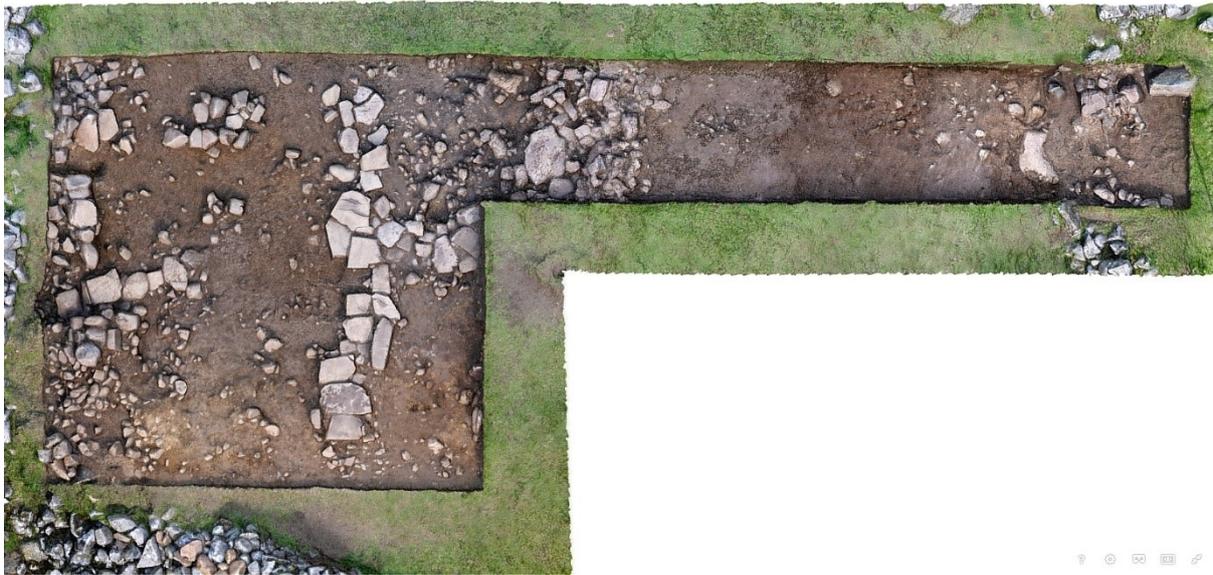
Figure 8: Trench 2 vertical photogrammetry view. (Stephen Eastmead)

Trench 2 investigated the two platforms (F15 & F16) on the stream side of the hillock with the aim of showing whether they were natural or man-made, and whether they were yards or had structures on them. Excavation showed no building foundations or post-holes. There was evidence of paving, perhaps paths. The platforms were clearly man-made with stony banks revetting the edges. The lower end of the paving extended under, so was earlier, than the stony bank by the stream.

A wall of the rectangular structure (F7) on the hillock was cut at the east end of the trench, possibly passed through an entrance. The wall was just a line of rubble not dressed stone. F7 is an oddity: it has a different orientation to the other buildings on the site and seems unlikely to be a long-house.

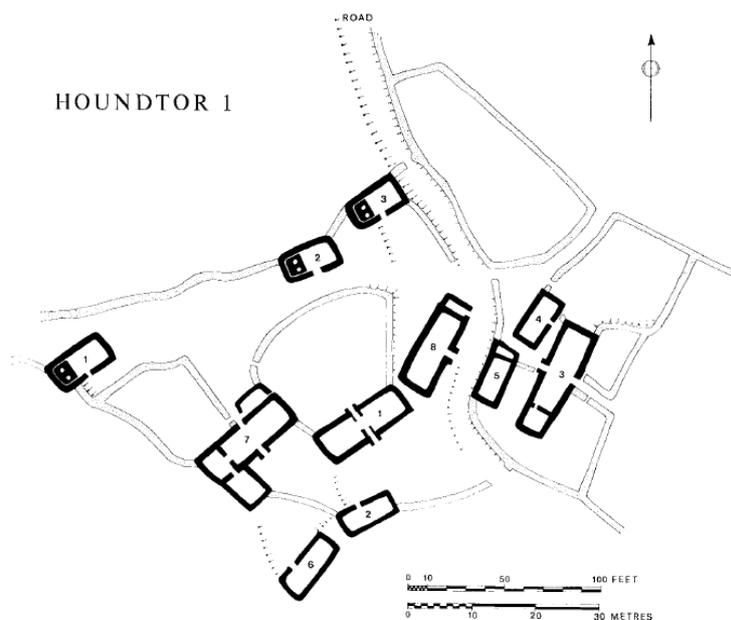
FIG. 2  
Houndtor Village. Plan of 13th-century settlement with stone houses.  
Buildings 1-3 to the north are corn-drying barns

**Figure 9: Plan of Hound Tor settlement, Dartmoor (from Beresford 1979)**

Comparisons are difficult as so little previous work on other upland medieval hamlets has been carried out. In one similar hamlet at Hound Tor (Dartmoor), excavations showed that not all of the rectangular structures were houses, three were barns with corn-drying kilns (Beresford 1979). The houses were dated to the 13<sup>th</sup> century but overlay earlier small scooped buildings of turf and wattle. The settlement was abandoned in the 14<sup>th</sup> century.

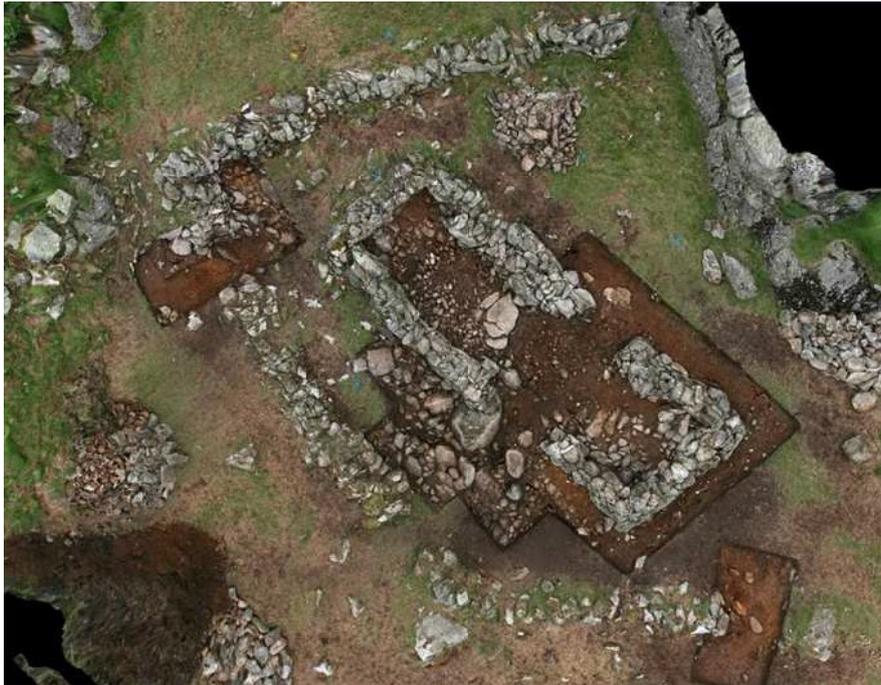
**Figure 10: Excavation of a long-house, Duddon Valley, Cumbria**  
*(from Bradley et al 2016, Oxford Archaeology North)*

In the Duddon valley, Cumbria, upland long-houses were recently excavated by local volunteers, directed by Oxford Archaeology North (Bradley et al 2016). The illustration below shows a 7m long-house with a central hearth and opposed doors on the long sides. Charcoal dating suggested last occupation in the 16<sup>th</sup> century.

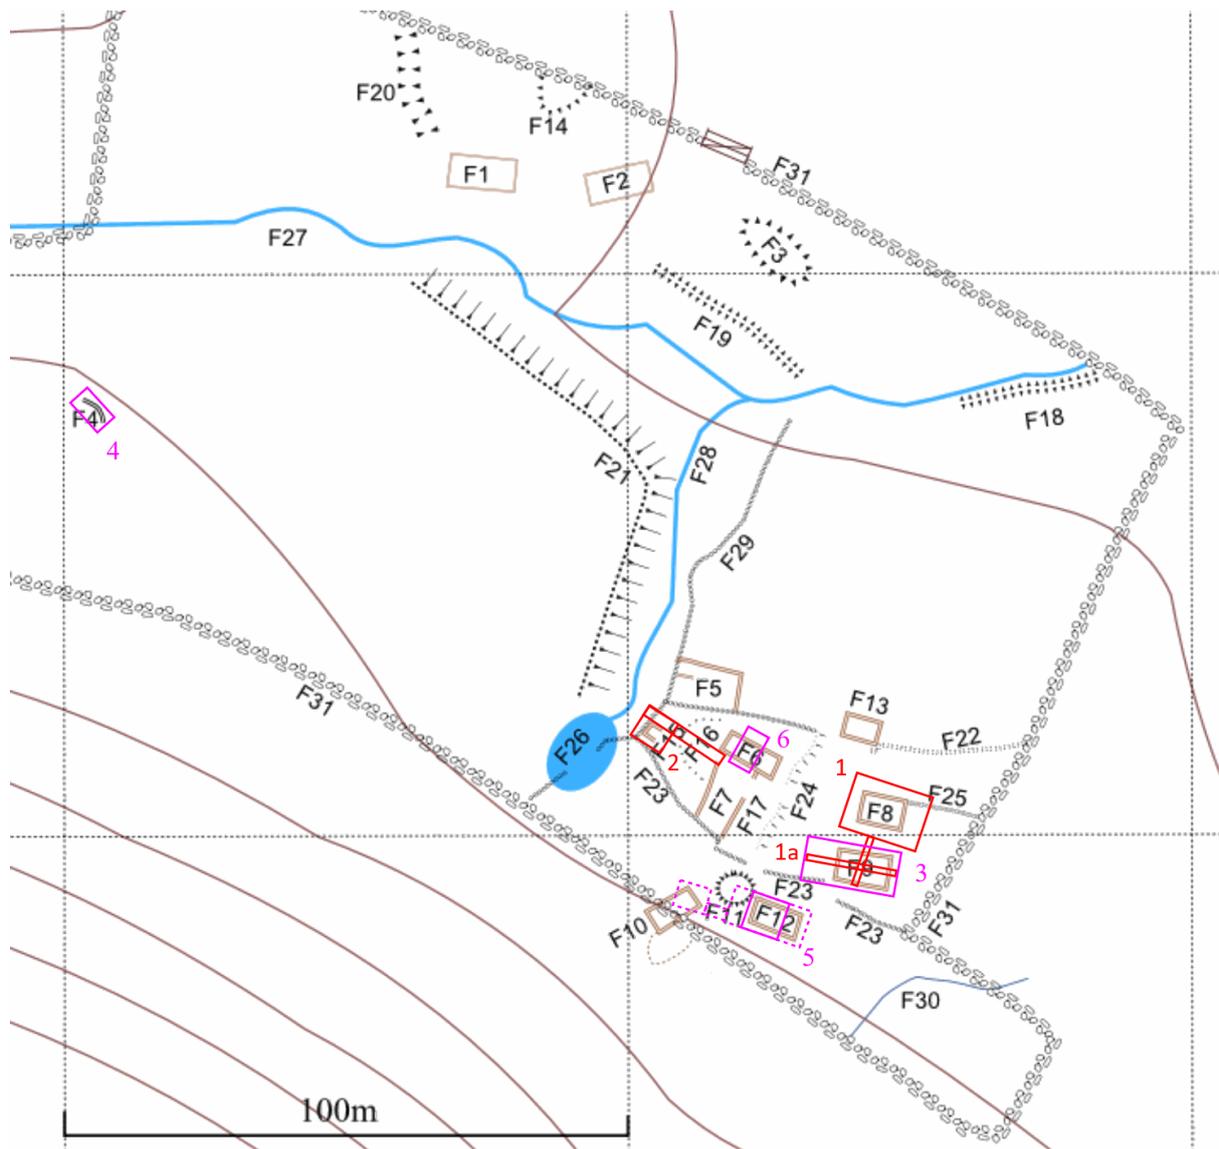
**Figure 11: Provisional location of 2018 trenches. Trenches excavated in 2017 are shown in red, those planned for 2018 are shown in purple.**

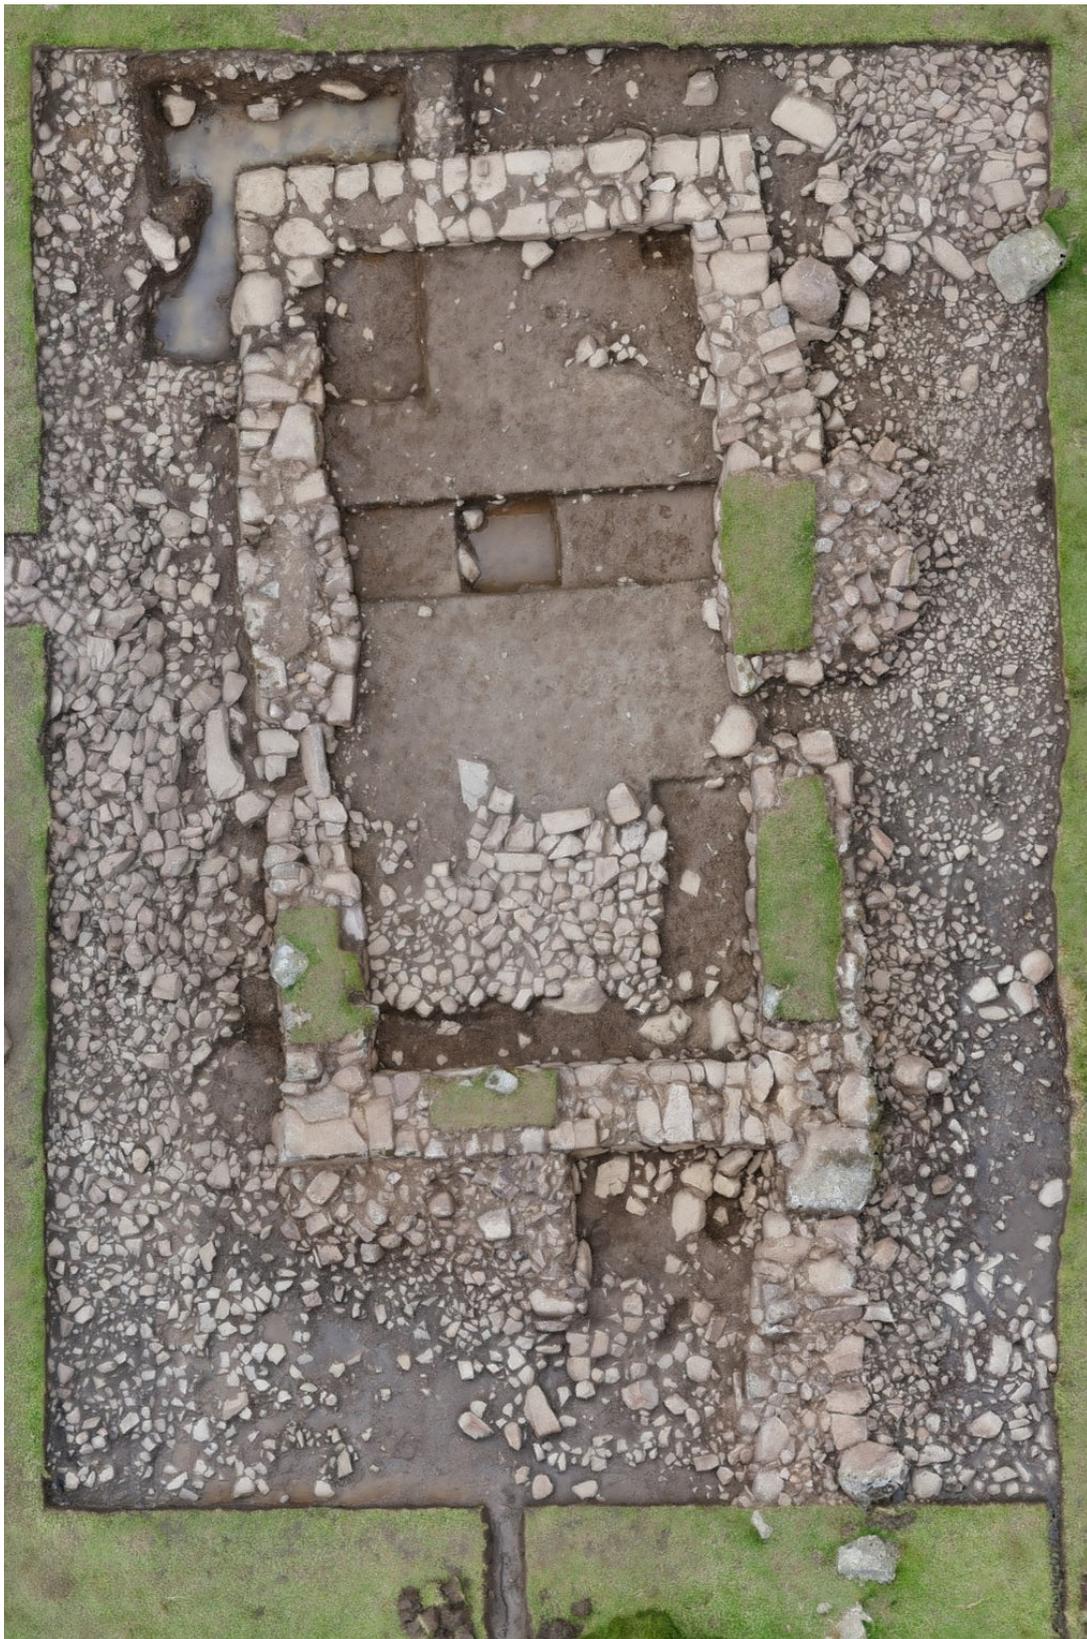
**Trench 1: North is to right. Trench is 10m wide (north-south). The interior cobbled surface in the east end of the building has been partially excavated.**

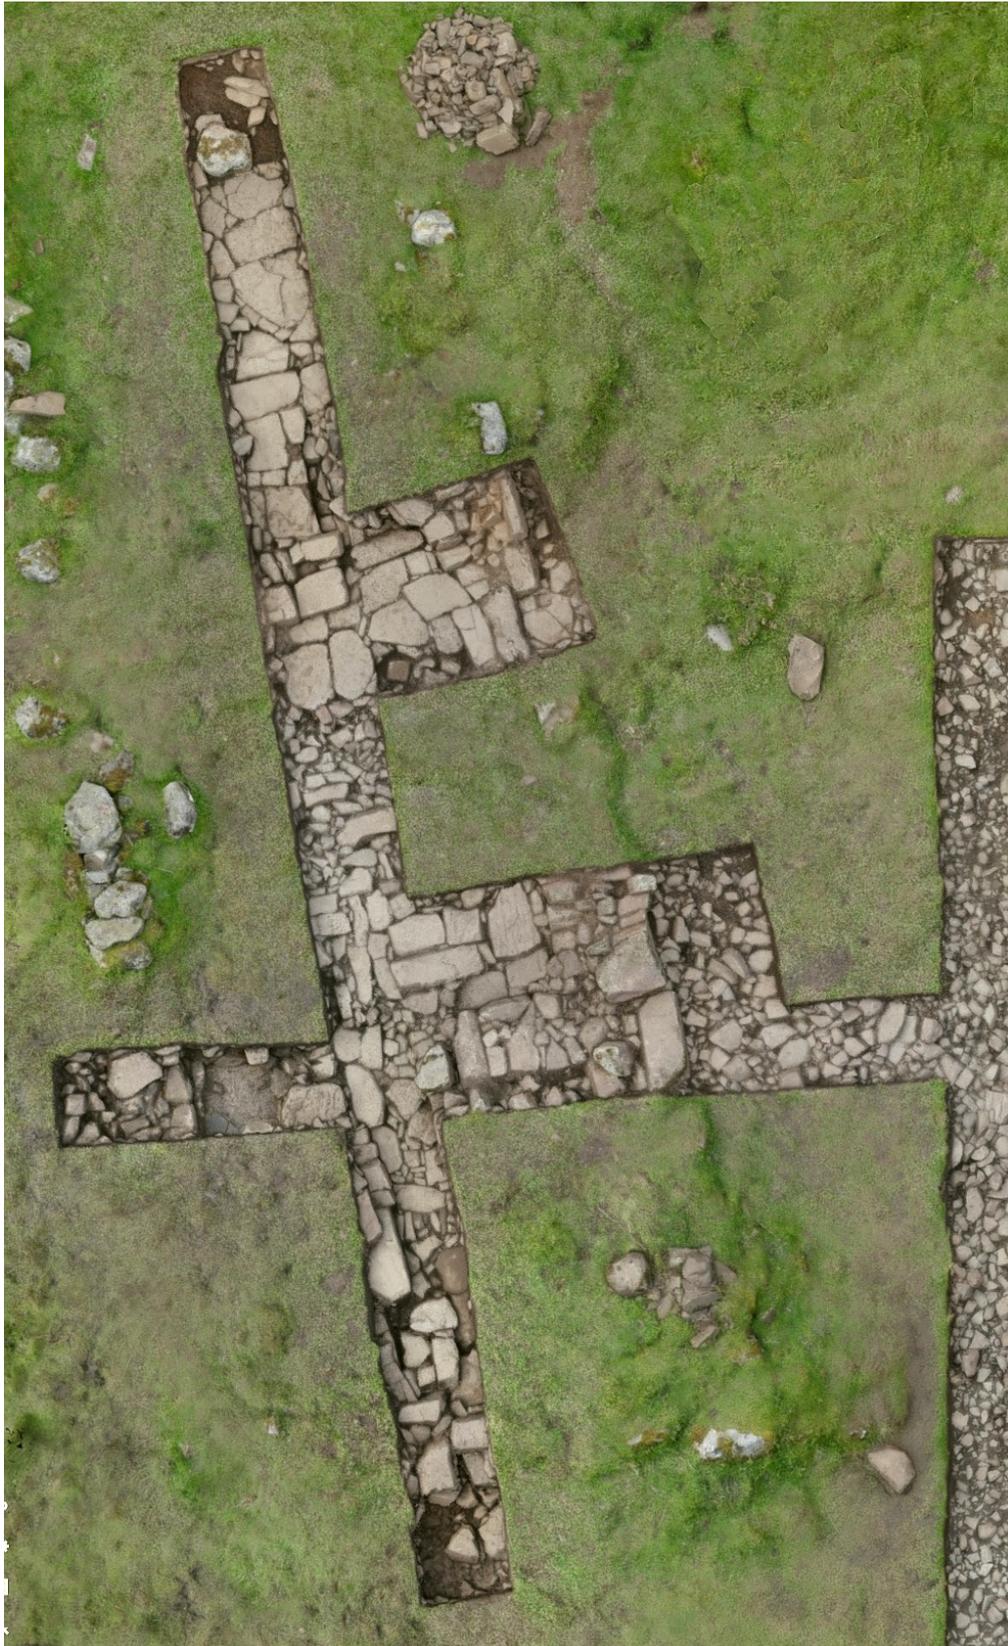
**Trench 1a: North is to right. Narrow trenches are 1m width. The edge of Trench 1 is at the right of this image.**

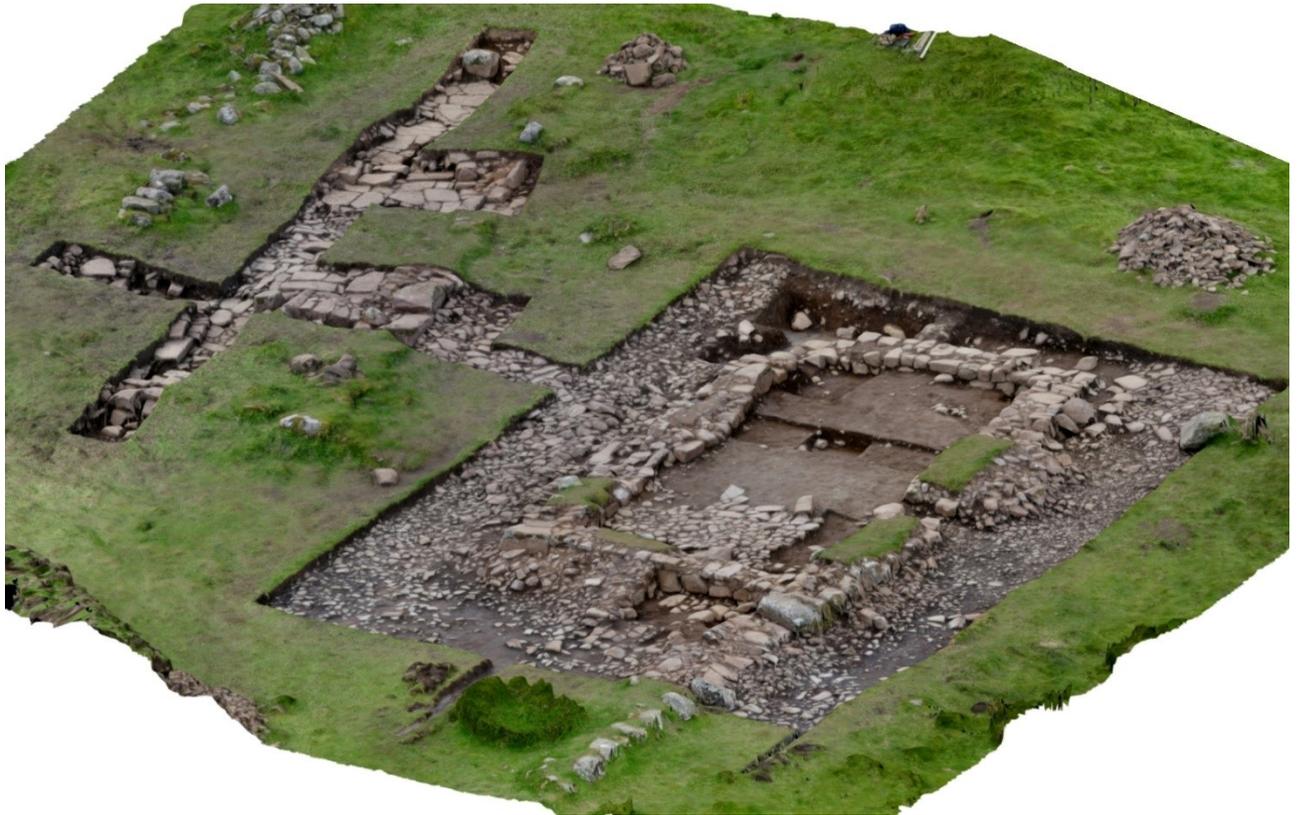
**Trenches 1 and 1a oblique view looking southwest**

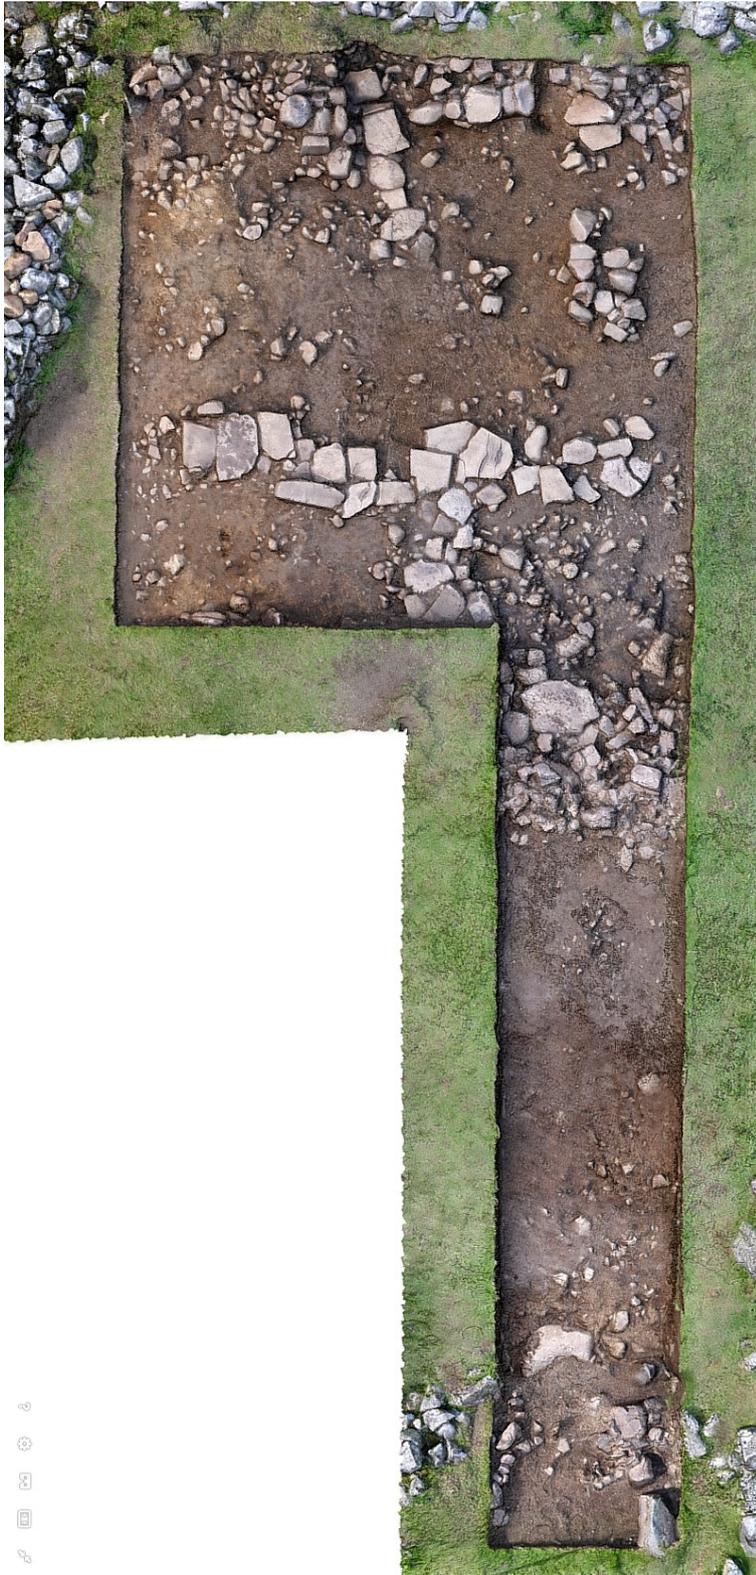
**Trench 2: North is to right. The narrow part of the trench is 2m wide, the wider part is 6m wide. (All photogrammetry by Stephen Eastmead)**

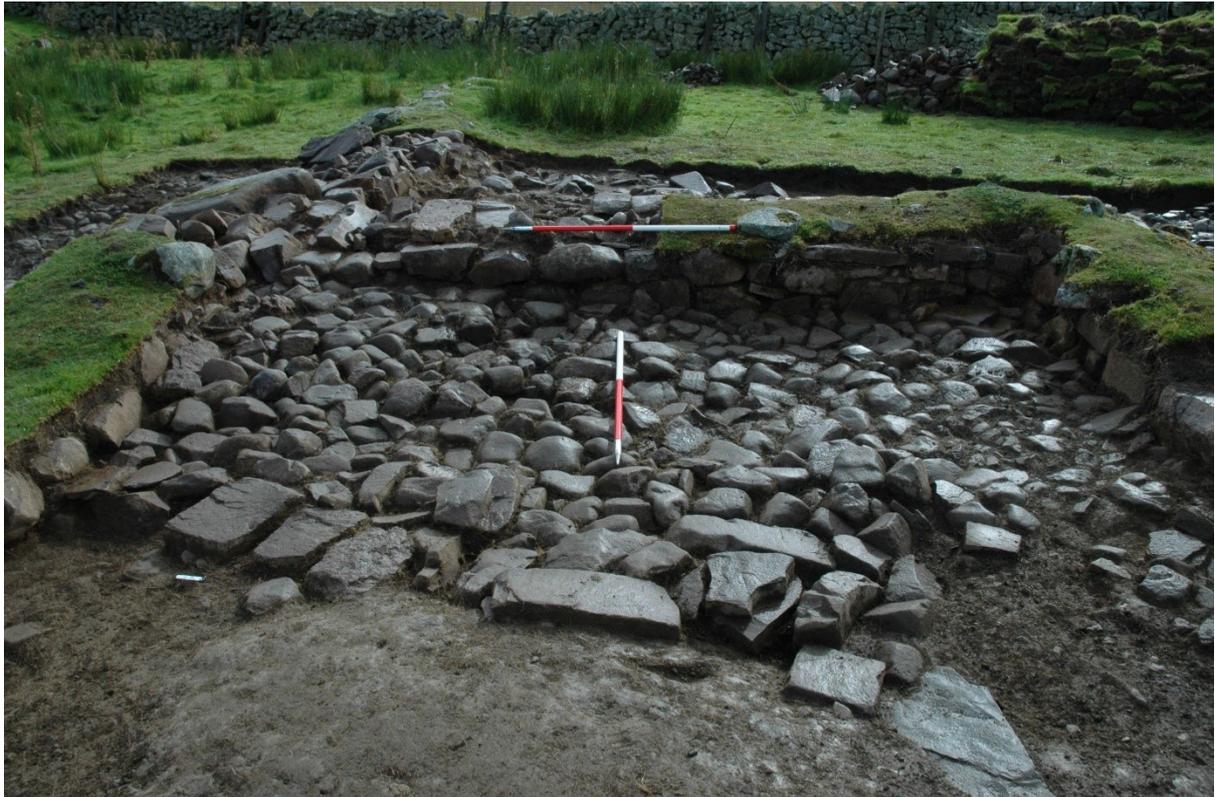
Interior of building F8: worn cobbled surface 106, looking east

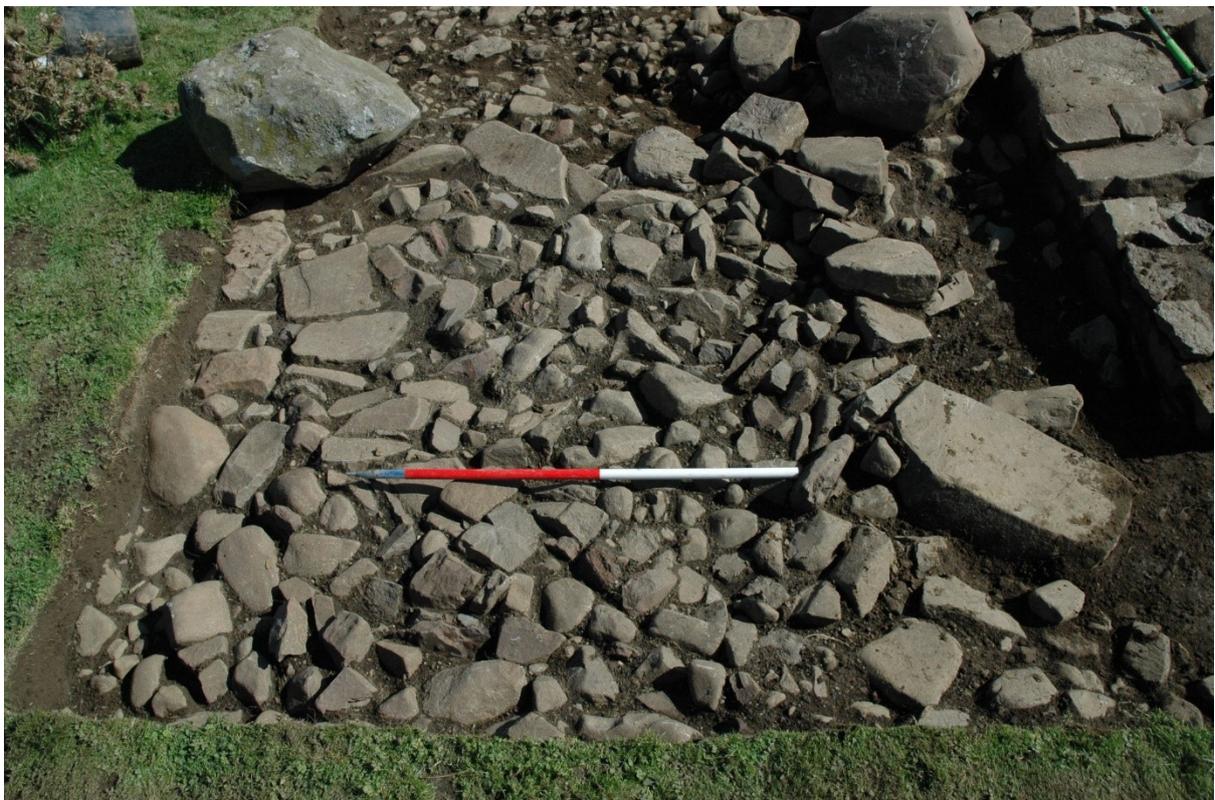
Cobbled surface 118 outside northwest corner of F8, looking east

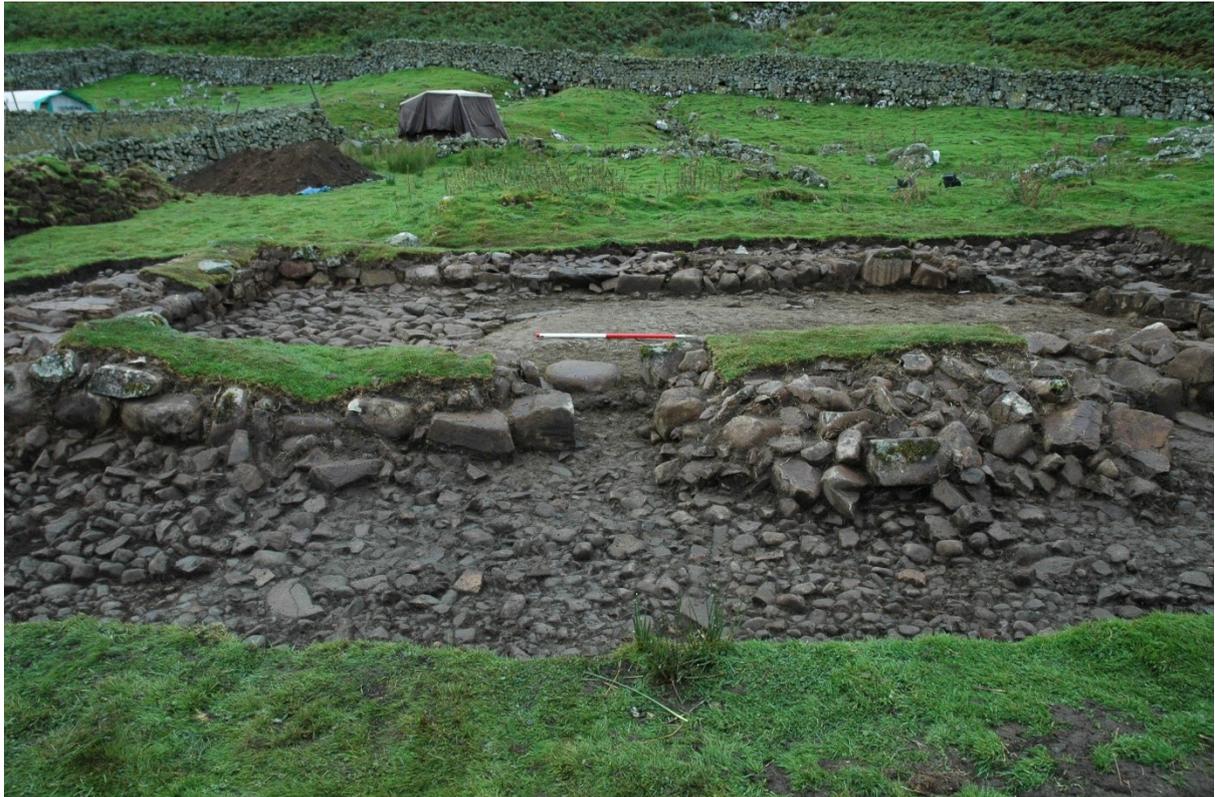
Building F8, looking south with worn small cobble surface 117 outside north door and rubble 108 piles against exterior of wall

A field wall abuts the northeast corner and rubble was piled against the outside of the north, east, and south sides of the structure, overlying the cobbled surfaces. There was also rubble piled against the inside of the west wall.

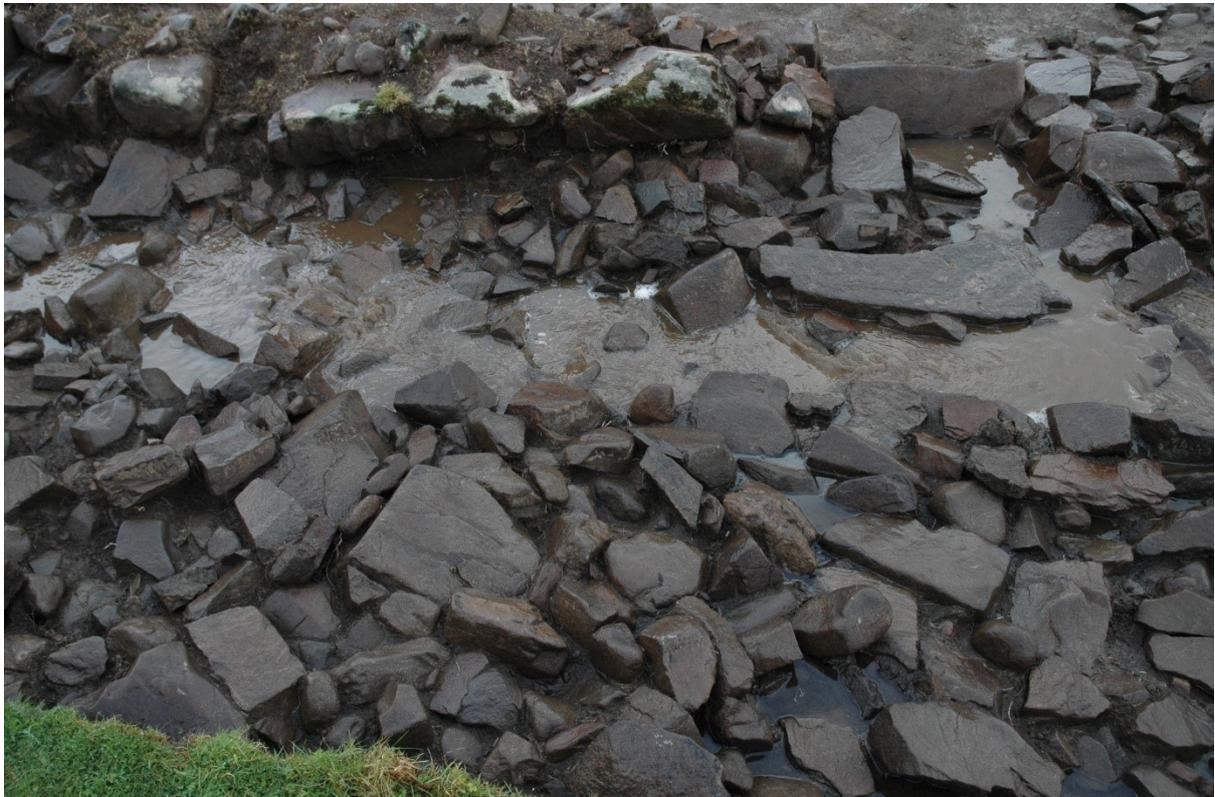
Rough cobbled surface 105 and gully (with water flowing) outside south door of F8

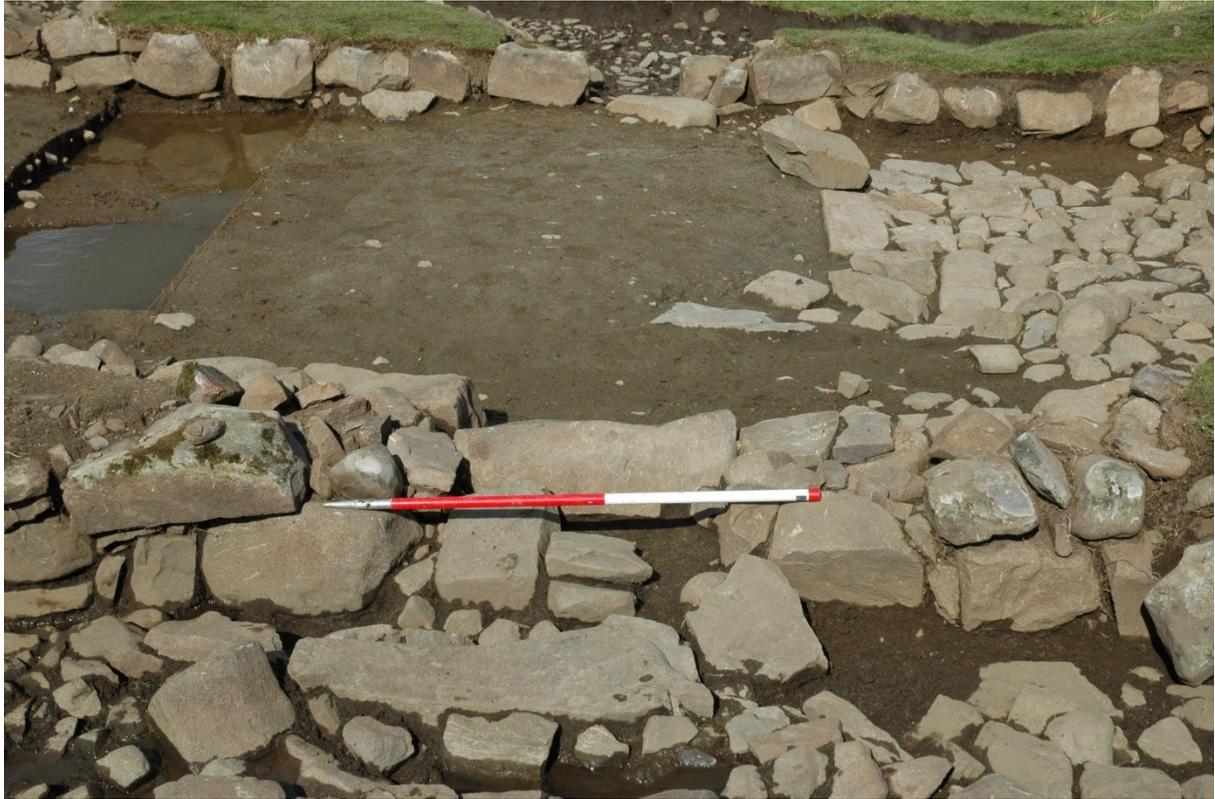
Building F8: south door looking north, blocked by displaced threshold-stone/doorstep

Cobbles run into the north door from the outside. The south door has a slab in a displaced position with deep scratches marks on underside, suggesting a failed attempt at robbing it.

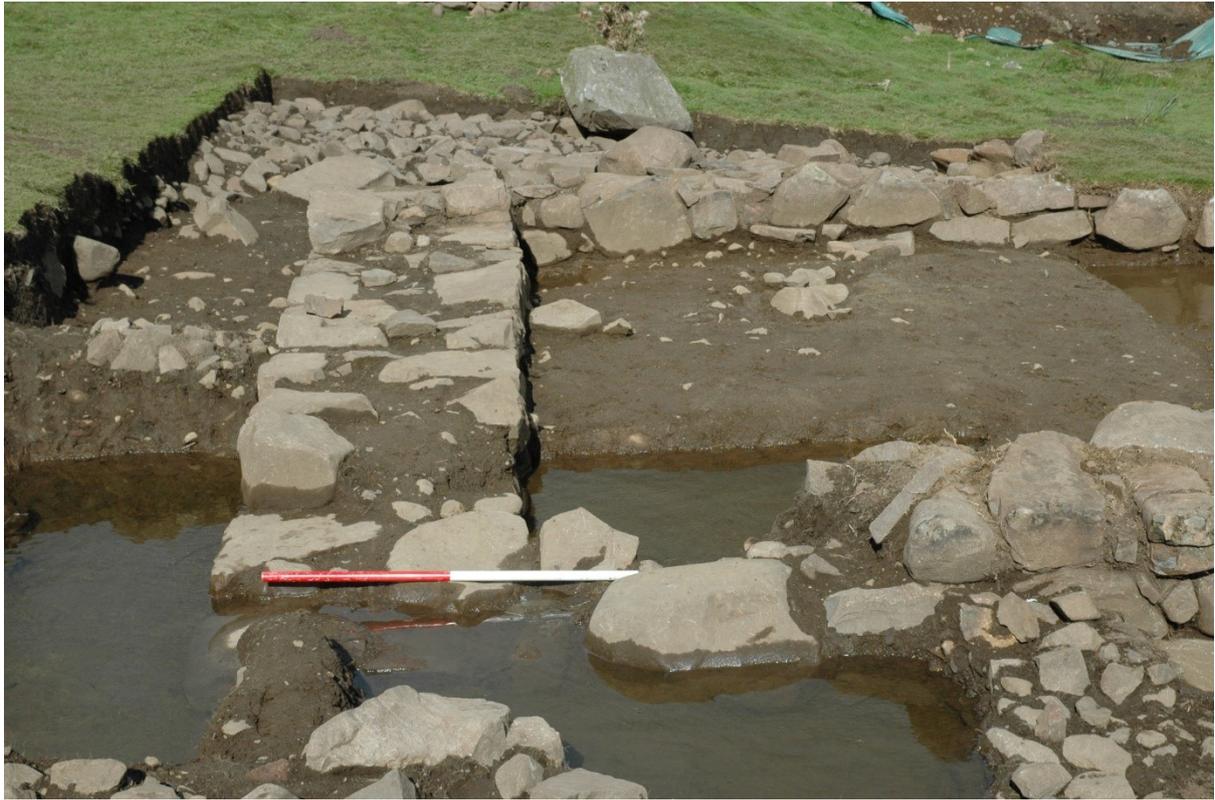
Building F8: west wall looking north

The west wall is strongly built to withstand earth pressure, the east wall is somewhat more lightly constructed, and the long north and south walls are even less robust; the south wall faces are slumping apart to the west of the south door. The east wall is later (abutting) the north wall, consistent with the east end of the north wall having been a pre-existing field wall.
