# WELL HEAD DESERTED SETTLEMENT Holwick, Teesdale

*Project Design for 2018 (2nd season) Excavation  
and Interim Report on 2017 Excavation*

Version 1.2 (11 April 2018)

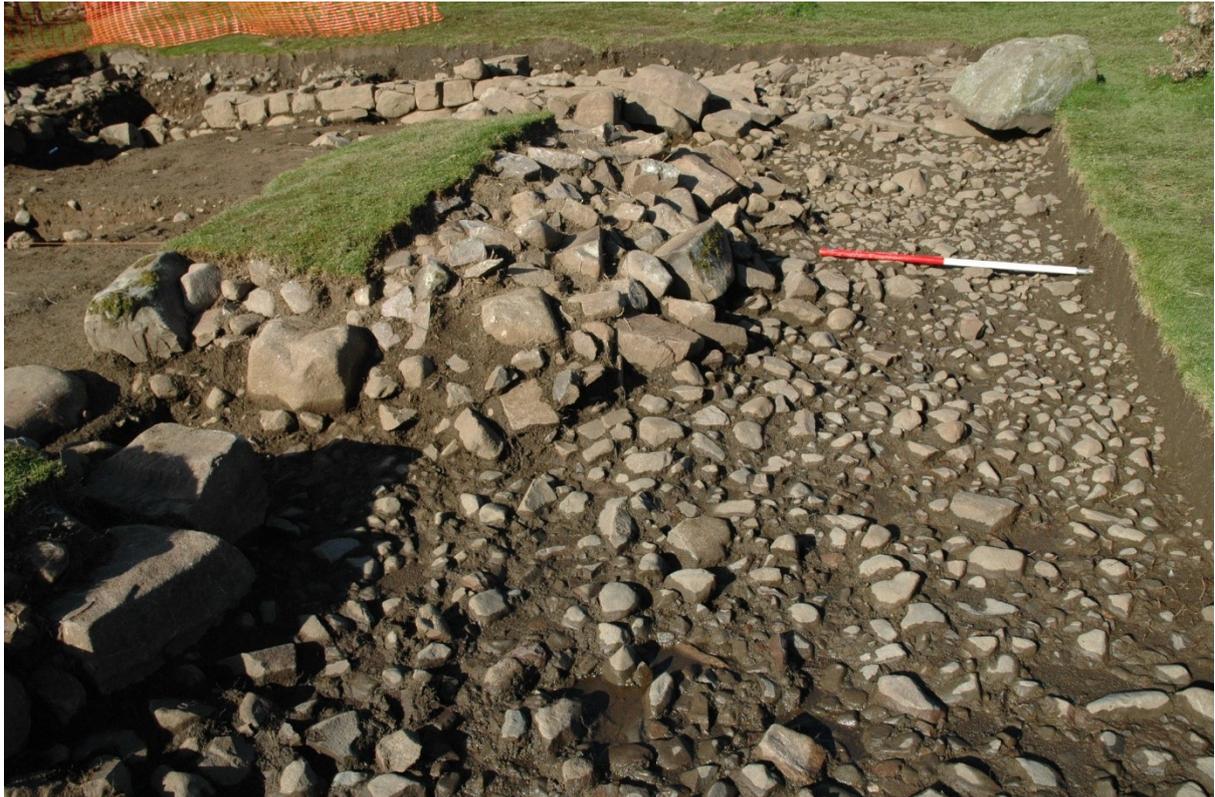
Building F8: worn cobbled surface 117 outside north door, with rubble 108 against outside of north wall

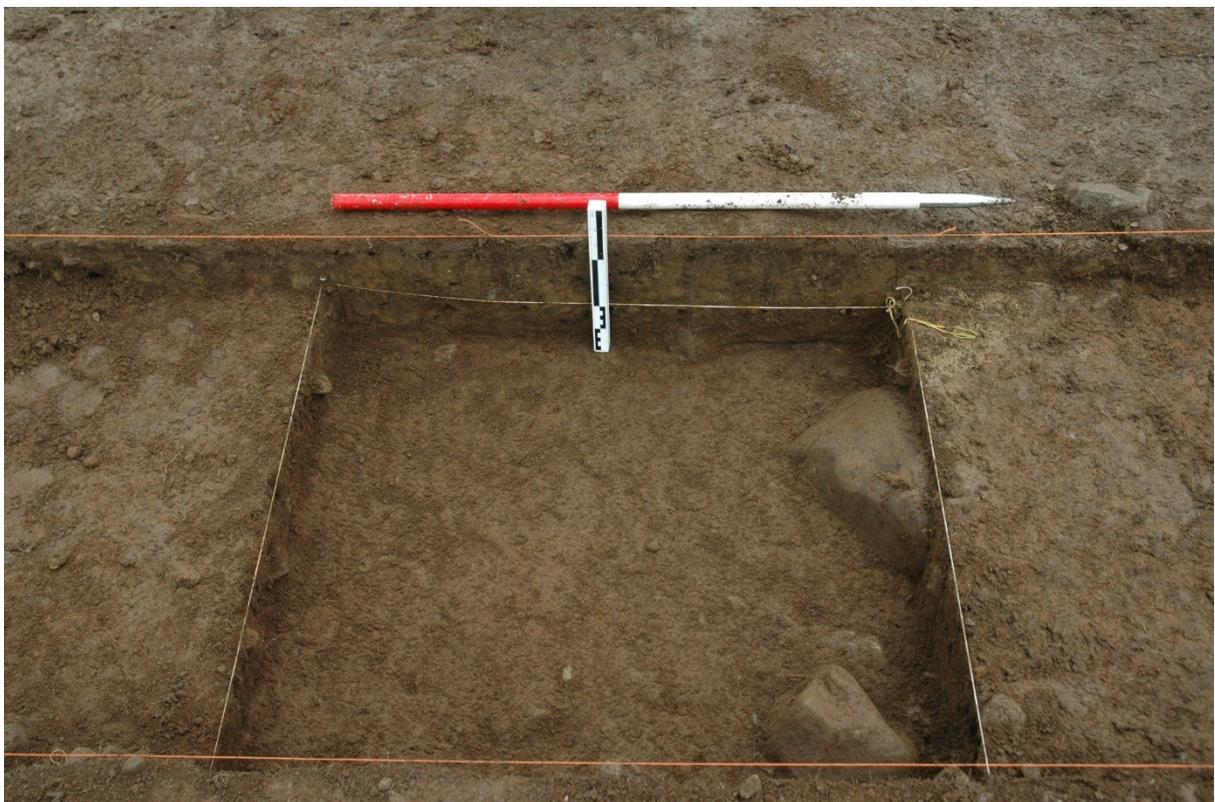
Building F8: sondage through floor of building F8

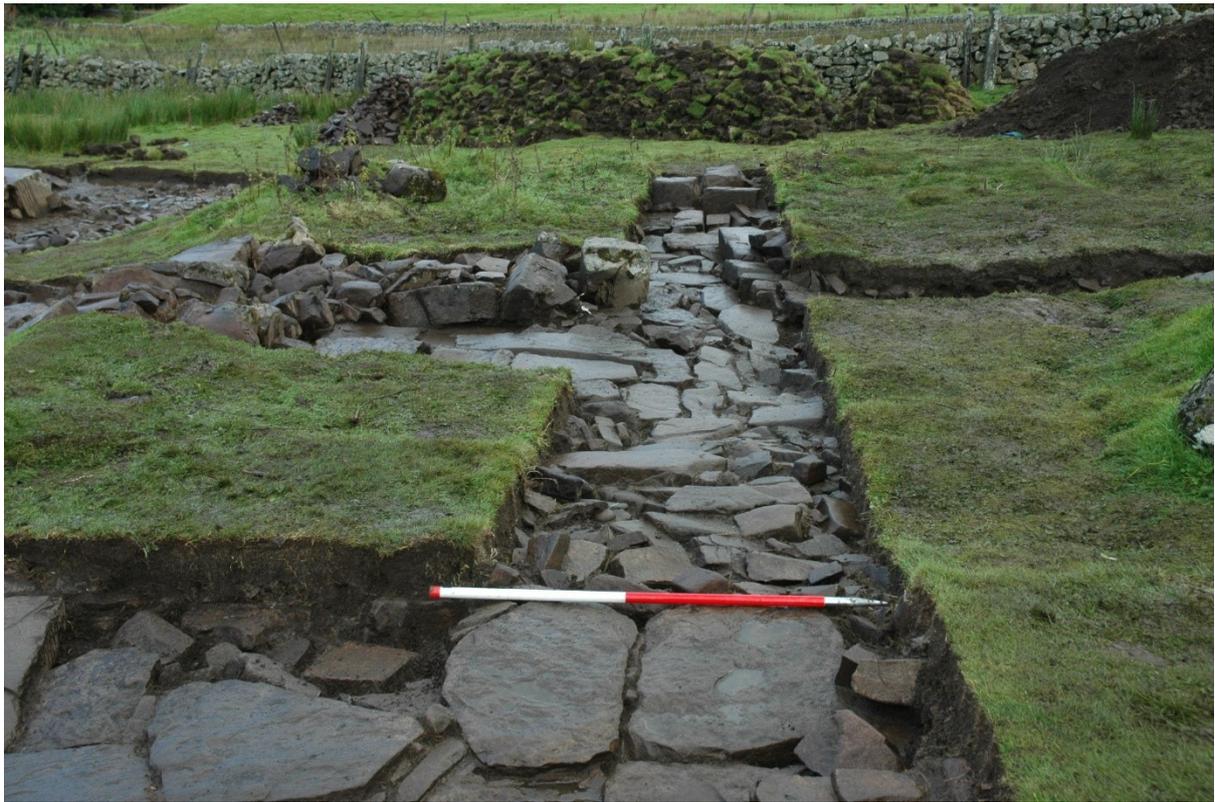
Looking east (east end of trench). Upper paved surface 132 seen in right-hand section, east wall 131 is at far end of trench.

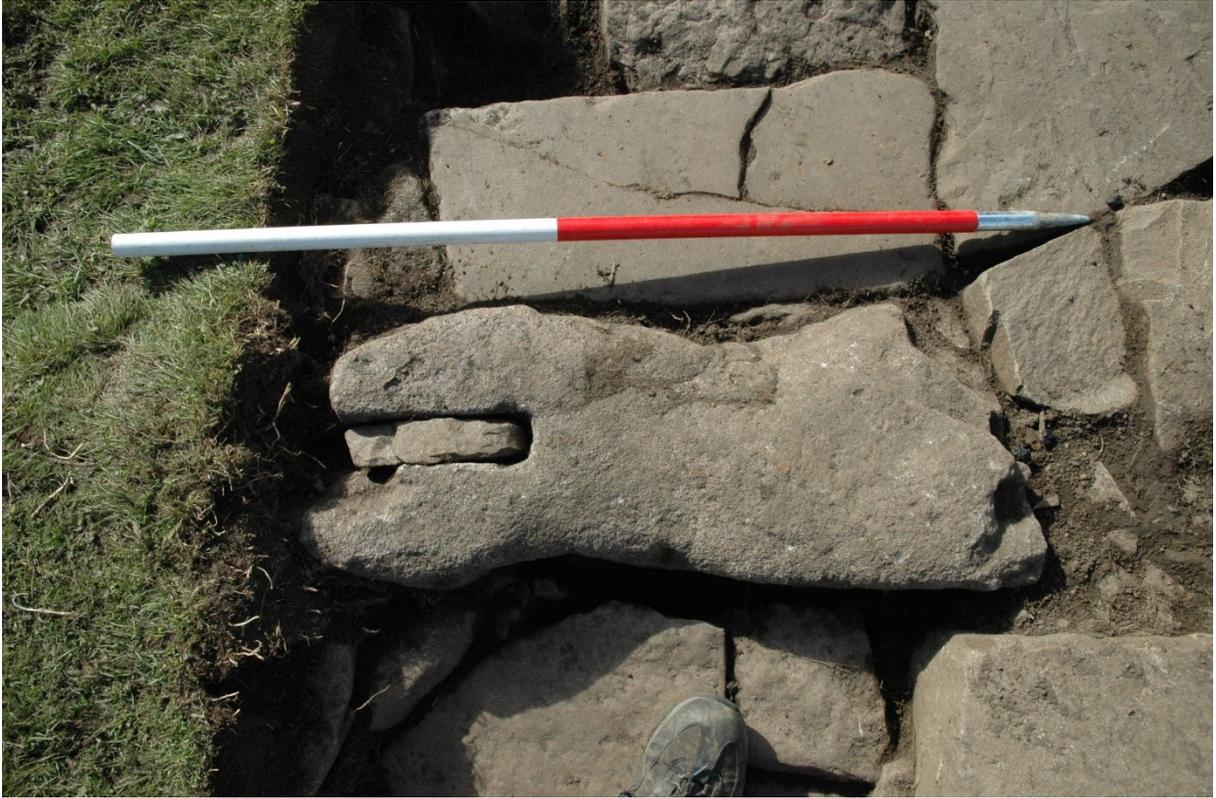
Building F9: Threshold stone/doorstep 1

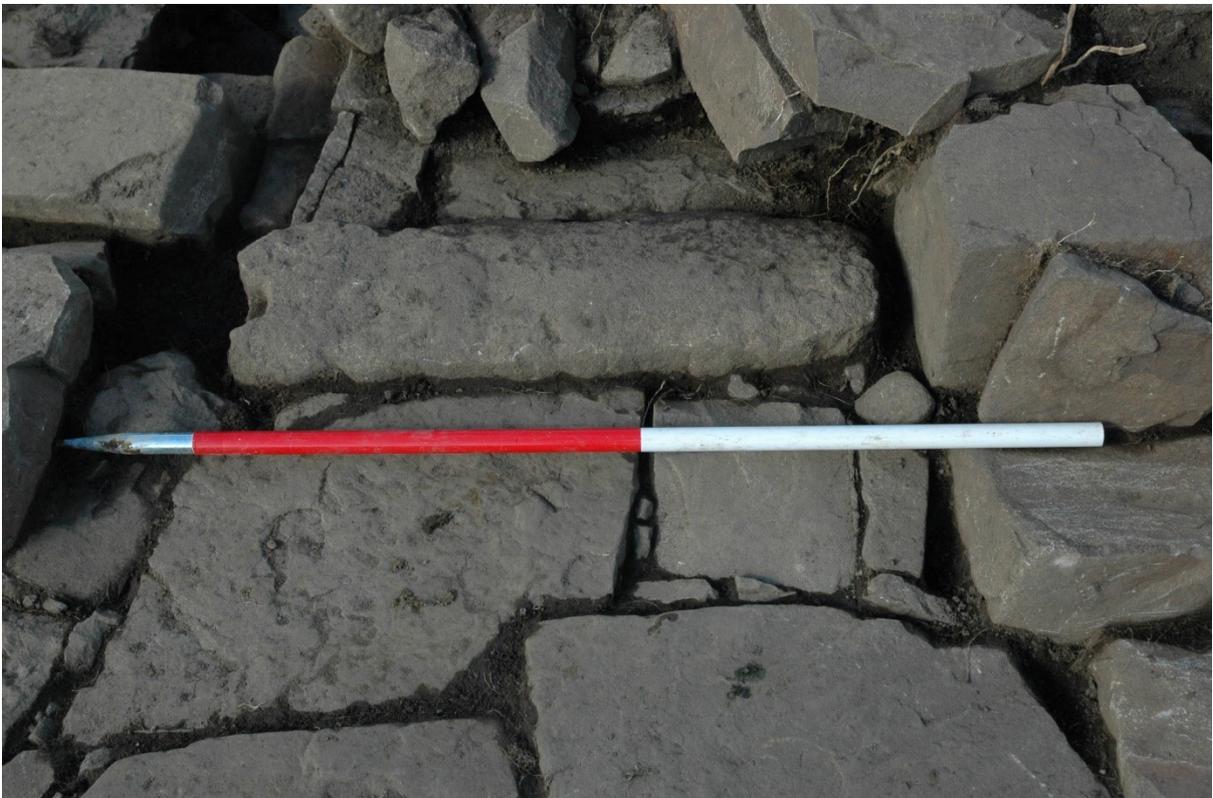
Building F9: Threshold stone/doorstep 2

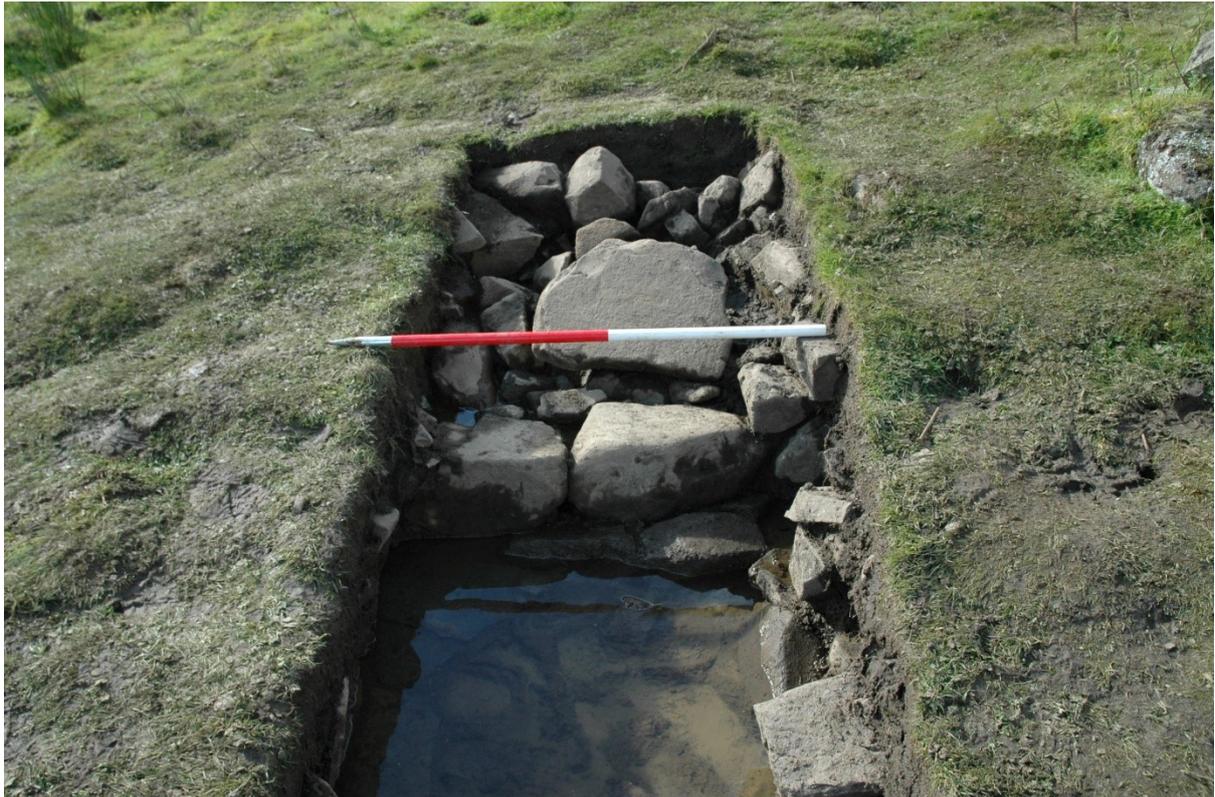
Building F9: south wall 135

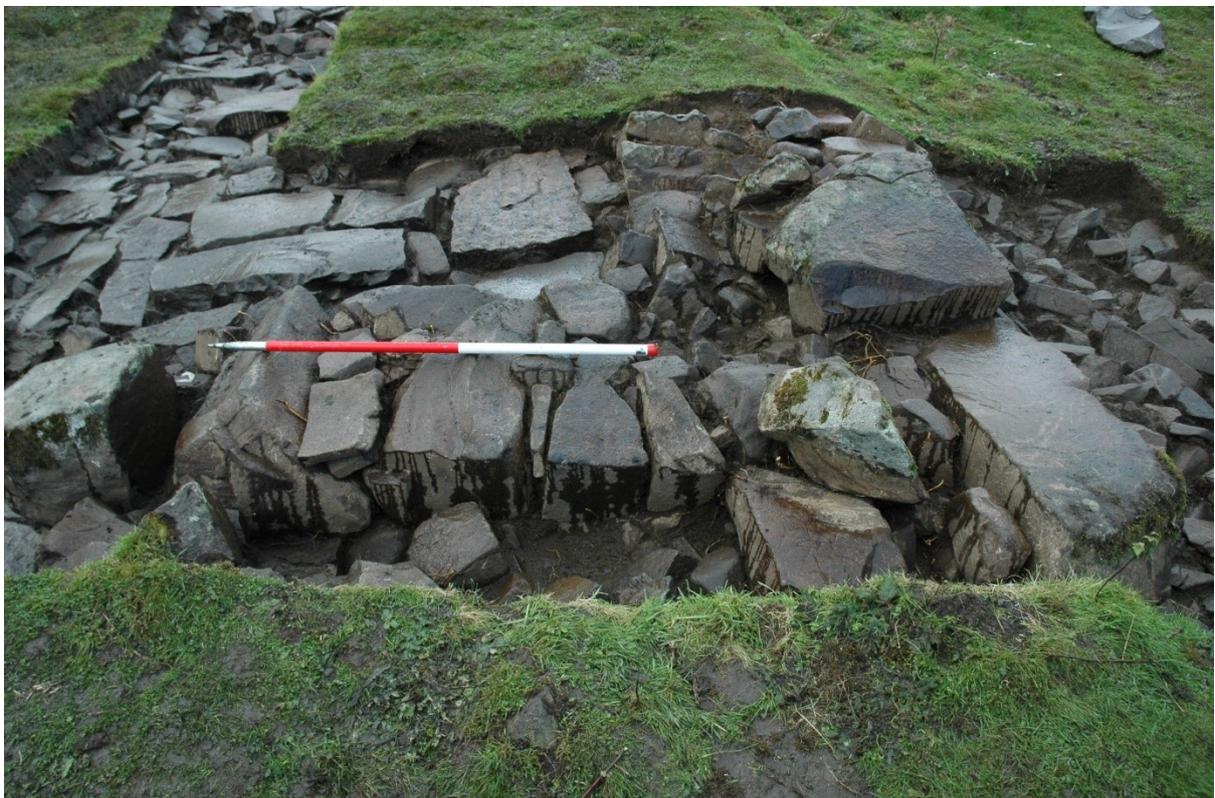
Building F9: short stub cross-wall 143

The cobbled surface stretched all way across the gap between structures F8 and F9. The walls of F9 were similar to those of F8: dwarf roughly-dressed stone walls, lacking mortar. The west end was not defined: there may be a cross wall or end wall two thirds of the way along the trench with the west end of the structure represented by the large stone and smaller stones. There was a short internal stub wall (143).

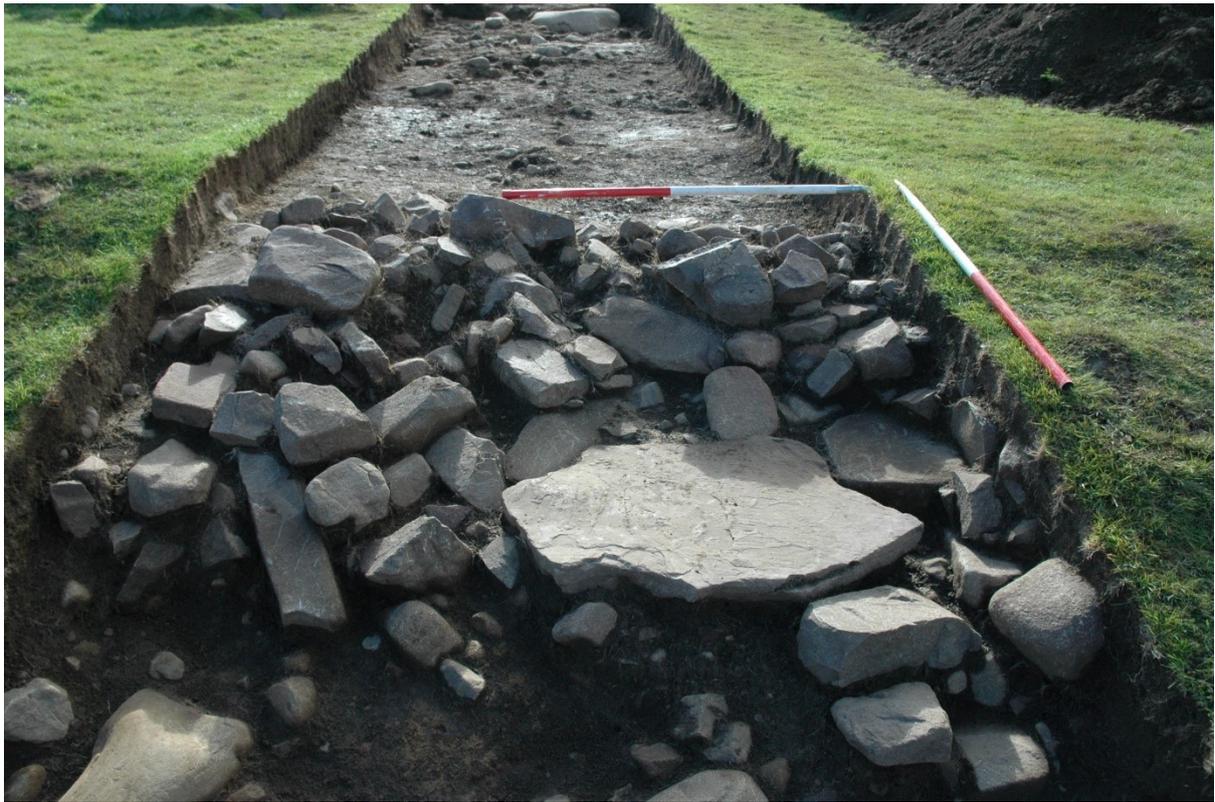
Revetted slope 204 between platforms

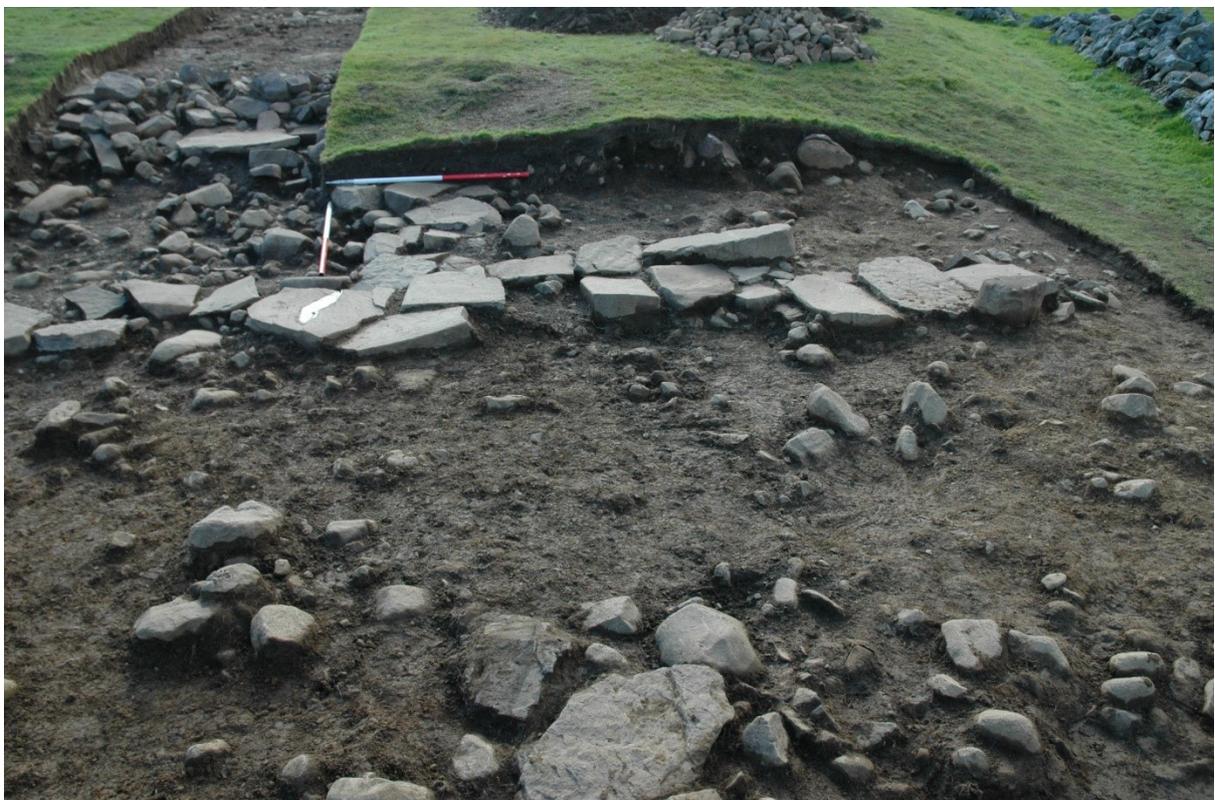
Line of paving 203, looking east
