WELL HEAD DESERTED SETTLEMENT

Holwick, Teesdale

Survey Report, 14th to 20th May 2017

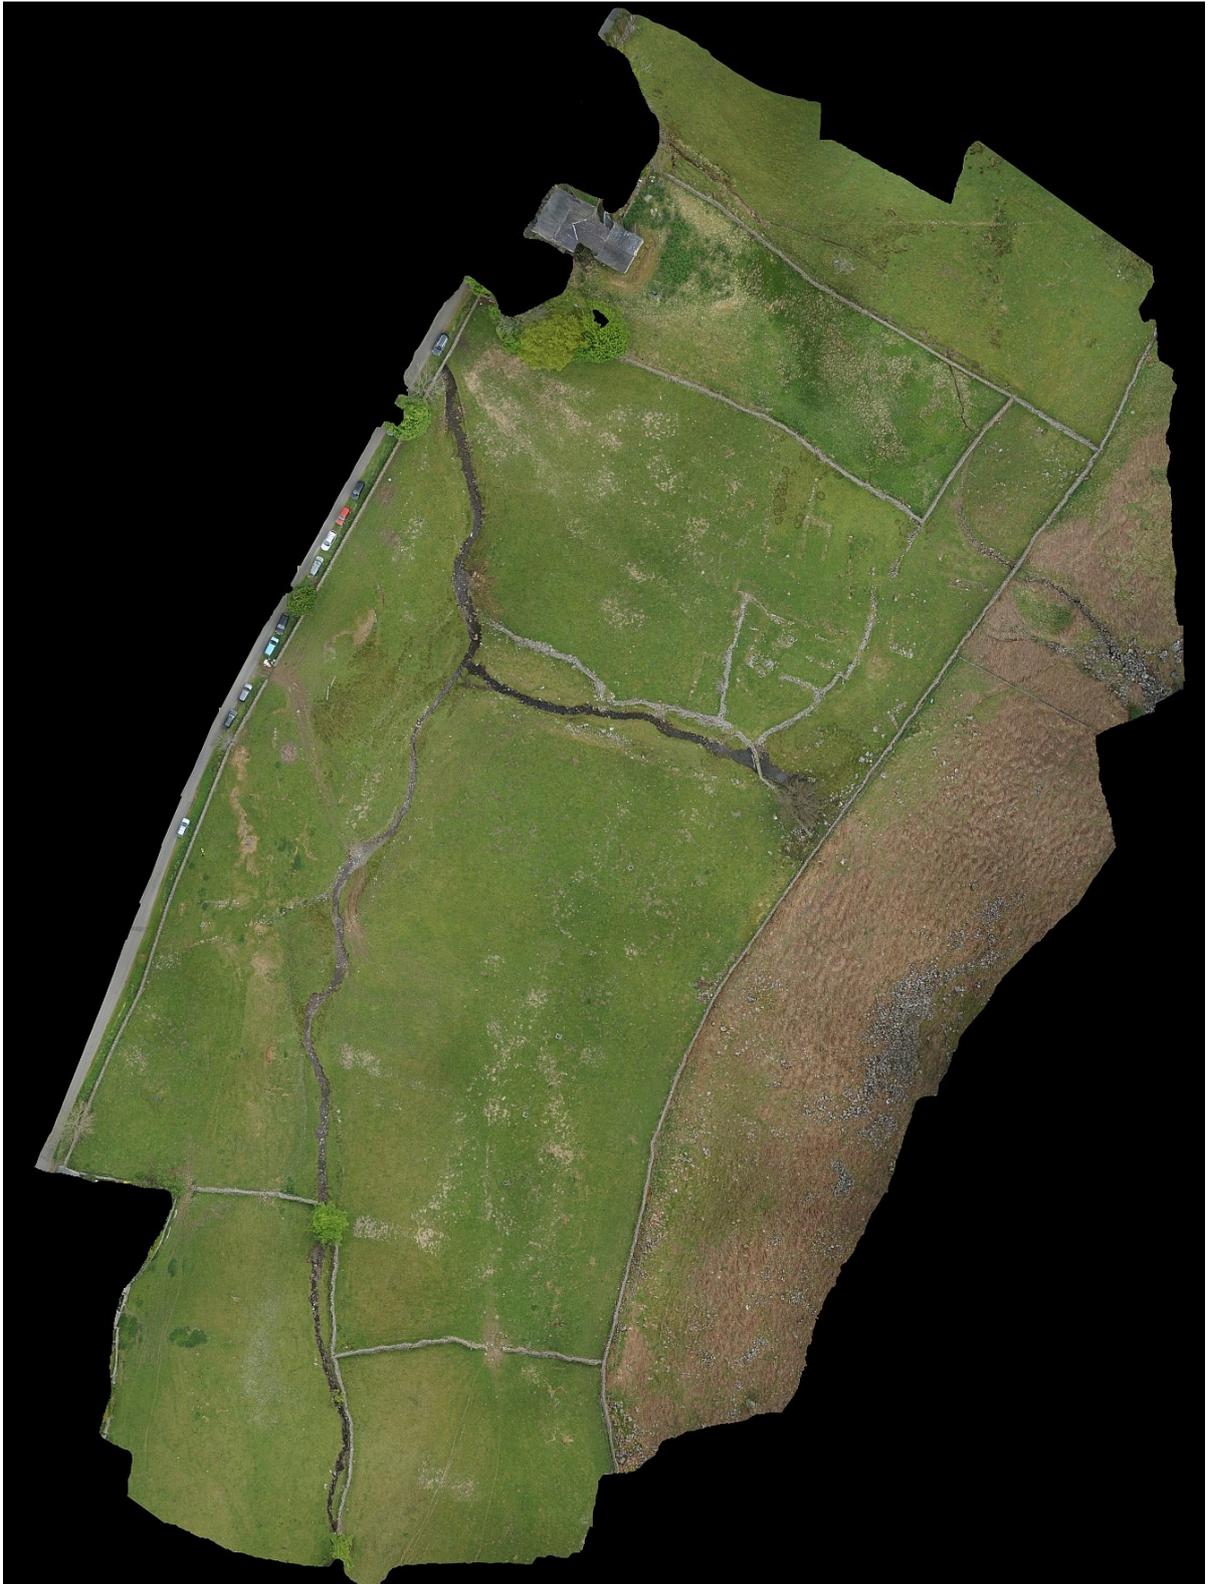
Figure 9: Drone photogrammetry: vertical isometric view of site.
By Pete Schofield (Oxford Archaeology North).

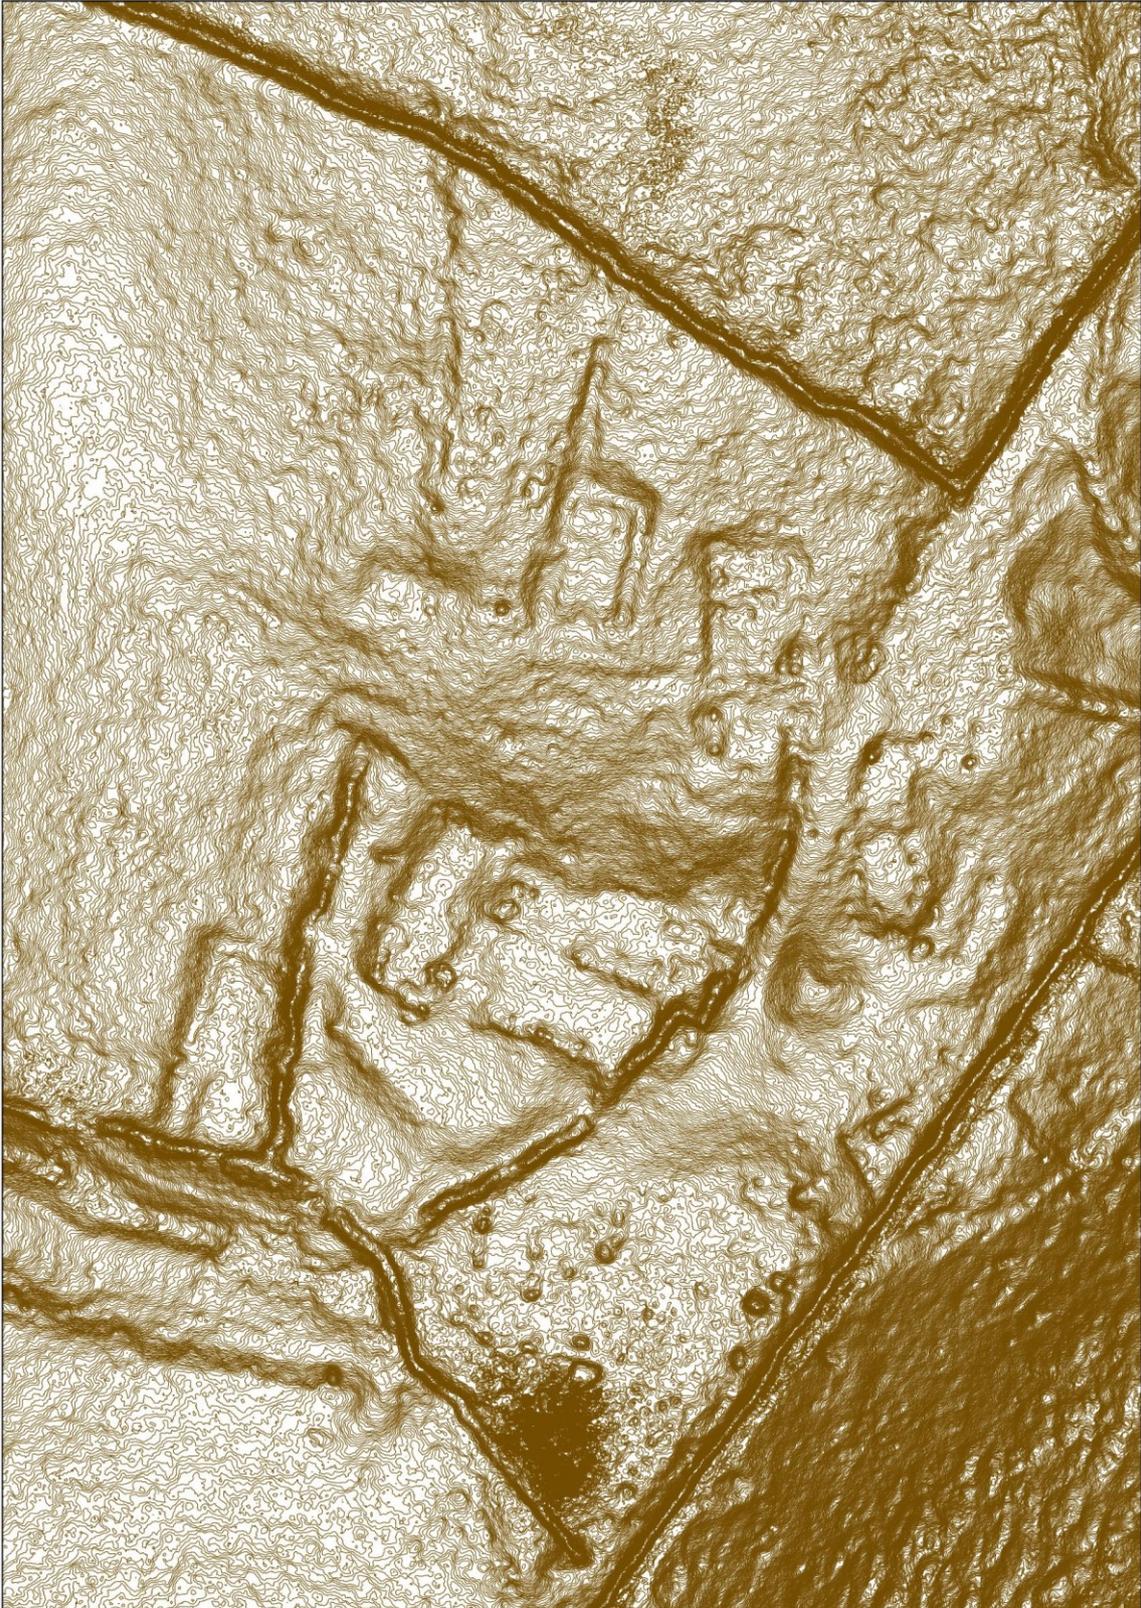
Figure 11: Drone photogrammetry: core area of site, contoured at 20mm intervals
By Pete Schofield (Oxford Archaeology North).

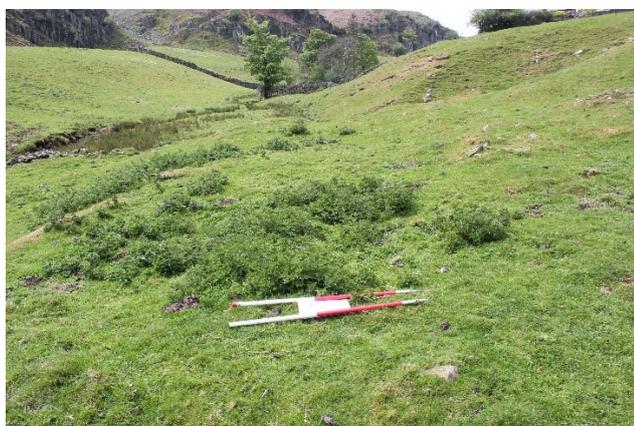
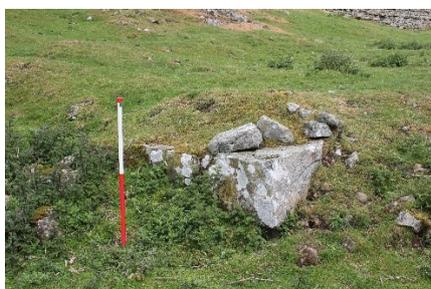
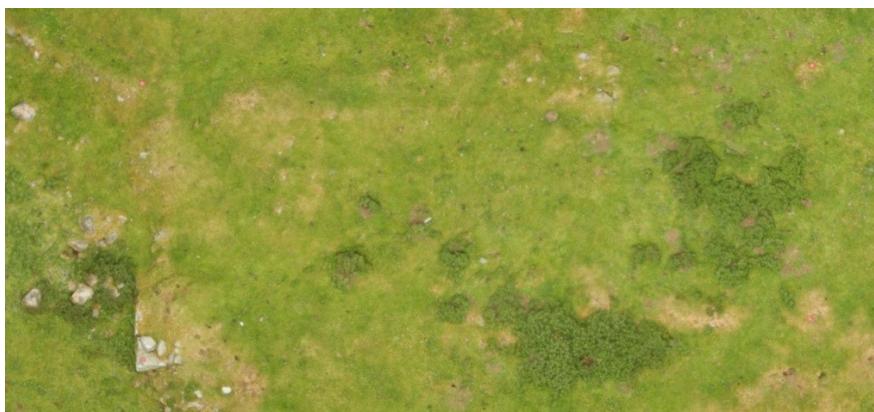
Photogrammetry: F1

Rectangular building possibly two-cell. Possible entrance in west end. Stone wall bases about 0.1m high, mostly earth-covered. Clear wall corner at SW. 5m x 15m.

House platform foundation remains, either double celled or an ancillary building at the eastern end. Approximate sizes: Total length: 16.5m. Main cell 10.5m long, ancillary cell 5m long. Width of both in the order of 5.3 to 5.6m. General orientation E-W.

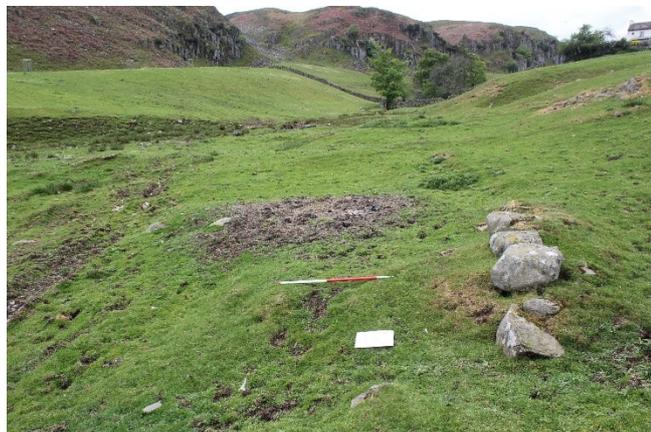
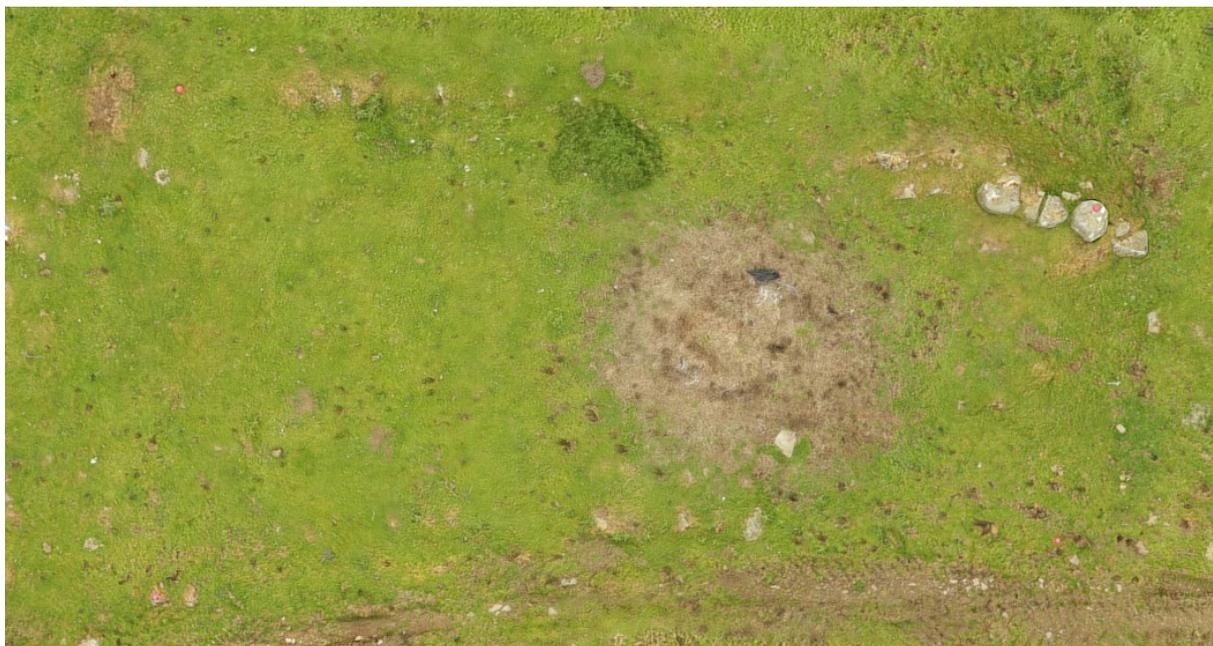
Photogrammetry: F2

Rectangular building platform. Clearly defined at N and W ends. Some of other walls may have been destroyed as rutted track runs along S side. Stone wall bases about 0.1m high, largely earth-covered. 6m x 13m. **Risks: Damage to south side by farm track.**

House platform foundation remains, either double celled or an ancillary building at the western end. Sited close to F1. The corners at the eastern end are very vague. Approximate sizes: Total length: 14.5m. Main cell 9.5m long, ancillary cell 5m long. Width of both in the order of 5.8 to 6.3m. General orientation E-W.

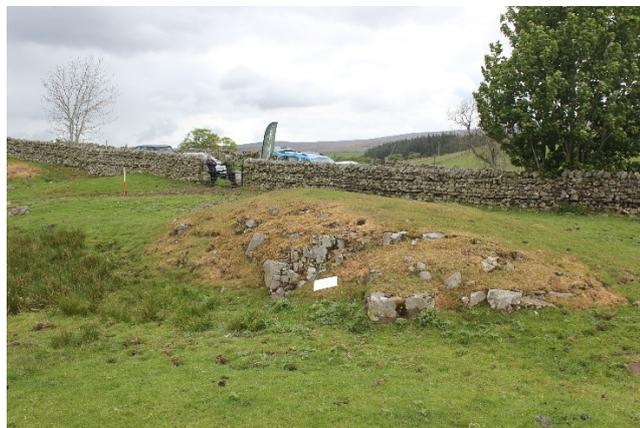
F3

Low oval-shaped mound with long axis aligned E-W. Maybe natural. Earthen with protruding stones. W end has been scooped out, probably quarried. 17m x 6m. At highest point is 1m high. **Some evidence of rabbit damage.**

Initially this looks like a partially quarried cairn, but on closer inspection it appears to be a small natural outcrop that has grassed over except for a small section at the western end. Approximately 6m x 3m.

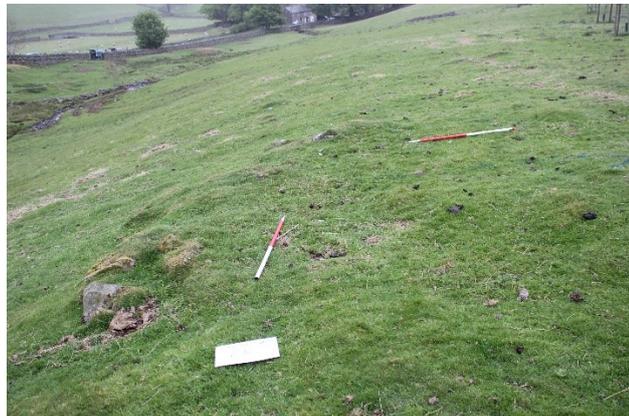
Low curving earthen bank with stones, becoming indistinct at E end. To the S are a group of 3 isolated earth-fast stones which may be related to the bank or may be natural. 6m long, 0.7m wide (E end) and 0.5m wide (W end). Height up to 0.5m (near E end).

F4 is a 5m length by 1m wide section of curving wall foundation, that looks as though it once could have been a base of a small roundhouse. This section would have been a small section at the northern side. To the south are a group of 3 natural stones that may have been incorporated into a structure, or perhaps more likely a foundation wall would have butted against them. Only excavation would clarify if this is archaeological, and if so, its extent.

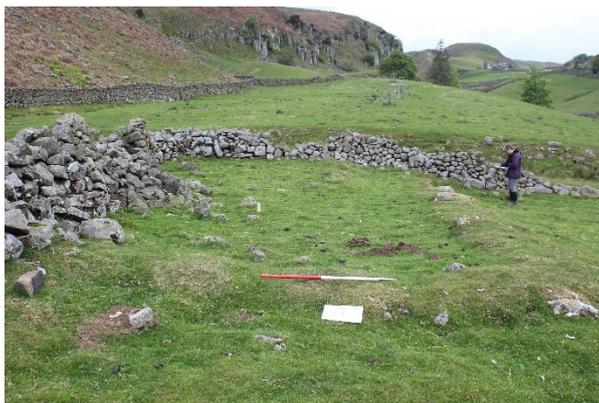
Photogrammetry: F5

Rectangular building foundation, bounded on S and W edges by dry-stone wall. N and E sides are earthen banks and large boulders. May be building or enclosure. 11m x 5m. Up to 0.4m high. Has internal curved bank, extending approximately 3m into interior from W edge. **Risks: Erosion of banks, collapse of dry-stone wall.**

House platform foundation remains, with a possible partitioned section at the eastern end. Approximate sizes: Total length: 13.2m. The partition at the west end, if present, appears to be in the order of 4m x 2m. Width of both in the order of 6.2m in the east to 7.9m in the west. General orientation E-W. The southern wall of this house platform appears to have been reused at a later period as a base for a field enclosure dry-stone wall, which subsequently has partially tumbled. In consequence, it is not possible to measure the platform width with any certainty. This enclosure wall extends eastwards beyond the house platform and probably once connected with wall F22.

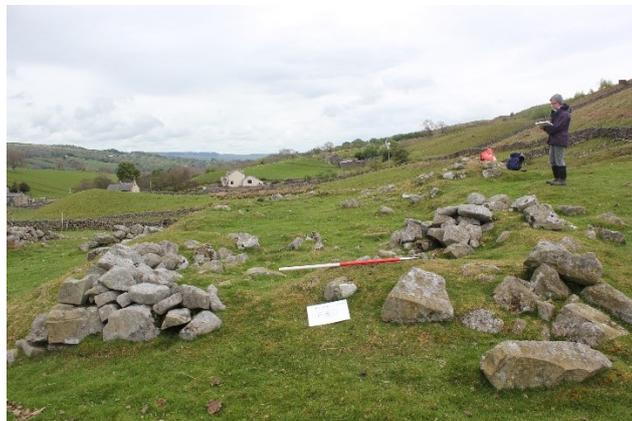
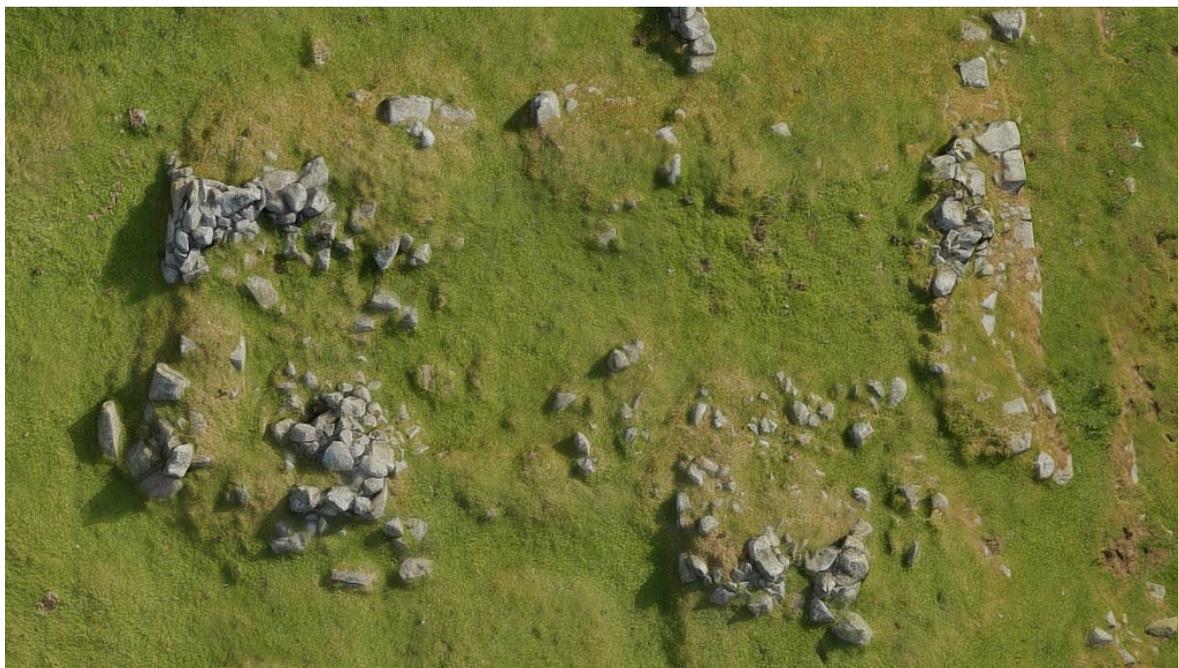
Photogrammetry: F6

Roughly rectangular building foundations, possible house. On platform, foundations are irregularly shaped boulders/stones, although some at base of E edge appear to have been worked. 8m x 4m. Foundation height 0.2m. **Risks: Some collapse of stone-work.**

F6 lies a few metres to the south east of F5. It is located on a slightly higher plateau than F5. Approximate sizes: Total length: 10.8m to 11.0m. Width in the order of 6.0m. General orientation NW-SE. A revetted bank F24 is located close to the eastern end of the platform, and a small semi-circular enclosure F16, lies to the west.

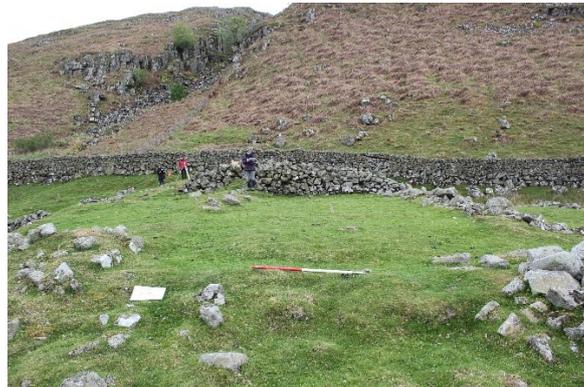
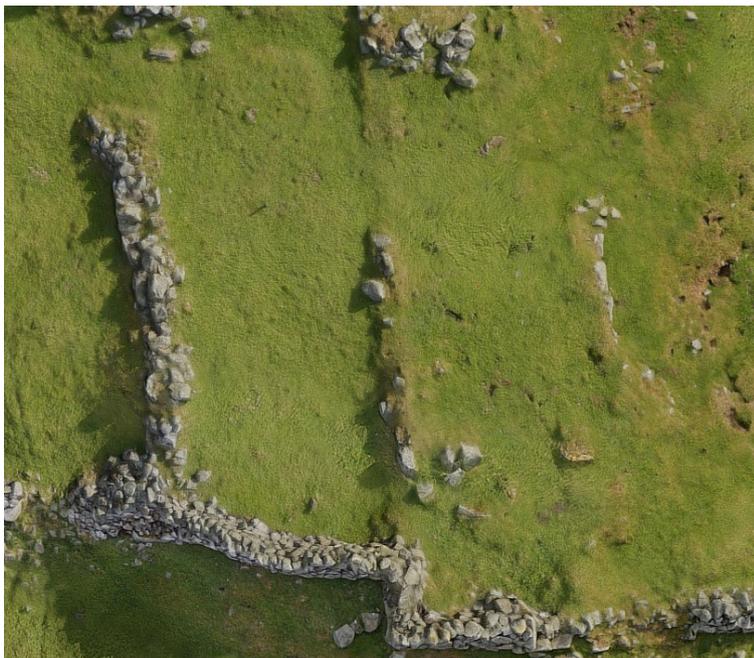
Photogrammetry: F7 and F17

Foundations of building, with associated platform (F17) lying to the E of it. Low foundations consisting of stones/boulders from 0.2m to 0.5m diameter. 11m x 5m. **Some smaller stones have been removed to form dry-stone wall overlying S end; this wall is collapsing.**

F7 and F17 are two adjacent platforms. However, there is only a single foundation wall between them. F7 looks more like the house platform and F17 an enclosure associated with it. The eastern side of F17 is the partially robbed out revetment wall. It is not possible to identify where the north wall of F7 is located. Looking between F6 and F7, it gives the impression that a narrow footpath passed between them. F7 western wall that is still visible is 9.3m long and the visible section of the eastern wall 7.6m. Width 6.5m. General orientation NE-SW.

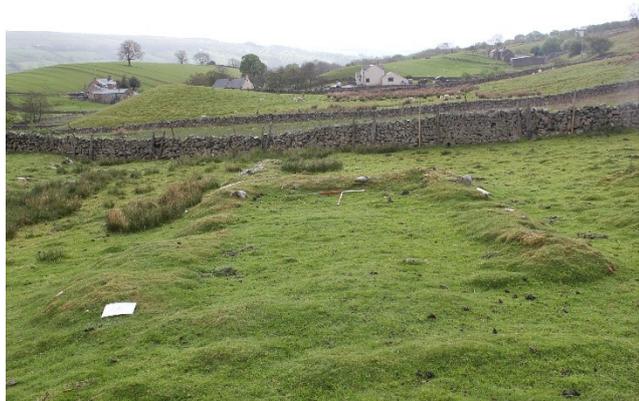
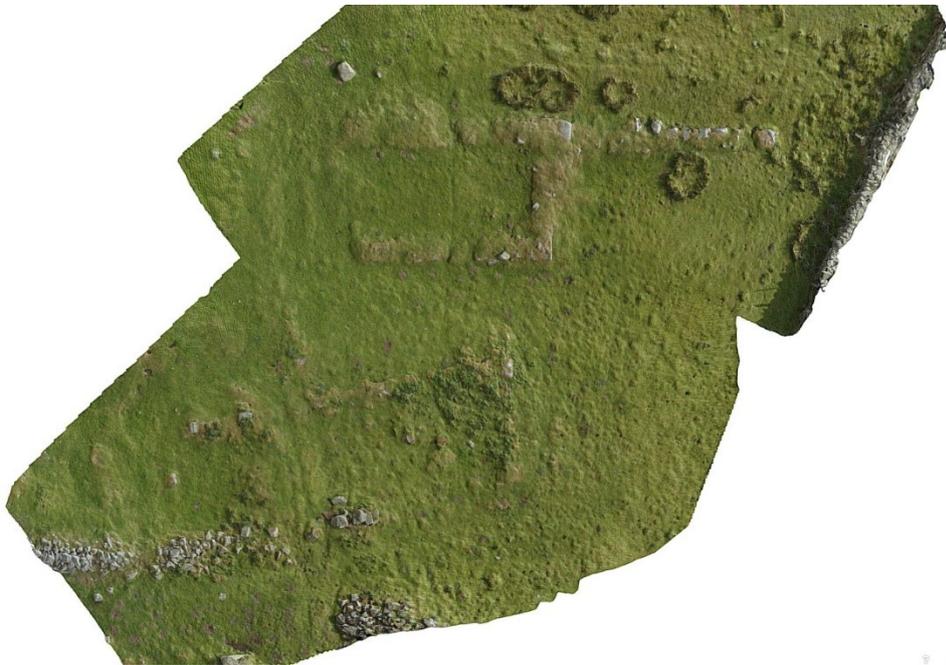
Photogrammetry: F8 (upper rectangular feature) and F9 (lower rectangular feature)

Foundations of rectangular building on platform with an external wall (F25) attached to NE corner and orientated E-W. Foundations are of stones, partly earth-covered. 7m x 4m. Height 0.2m to 0.3m.

House platform foundation remains. The corners are easy to see. Approximate sizes: Total length: 8.5m. Width 5.9m. General orientation E-W. The northern wall appears to also form part of an enclosure boundary that extends 13.2m further eastwards as feature F25.

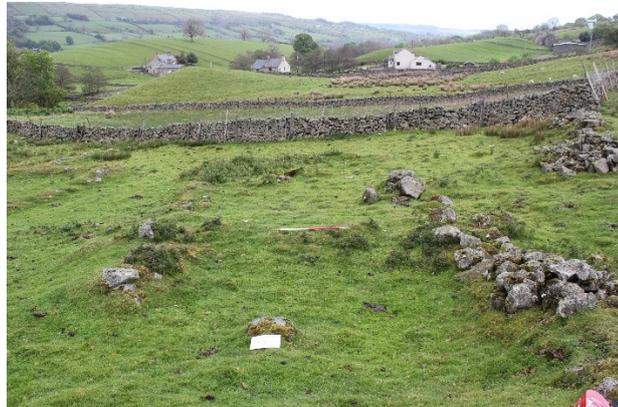
Photogrammetry: see F8

Foundations of rectangular double-celled building on platform. The eastern cell is the larger. Orientated E-W. Foundations formed of stones (up to 0.3m diameter) partly earth-covered. A ruined dry-stone field wall overlies the SW corner (part of F23). 12m x 5m, height up to 0.25m. **Some evidence of stone disturbance.**

House platform foundation remains. The corners are not all easy to see. It could be doubled celled extending further westwards. Approximate sizes: Total length:14.5m. Width 6.2m. The partition wall centred approximately 9.5m from the western end. General orientation E-W.

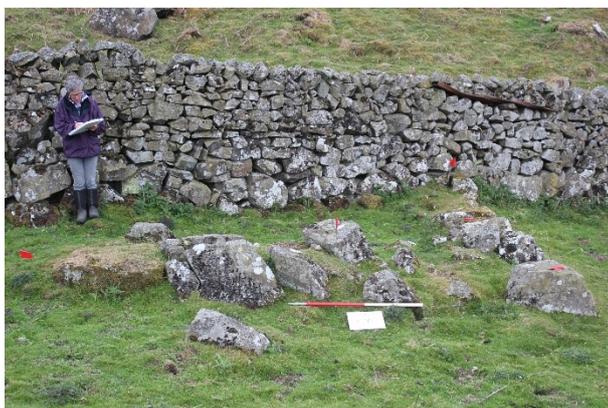
Photogrammetry: F10

Rectangular building foundations, overlain by the dry-stone wall enclosing the field. 6m x 4m, foundations 0.5m high. Formed of large stones/boulders up to 0.5m x 1m. From southern corner a wall extends SE then NE defining a small enclosure. A pathway running diagonally up the slope towards moorland lies along the SW side of F10. **Risk of collapse of dry-stone wall on to feature.**

House platform foundation remains. Compared with the other house foundations the stones used are significantly bigger. Very approximate sizes: Total length: 7.5m. Width 5m. General orientation NE-SW. The house platform is bisected by the dry-stone wall that separates the unenclosed moorland from the improved pasture. It is general appearance is of a much cruder structure. On the moorland side of the boundary wall there is evidence of a small enclosure on its eastern side.

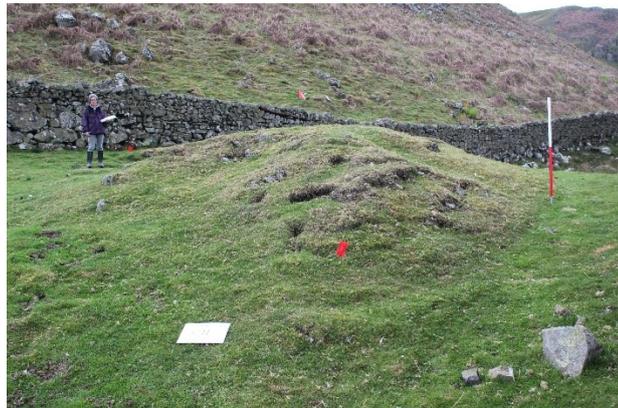
Mound formed of earth and stones. Semi-circular scoop into E side. Mound diameter 6m, height 0.8m. **Some erosion, risk of livestock damage.**

A slightly ovoid cairn 5.3m N-S and 5.5m E-W. Could be a burial cairn.

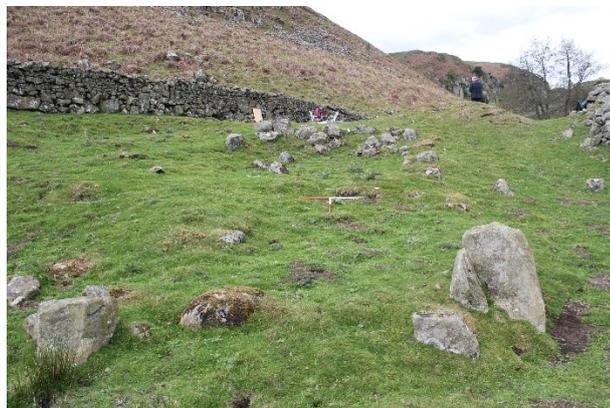
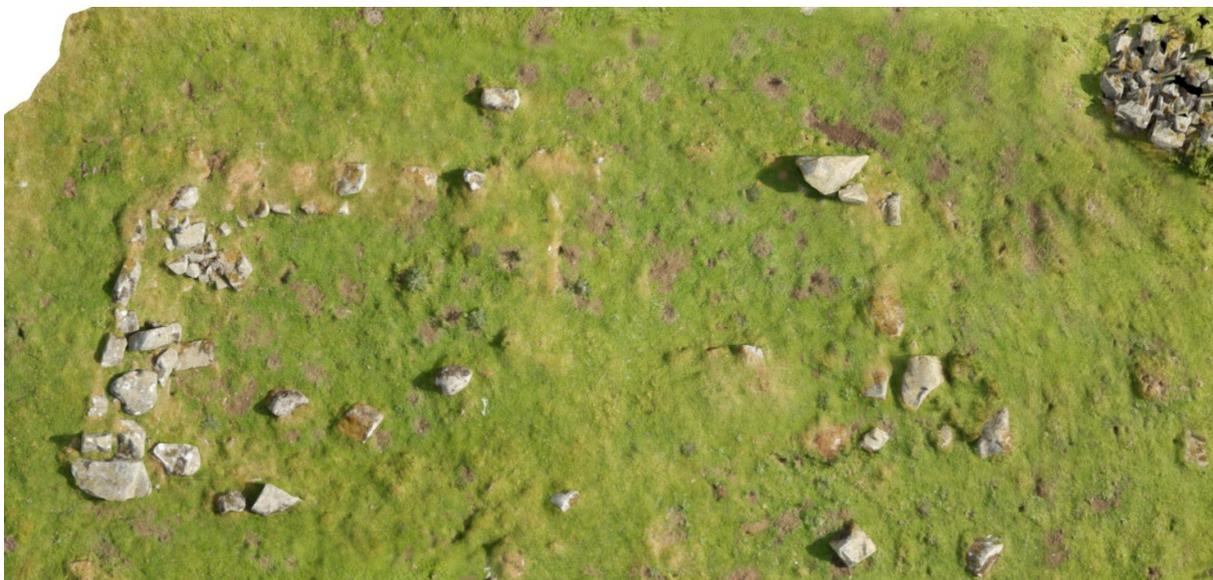
Photogrammetry: F12

Double-celled rectangular structure orientated between SE-NW and E-W. Foundations of boulders and stones. 12m x 4m, foundation height 0.2m. Western cell approximately 4m internally, eastern 6m. **Risk of stone disturbance/falling.**

House platform foundation remains just to the east of F11. Corners not well defined. Length between 6.7m and 7.5m and width between 5.7m and 6.5m. General orientation NW-SE

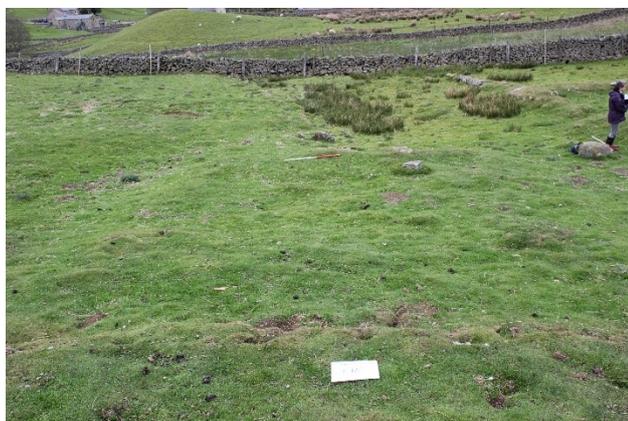
Roughly rectangular platform, possibly for building, some stones on raised edge, scooped into slope running downhill eastwards from F6 and F7. 8m x 4m, height 0.1m. A boundary, F22, a probable field wall foundation, is attached to the centre of the E side and runs eastward from the feature. **At risk from livestock and erosion as on steep slope.**

F22 appears to be the remains of field wall foundation that may have also been the part of the house platform foundation of F13. The western end is very indistinct. Not measured but looks slightly smaller than F8.

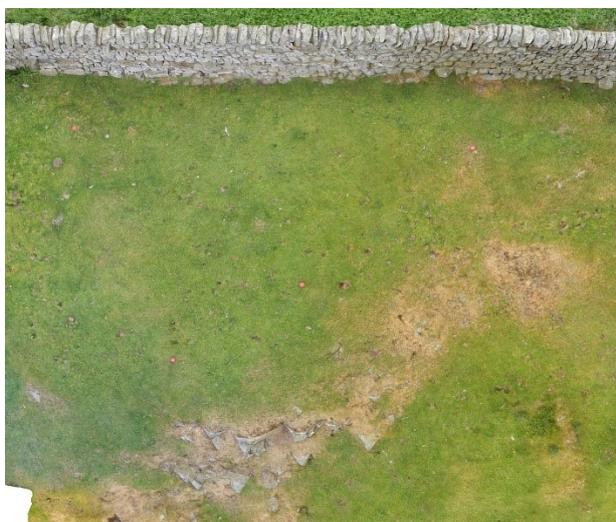
Photogrammetry: F14

A raised platform that appears to extend under the dry-stone field boundary wall and possibly the road through Holwick. The edge of the platform within the field is well delineated. There is no evidence of any structure on the platform.

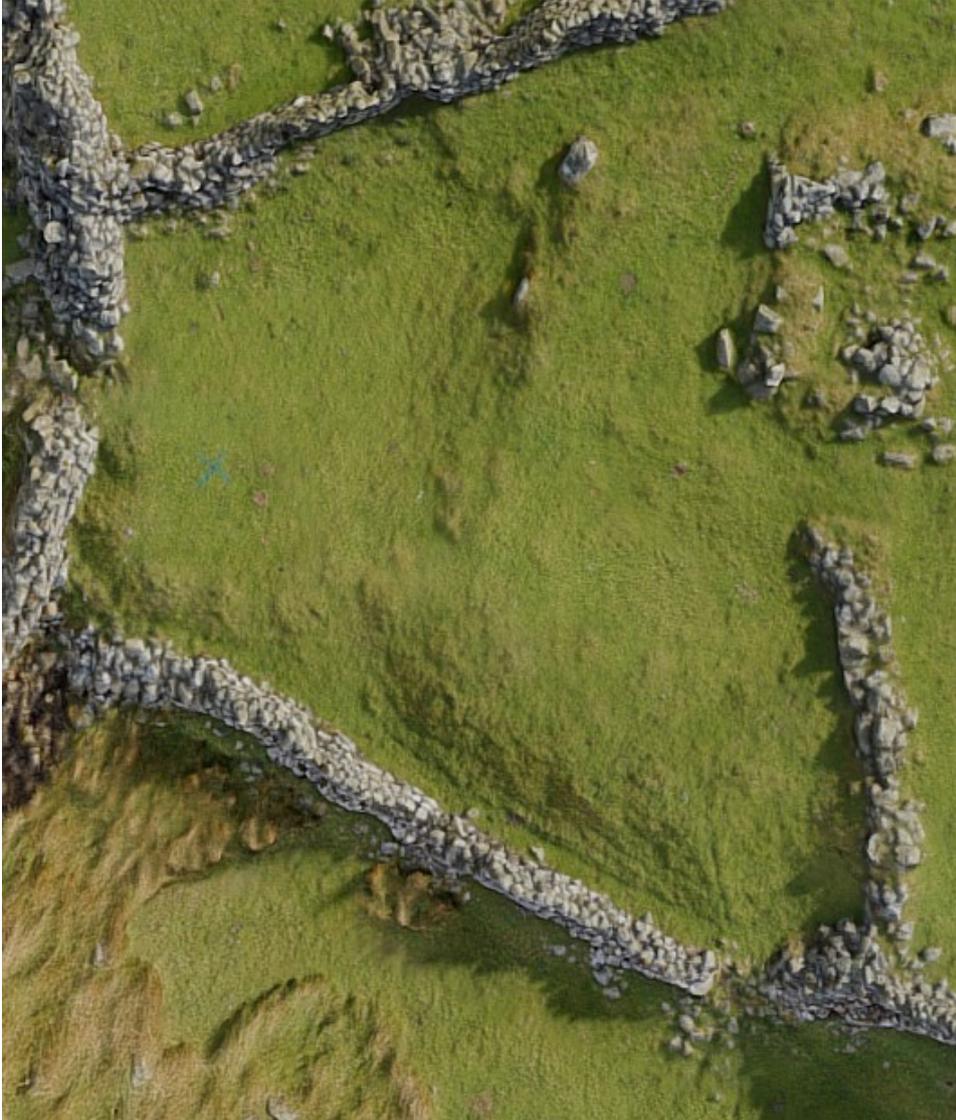
A curving enclosure foundation to the west of F6.

Photogrammetry: F15 (platform on left) and F16 (platform on right)
