# WELL HEAD DESERTED SETTLEMENT Holwick, Teesdale

*Interim Report: 2018 (2nd season) Excavation*

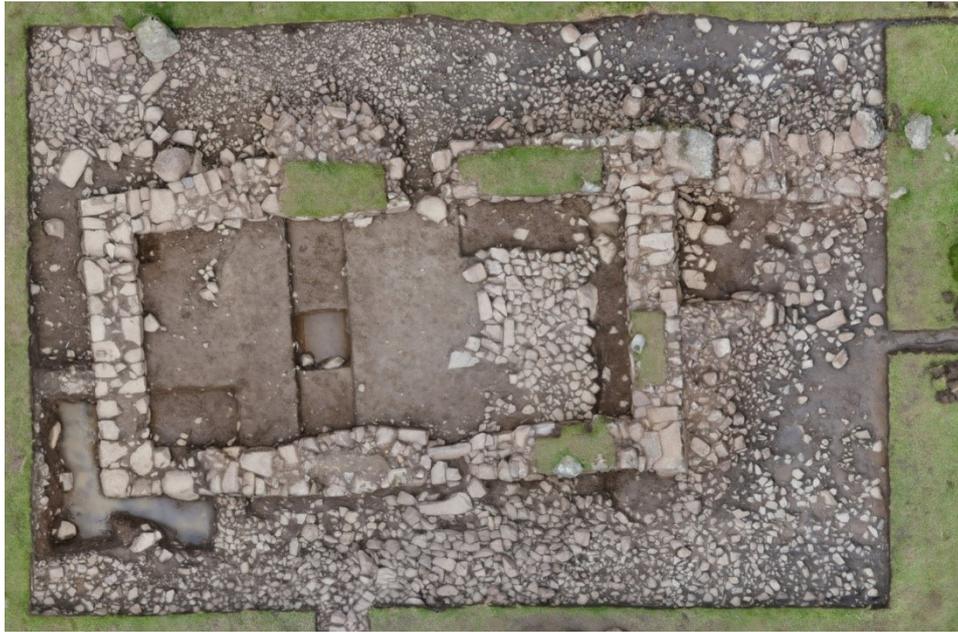
**Figure 5:** Trench 1 vertical photogrammetry view. Building F8. The cobbled surface in the east (right-hand) end of the building has been partly excavated in this view. (Stephen Eastmead).

The trench examined F8, a longhouse 10mx5m (at wall centres) with entrances in the middle of the long sides. The dwarf walls were roughly-dressed stone structures with a rubble core and no mortar bonding. No hearths were found. There was a surface of worn cobbles in the downhill half (probably the part used to house livestock), but no drain. In the other (western) end of the house there was a surface of redeposited clay and subsoil. There were fragmentary remains of a robbed flagstone floor overlying this.

Outside the structure were cobbled surfaces: there was a good surface of small worn cobbles outside the north door, along most of the length of the north wall. On the south side of the structure was a surface of larger, rougher cobbles continuous between F8 and the neighbouring structure F9. To the northwest of F8 was a cobbled area, edged with larger stones and overlying the cobbles outside the entrance.

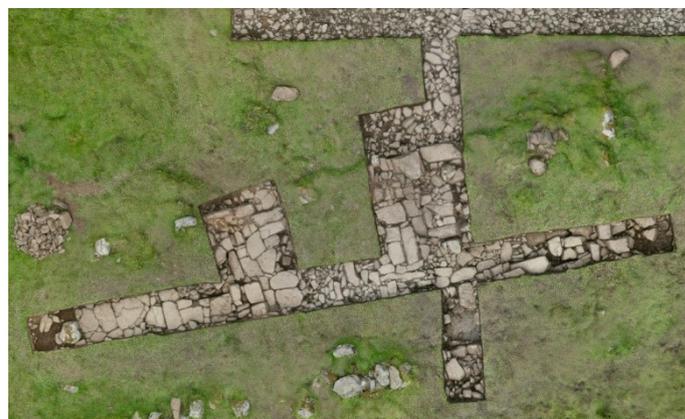
**Figure 6:** Trench 1a vertical photogrammetry view. Structure F9. (Stephen Eastmead).

This trench showed clearly that F9 was a more complex structure than F8, with flagged floor surfaces and one or more internal walls. Excavation of its whole area was carried out in 2018 (Trench 3) and is described later in this document.

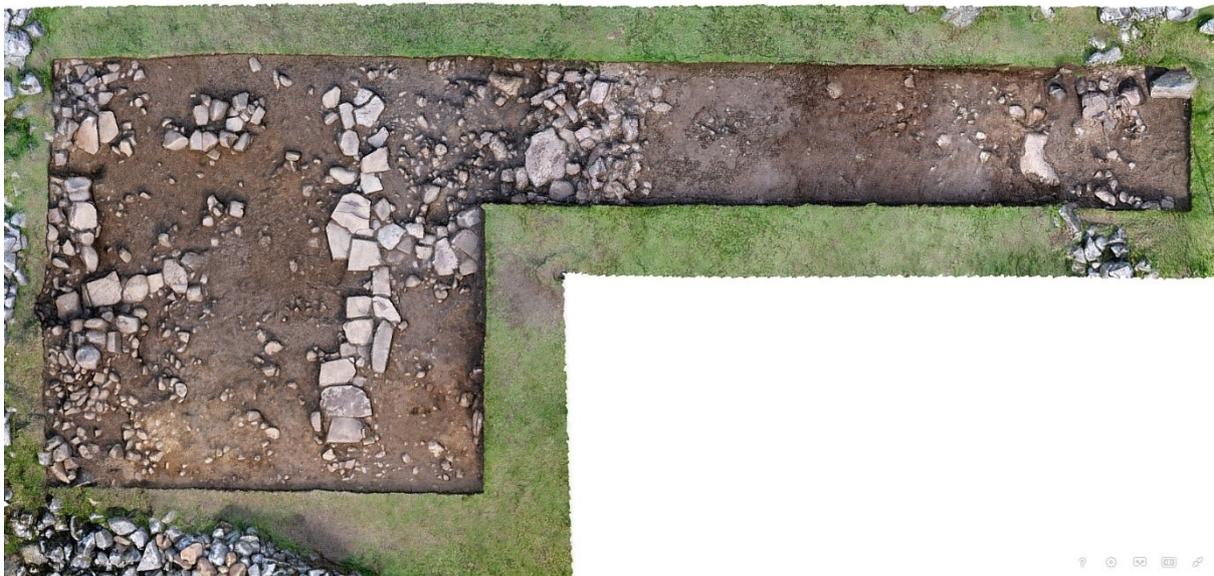
**Figure 7:** Trench 2 vertical photogrammetry view. *(Stephen Eastmead).*

Trench 2 investigated the two platforms (F15 and F16) on the beck side of the hillock. Excavation showed no building foundations or post-holes. There was evidence of paving, perhaps paths. The platforms were clearly man-made with stony banks revetting the edges. The lower end of the paving extended under, so was earlier, than the stony bank by the beck.

A wall of the rectangular structure (F7) on the hillock was cut at the east end of the trench, possibly passed through an entrance. The wall was just a line of rubble not dressed stone. F7 is an oddity: it has a different orientation to the other buildings on the site and seems unlikely to be a longhouse.

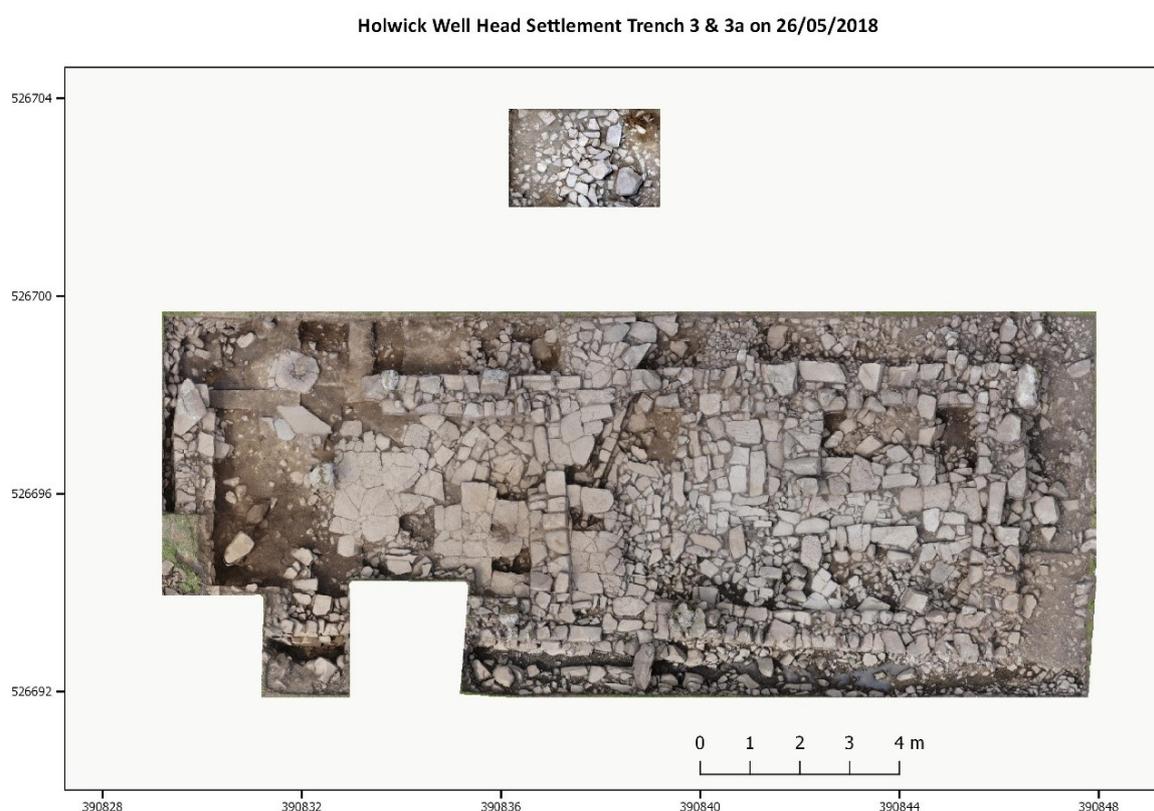
**Figure 10: Photogrammetry image of Trench 3 at end of excavation.** Image by Stephen Eastmead. See Appendix 2 for an enlarged version of this image.

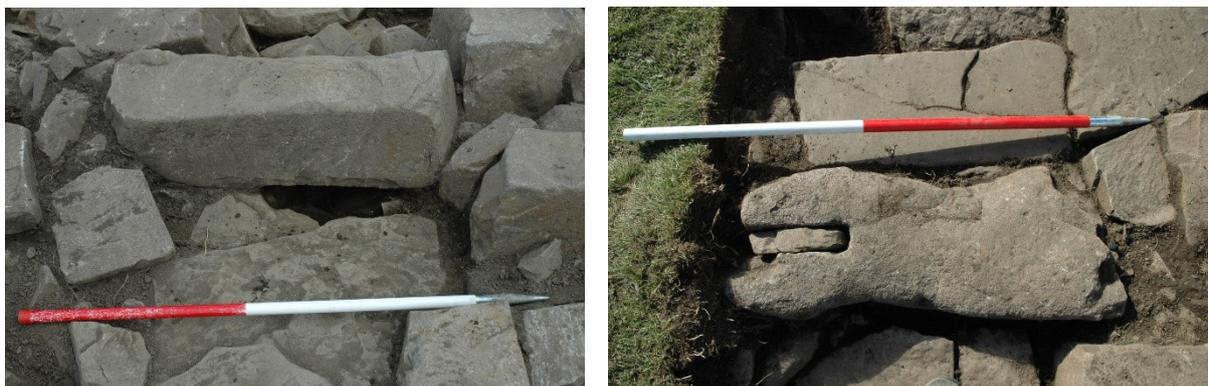
**Figure 11 (left):** Drain lintel stone, from interior, showing chipping of lower edge.  
**Figure 12 (right):** Threshold stone of north entrance, showing locking stone in slot.

The north entrance 341 had a well-worn threshold stone with a fractured hinge hole at one end and a slot at the other into which a loose rectangular stone fits: probably a primitive locking mechanism.

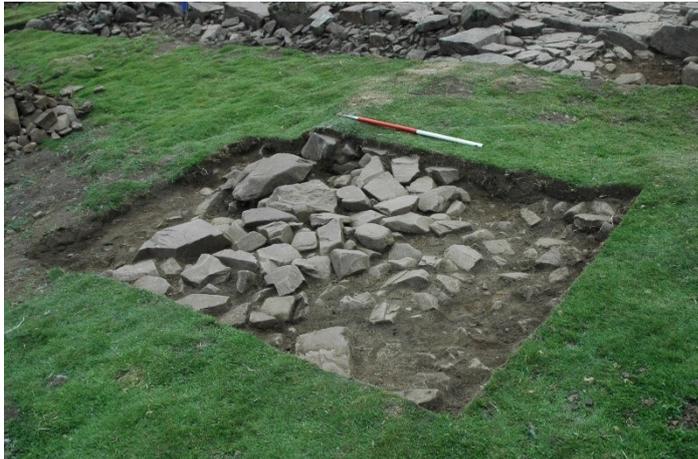
**Figure 13 (left):** Flagstone path leading to north entrance. Threshold stone is at top right of image.  
**Figure 14 (right):** Drain along exterior of south wall. South entrance is by ranging pole.

Leading up to the north door was a flagstone path 343. Trench 3a was excavated north of Trench 3 to examine this path further from F9 (see Figure 13). The path was about 0.8m wide: it had a well-defined east (downhill) edge of kerb-stones, but the paving was irregular. The stones were worn near F9, less so further away from the building. Its course was straight, due north from F9. Beyond the excavated first 5m, it can be seen as a subtle earthwork climbing diagonally up the east side of the hillock in the centre of the settlement, passing to the west of longhouse F8.

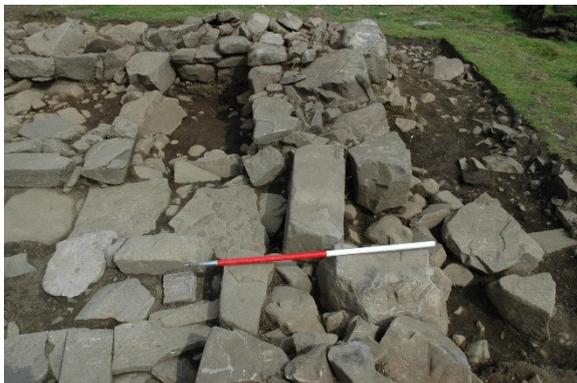
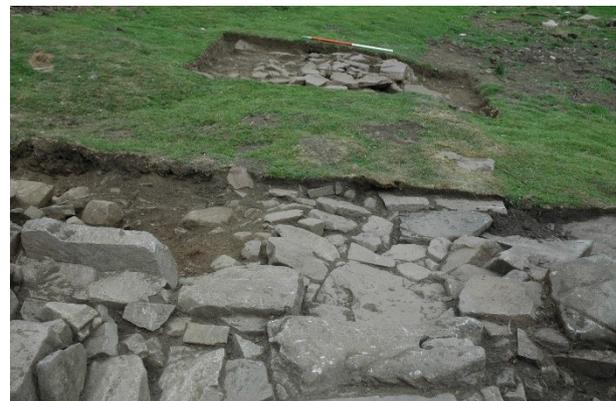
**Figure 15 (left):** Looking north along east wall of F9, the ranging pole is in front of drain lintel.  
**Figure 16 (right):** Looking north through north entrance to flagstone path. Threshold stone in foreground.

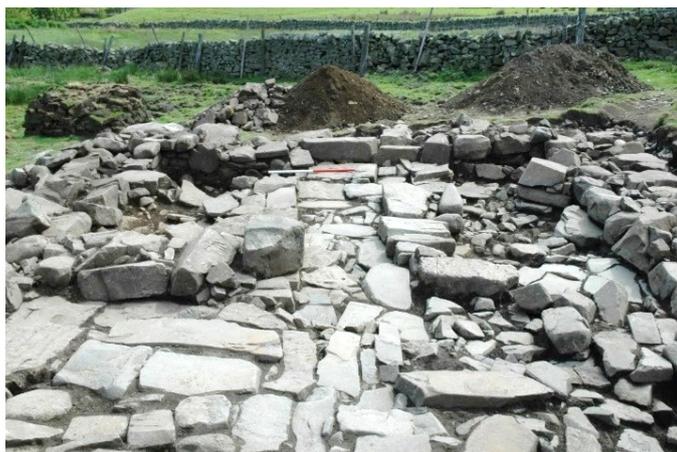
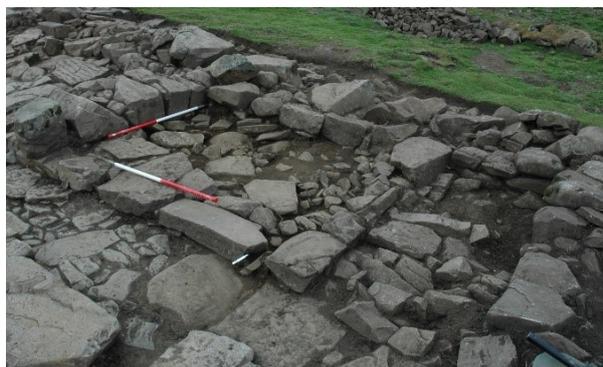
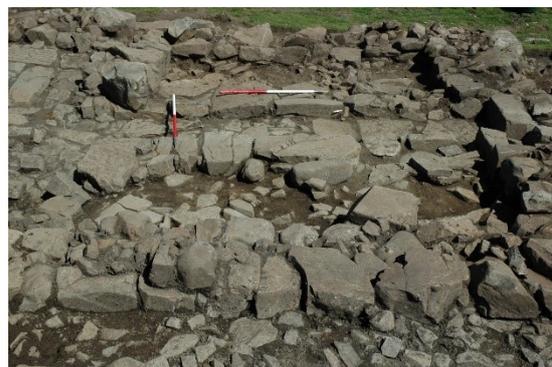
**Figure 17 (top):** Looking east down long axis of building, showing animal pens. The ranging pole is in front of the lintel over the drain through the wall.

The lower cell had an irregular flagstone floor 344, showing evidence of wear and patching, with some areas cobbled. It had a pronounced downhill slope to the east. The floor was continuous, under the cross-wall, with the lower floor of the eastern cell. In the north-east and south-east corners of F9 were rectangular animal pens 312 and 315, formed by a single course of stones laid on top of the floor, possibly originally the edge of a raised platform. Both pens were small: 3.2m x 1.8m and 3.5m x 1.6m. This is too small for modern cattle, but could house old breeds like Dexters, as well as other types of livestock. The pens might also have been used at times as storage platforms. The floors 313 and 316 of the animal pens are of earth and stones with little paving, merging into the underlying subsoil with no clear demarcation. The eastern end of the northern animal pen was partitioned to form a small 0.8m wide enclosure 313, possibly for small livestock or dogs. Between the animal pens was a 0.8m wide paved passageway which would also have served as a drain: its floor was continuous with the floor of the rest of the eastern cell and it passed through the west wall (see previous section).

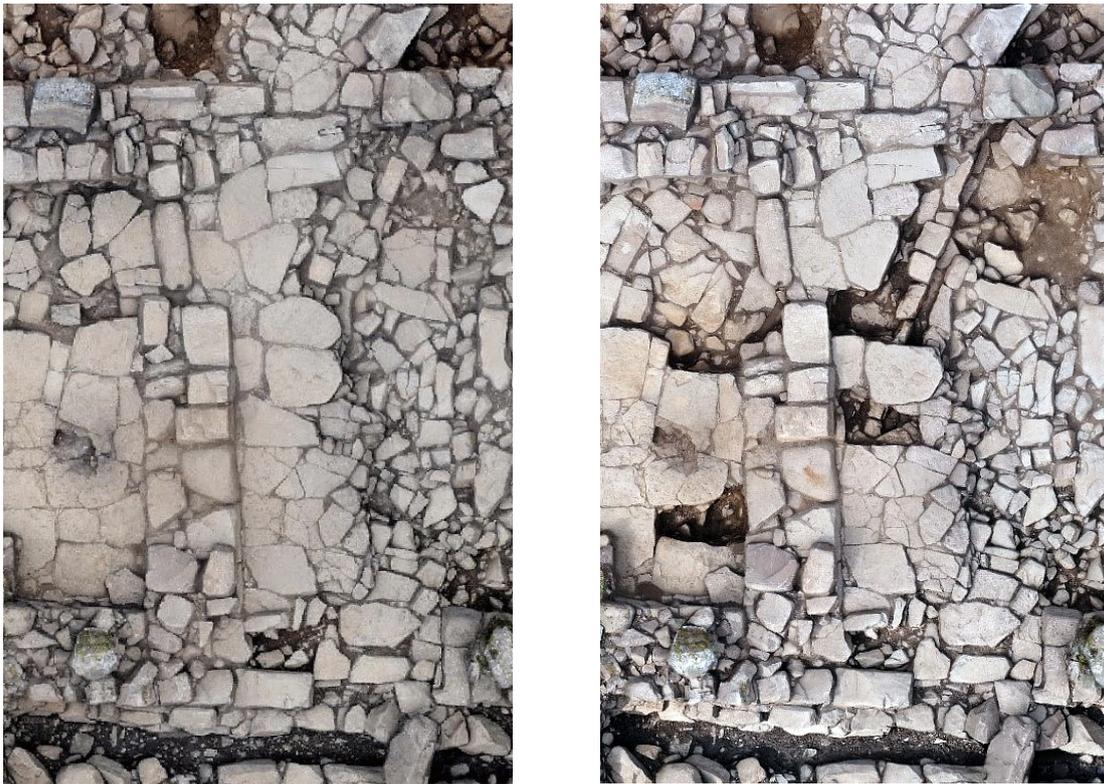
**Figure 20:** Photogrammetry images of the same area of the central part of the building F9. That on the right was taken after removal of part of the upper floors of the cross-passage and western cell to show the underlying cross-passage drain and lower floor level.

The cross-passage has had a higher-level flagstone floor 342, inserted over the floor 344 of the eastern cell. In between the two floor levels was a soil-like deposit 352, through which a stone-lined drain 350 was constructed, emptying through the north wall of F9, just to the east (downhill) of the north entrance. A higher flagged floor 311, had also been inserted in the western cell. This floor is at the same height as the upper cross-passage floor, with an intervening deposit 340 needed to level-up the higher floor as the lower flagged floor of the western cell 347 is sloping. Thus, the intervening deposit varies in depth from 0.3m against the cross-wall to nothing at its western margin. These upper slabbed floors of the cross-passage and western cell are of higher quality and more horizontal than the lower floors.

The eastern side of the upper cross passage floor is ragged and some has probably been lost, possibly due to damage from livestock turning and stepping down from the cross passage into the lower cell. There is no wall defining the east side of the cross-passage, but a linear arrangement of stones on the floor of the eastern cell may mark the line taken by a wooden partition (see right side of photogrammetry images above, Figure 20).

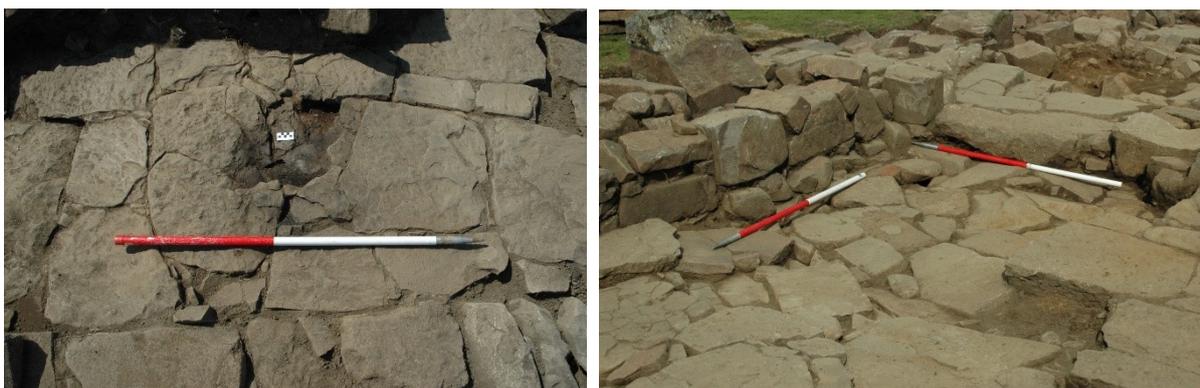
**Figure 21 (left):** The hearth 333 of F9. The cross-wall is at the bottom of the image. Looking west.  
**Figure 22 (right):** The threshold stone through the cross-wall (above right ranging pole). The upper floor surface has been removed, so the poles are on the lower floor. Looking north-east.

A hearth 333 was located in the western cell, close to the back of the cross-wall. It was slightly offset southwards from the centre-line of the building, probably to keep it away from the door through the cross-wall. (see left centre of photogrammetry images above, Figure 20). It consisted simply of an area of the flagstone floor which had been heat-damaged, forming a depression, and blackened (see Figure 21). Burnt material remained in the scoop and was 100% sampled. This was the only hearth in the western cell, and the eastern cell had no hearth.

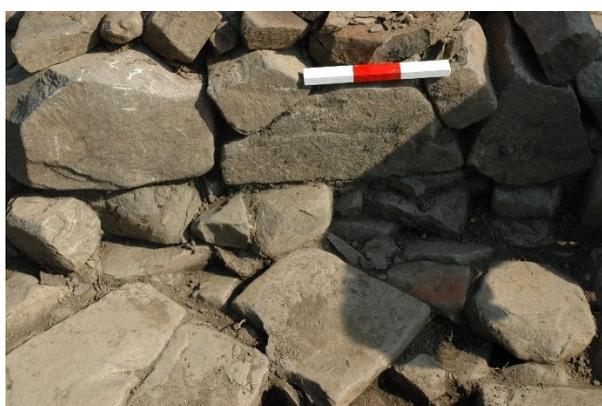
**Figure 23:** Close-up of interior face of north wall (above left ranging pole in previous figure). The wall is built over the lower floor surface.

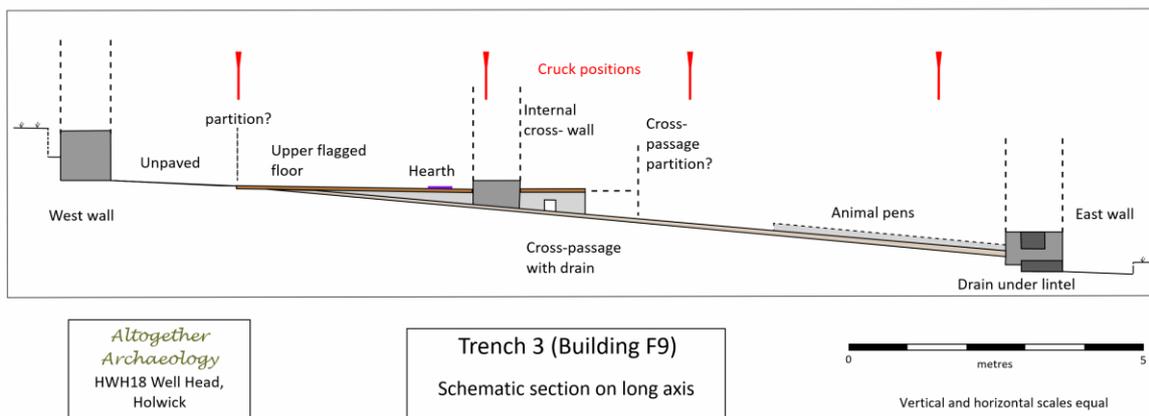
**Figure 24: Schematic section east-west through F9, showing the relationships of floor-levels and cruck positions.**

The upper floor can never have been present in the rest of the western cell, as it would have been well below the base of the western wall of the building. Only enough material was placed over the lower floor to allow the new floor to be inserted level for the first 4m (see diagram above). The unpaved floor of the last two metres continued on its upward slope to reach the base of the western wall. This unpaved floor level was an indistinct layer of compacted material, not clearly distinguished from the subsoil. The only extant paving was a single diamond-shaped slab at its northern edge.

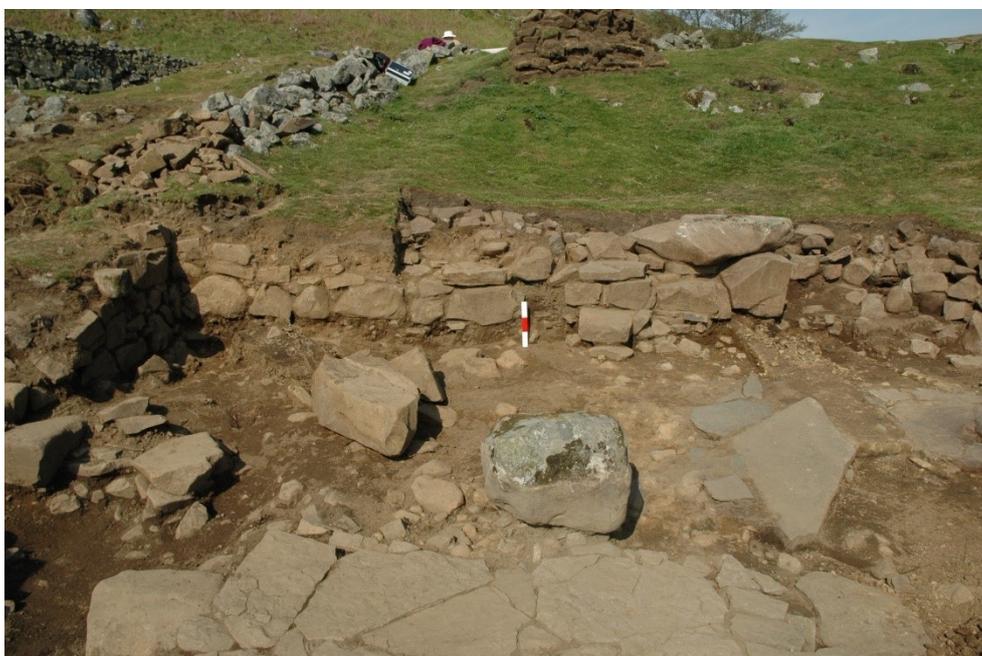
**Fig 25: Western wall of F9. The western padstone is to the right of the scale. There is no paved floor in this area, and the base of the wall lies at a higher level than the upper paved surface of the western cell.**

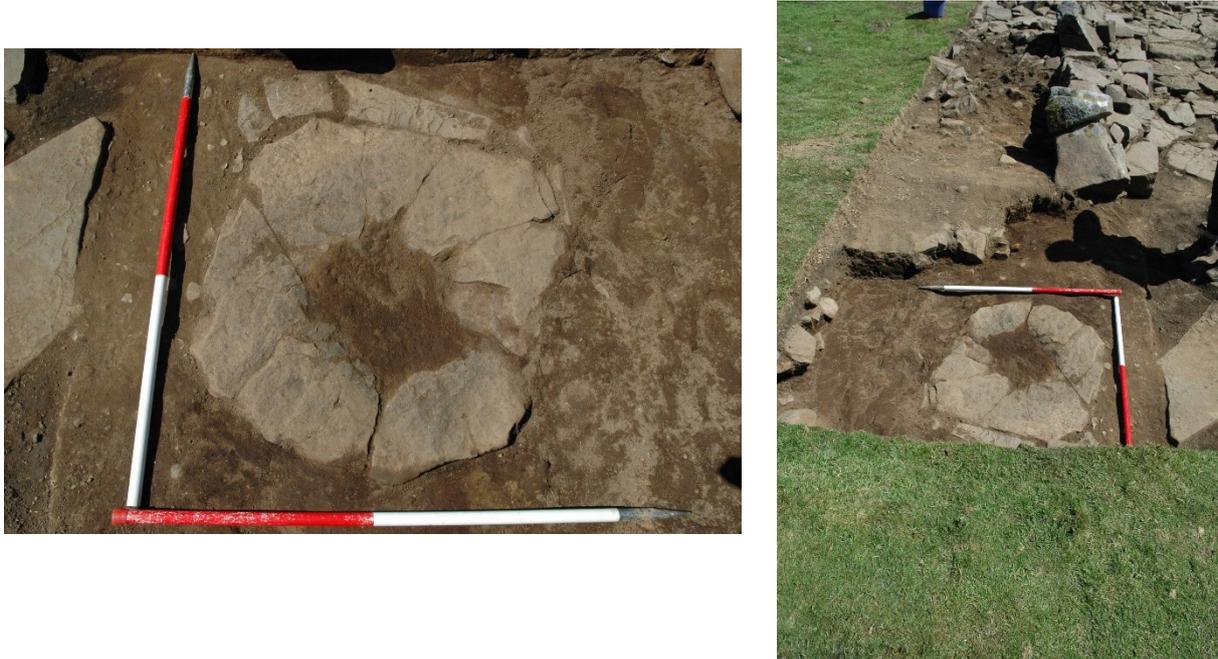
**Figure 26:** Hearth 320 under the line of the north wall. It is set in surface 319, which is cut off on the line of the internal face of the north wall, abutting the diamond-shaped slab inside F9.

Under the line of the absent north wall, a hearth 320 was found, projecting outside the line of the external edge of the building (see Figure 26). It is set in a compacted clayey surface 319 which includes some burnt material. This surface underlies both the west and north walls of the buildings which are set on it. However, the surface is cut-off at the line of the interior edge of the line of the north wall. The diamond-shaped flagstone in the unpaved area abuts this surface.

The hearth 320 was formed of a large flagstone, with several smaller flat stones set around it. It was radially cracked and blackened by heat, and part of its centre eroded by heat damage. In the resulting depression was burnt material, which was sampled and is being carbon-dated. No structure of any type was found around it.

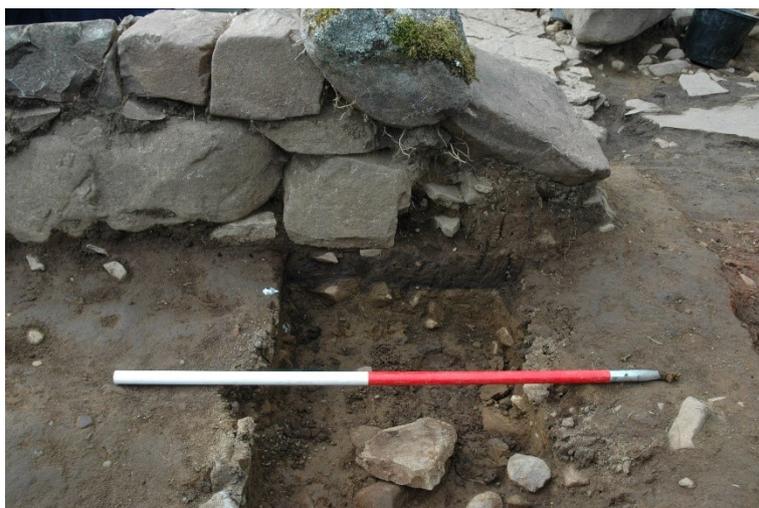
**Figure 27:** The west end of the north wall, showing stone in second course slumping due to robbing out of stone below it. The sondage dug outside the building shows the surface 319 underlying the wall, with a dark layer 337, possibly a turf-line, under 319.

cruck. No northern padstone was found for that cruck. The westernmost stone of the second course of the north wall is unsupported at its west end and so is slumping, suggesting that at least part of the wall has been robbed out (see Figure 27).

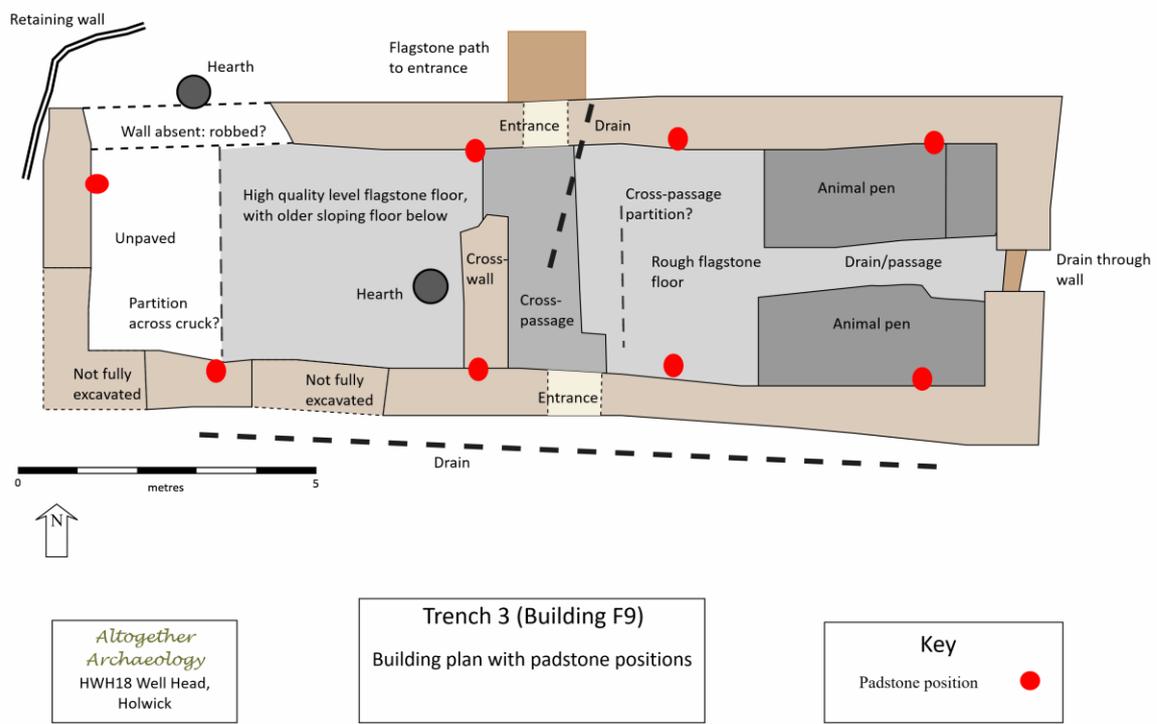
**Figure 28:** Plan of building F9, showing absent section of north wall and underlying hearth.

The missing western 3m of the north wall may have several explanations:

- At no stage in the building's history was a wall present there, as it was the site of a kiln (now robbed). This is unlikely as the westernmost cruck would have been sited inconveniently close to it.
- The wall was there in the early phase of the building's evolution, but when the current walls were built, that location was used for a kiln and the cruck re-replaced by a beam. Later the kiln was removed (maybe for re-siting) leaving only the hearth.
- The hearth was part of an earlier building and was by chance under the wall-line. The north wall was complete in all phases, but for some reason that section was robbed away after the building went out of use.

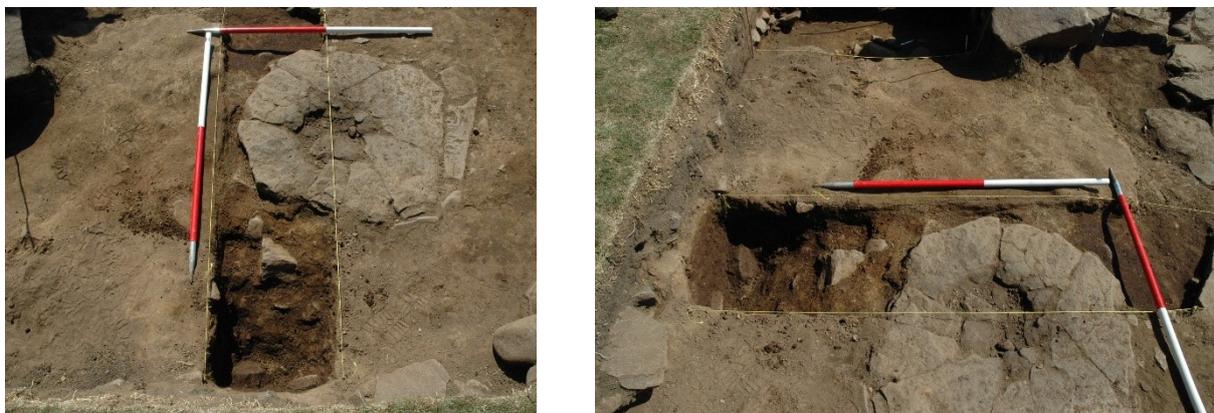
**Figure 29:** Cut 335 north of F9 and beneath surface 319. Views looking south (left) and east (right).

Underneath surface 319 and to the north of the hearth was a cut 335, extending beyond the trench margin. Its shape was consistent with a small ditch running east-west and its fill 336 was a silty humic deposit lacking finds.

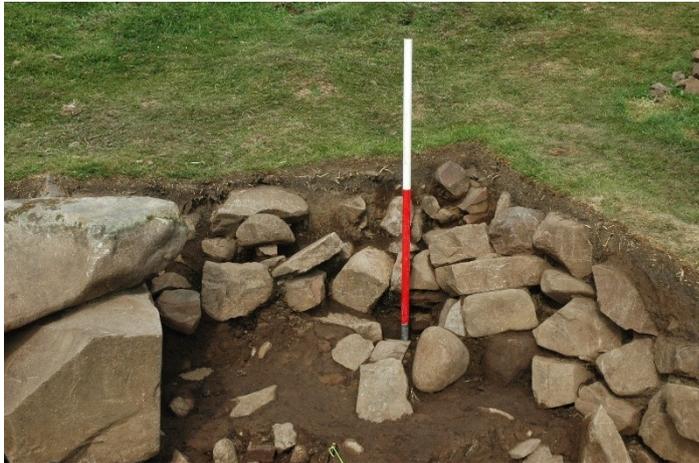
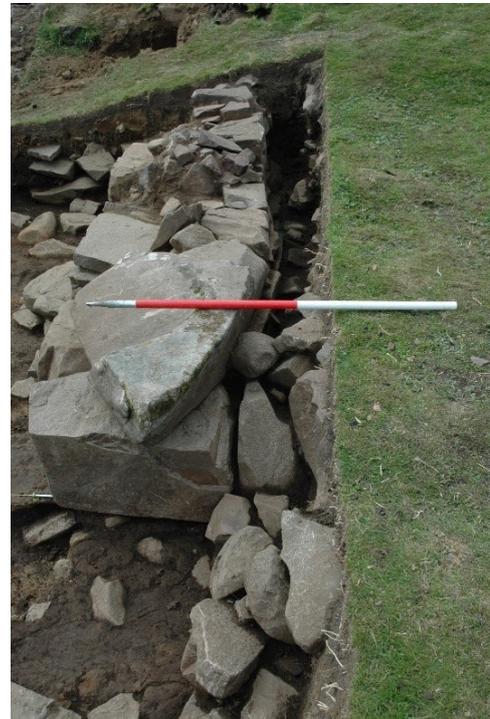
**Figure 30: Crude revetment wall outside north-west corner of F9, passing outside the west wall. Views looking north-west (left) and south (right) along outside of west wall.**

Immediately to the north-west of F9 was a crude curving revetment wall 339, holding back the hillslope from the corner of the building. It consisted of four irregular courses of unbonded masonry and passed behind the west wall of F9, and was not keyed into it. Only 2m of it was seen in the trench: both ends pass outside the trench edges.

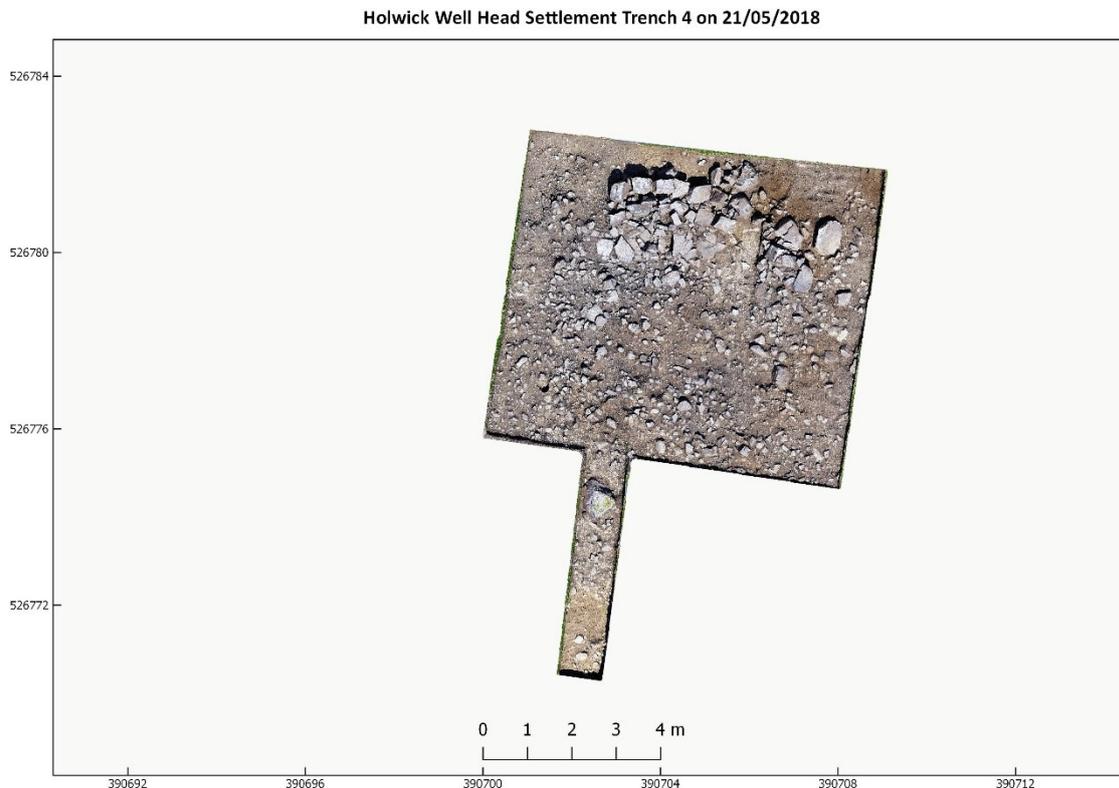
**Figure 31:** Photogrammetry image of Trench 4 at end of excavation. *Image by Stephen Eastmead.*

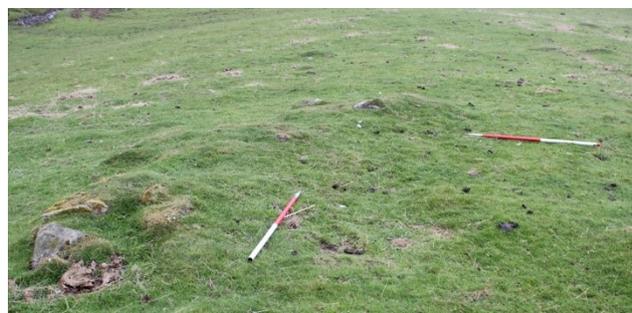
**Figure 33 (right):** Photograph showing bank before excavation, looking east.

Trench 4 examined a short curving length of bank about 150m west of the centre of the Well Head settlement. This bank, F4, lies in otherwise featureless pasture. It is set on a comparatively flat area of the field, at the base of the crag. To the north of F4 the land drops steeply to the beck 10m below.

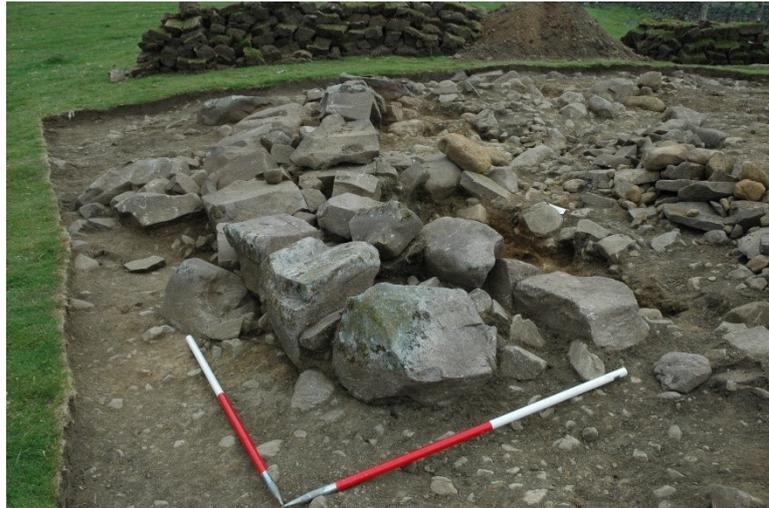
**Figure 34:** Looking east along line of bank. Some of the interior flat stones have been removed.

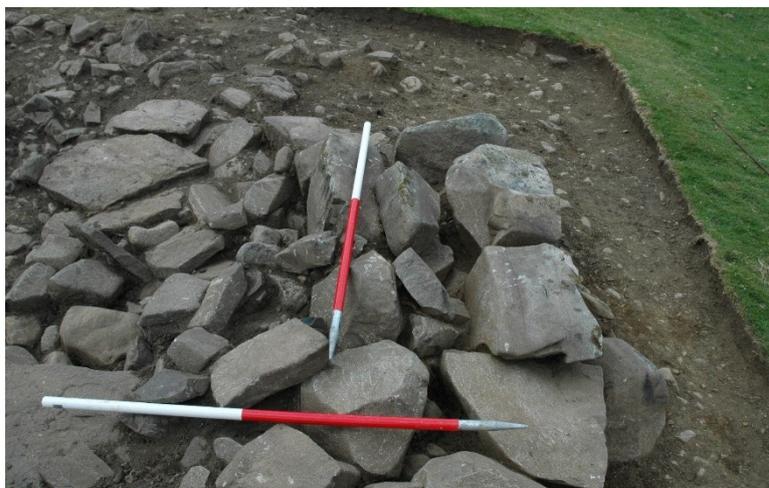
**Figure 35:** Looking west, showing west end of bank, with area of flat stones internally (to left).

Adjacent to the inner (concave) face of the bank was a very irregular surface of flat stones 403, 1.3m wide, but with an ill-defined edge. The stones were very variable in size and undressed. e.g. 0.64m x 0.40m, 0.55m x 0.50m. Beneath the stones was a deposit of orange clay/sand containing small stones, similar to the subsoil but less compacted. Its depth was variable, up to 0.4m maximum. It appeared to be redeposited material to form a bed for the flat stones. A sample was taken, including some fragments of charcoal.

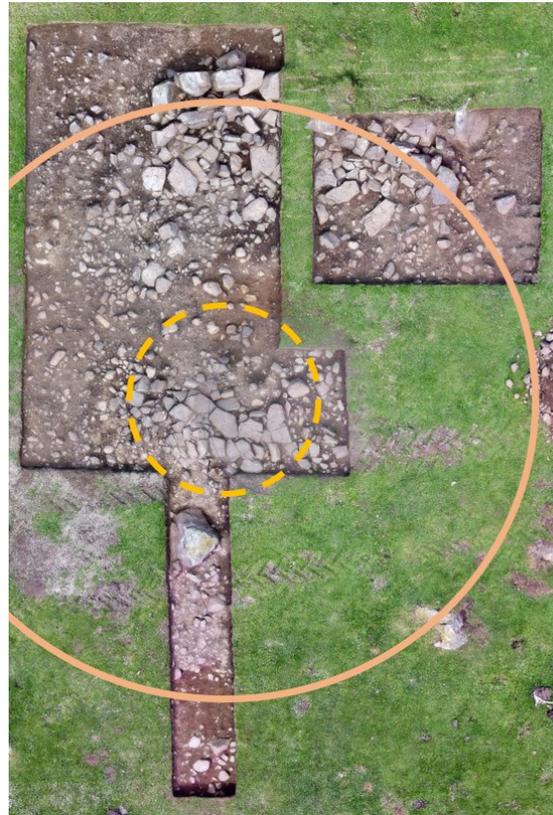
**Figure 36:** Trench 4, before removal of areas of flat stones interior to bank and in centre of hypothetical 9m circle (drawn on). *Photogrammetry image by Stephen Eastmead.*

After lifting of the flat stones, the area inside the circle was cleaned and examined for any evidence of pits, post-holes or burials. No burials or cremation remains were found. As mentioned above there were charcoal fragments in the irregular deposit under the flat stones by the bank. A single 0.3m x 0.25m circular cut was found, 3m west of the centre of the circle, so not under the area of flat stones. It was 0.21m deep with an irregular rounded floor, and the fill was sandy/loamy with small stones and no evidence of organic material. It may have been a post-hole or animal burrow.

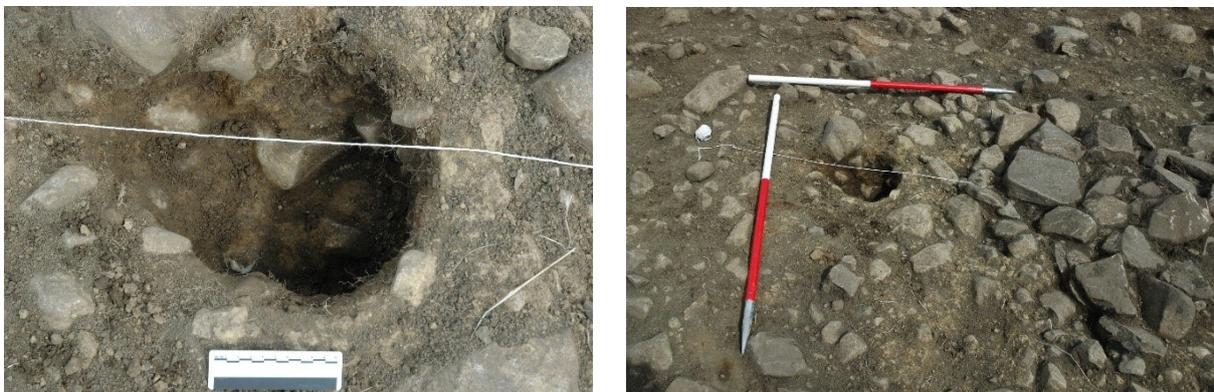
**Figure 37:** Small post-hole or burrow, located west of the central area of flat stones (seen at right)

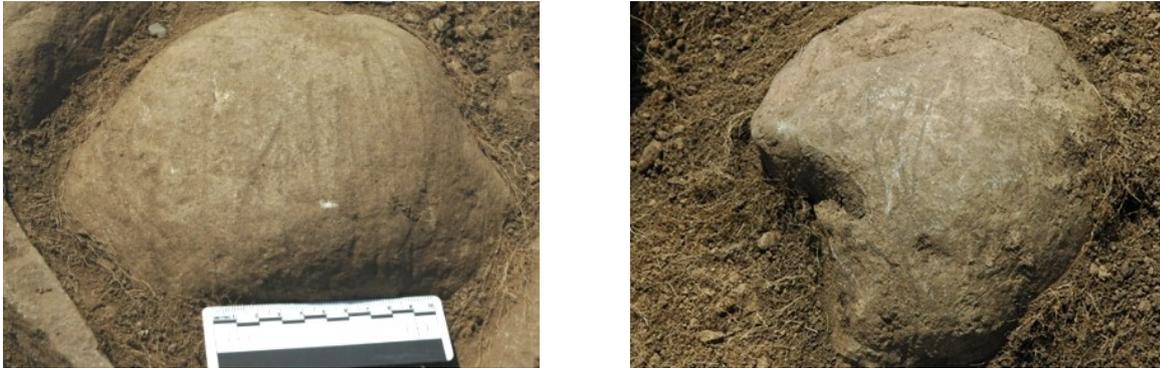
**Figure 38: Two example of earth-fast stones inside the circle showing damage from ploughing.**

Plough marks were found on earth-fast stones inside the circle: parallel scores across the stones. The ploughing appears to have been in a single direction, consistent with medieval practice.

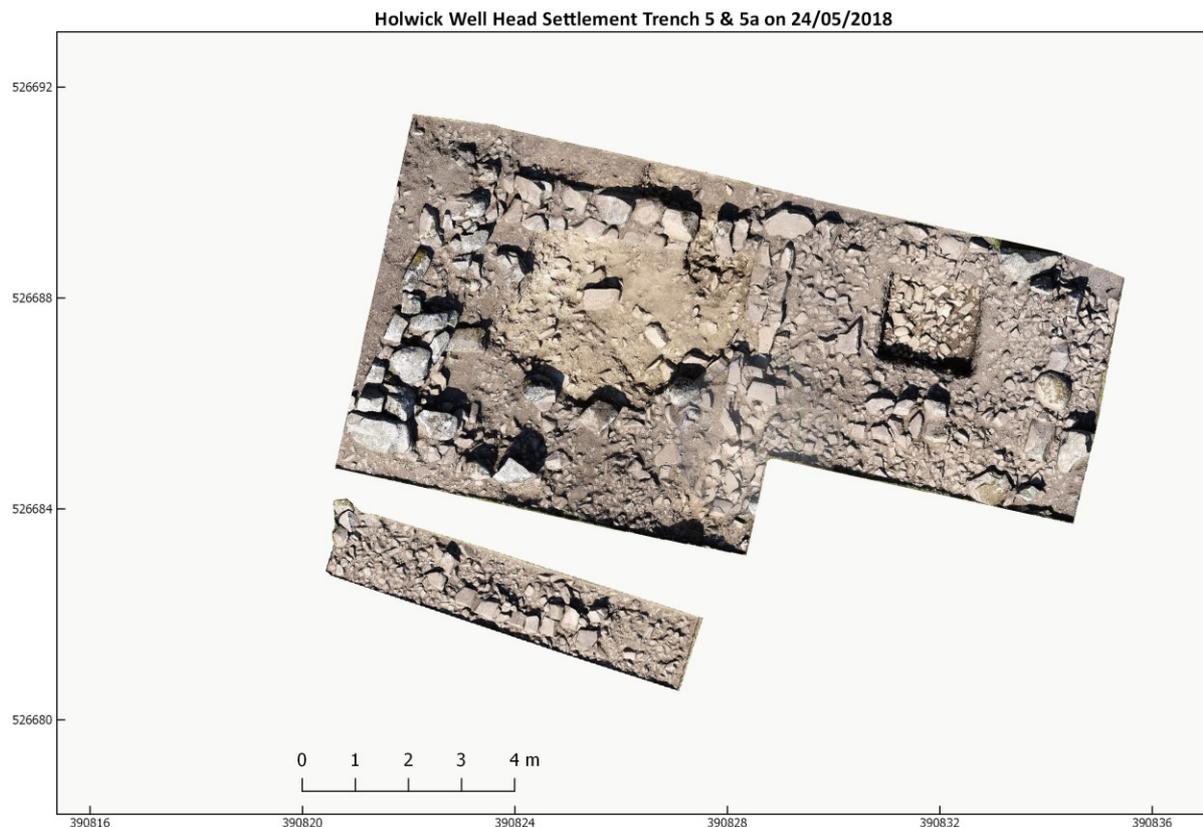
**Figure 39:** Photogrammetry image of Trenches 5 and 5a at end of excavation. *Image by Stephen Eastmead.*

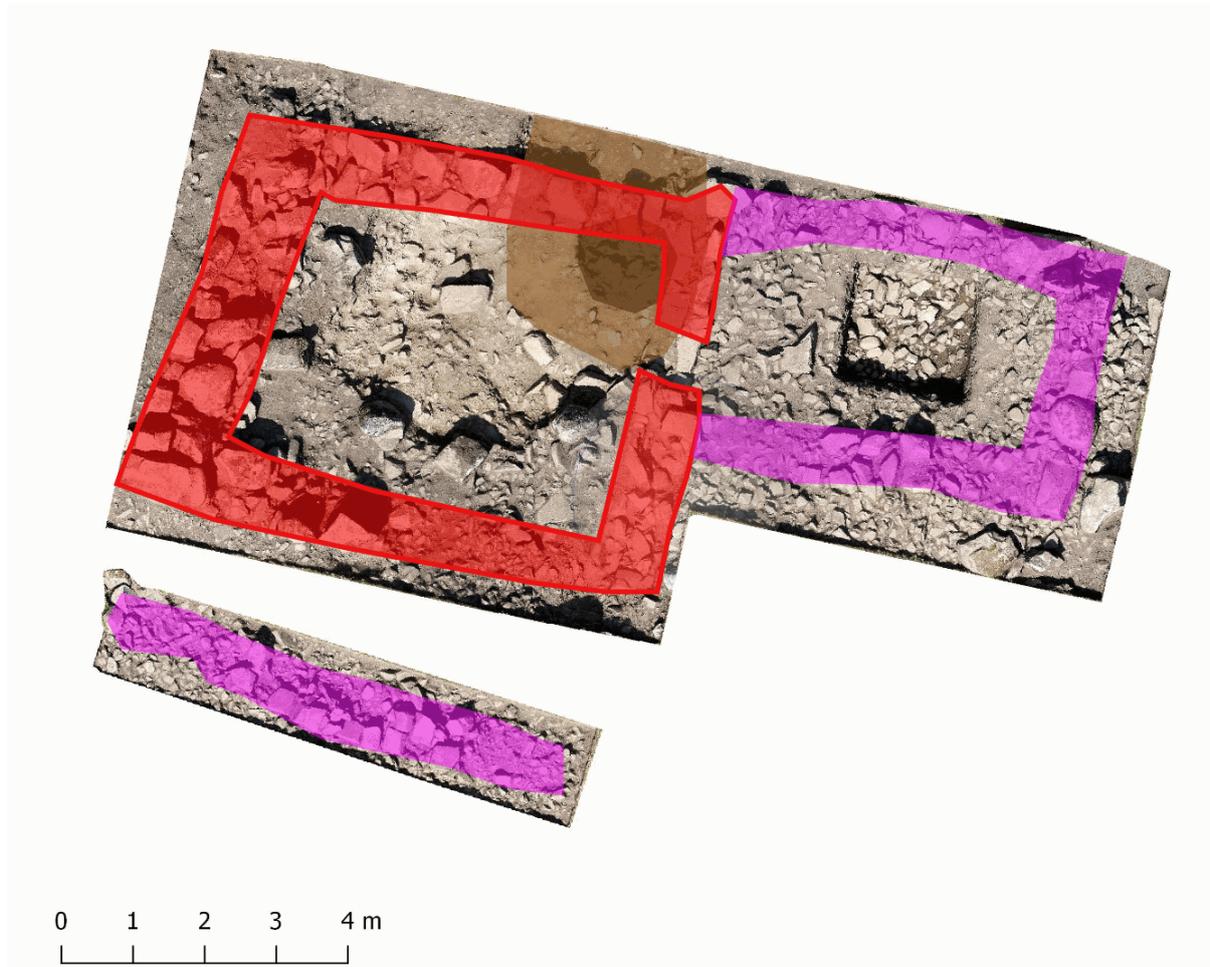
**Figure 40:** Annotated photogrammetry plan of F12. Walls are shown in red and purple. In the north-east corner of the western cell is a heat damaged area 521 (dark brown). It is embedded in surface 512 (light brown) which extends beyond the north wall as 519.

A small area 512 (by 521) was a compact sandy clay layer that appeared to be a floor surface. This layer was found to extend under the north wall 506, suggesting that the surface predated the rectangular building. If so, then it may have been an earlier roundhouse floor, which would account for it being scooped. The soil samples from 512 may shed some additional information on this too. Unfortunately, no other floor surfaces or any post-holes were present.

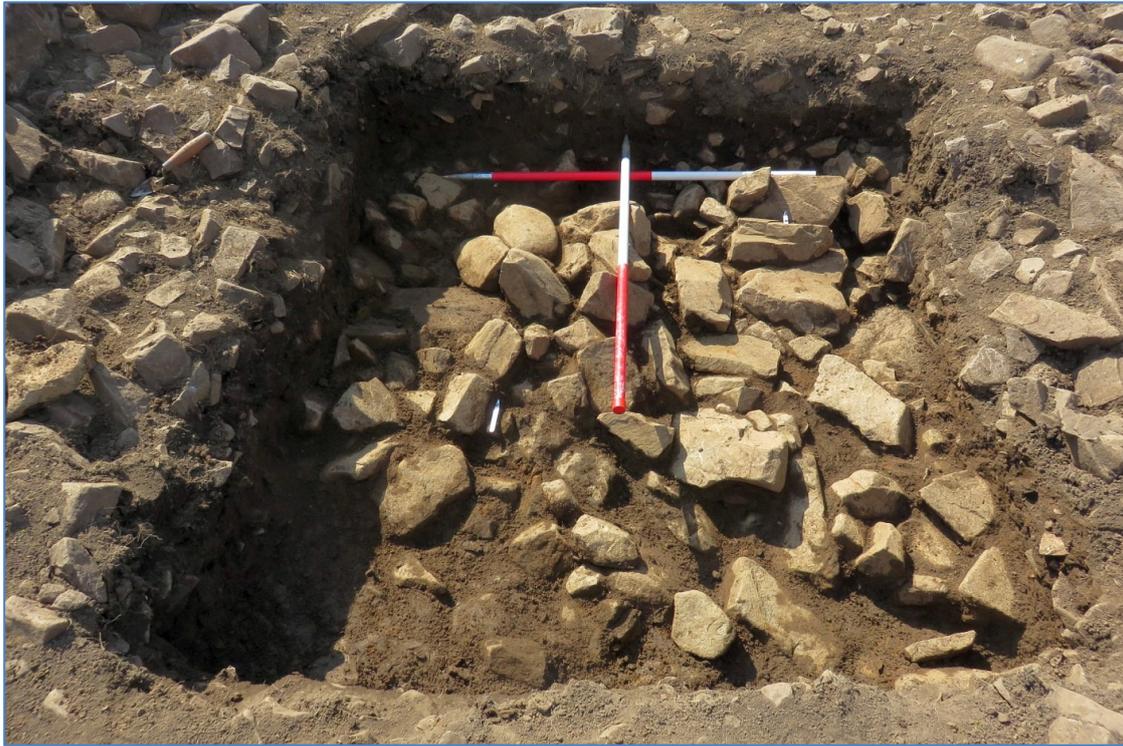
**Figure 42:** Sondage in eastern cell of F12, through stony context 517.

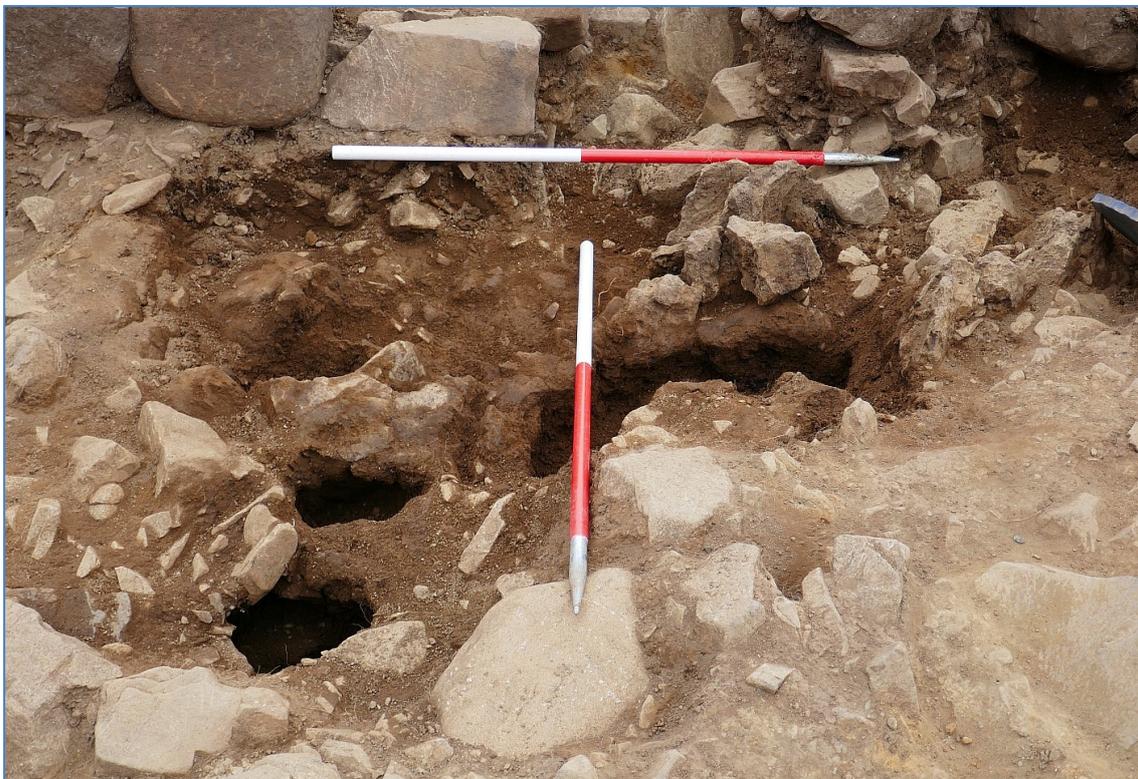
**Figure 43:** Heat-altered area in north-east corner of western cell of F12, looking north.

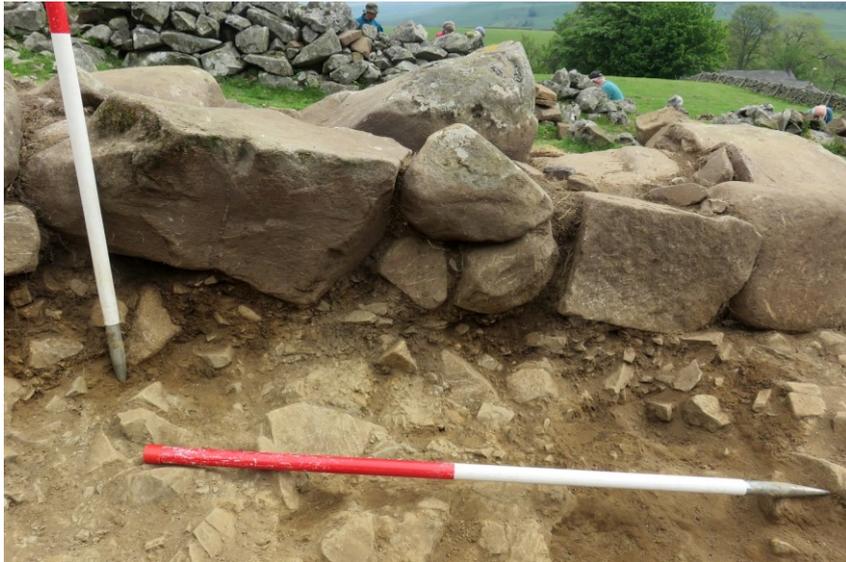
**Figure 44:** North wall 506, on boulder clay which dips to the east, looking north.

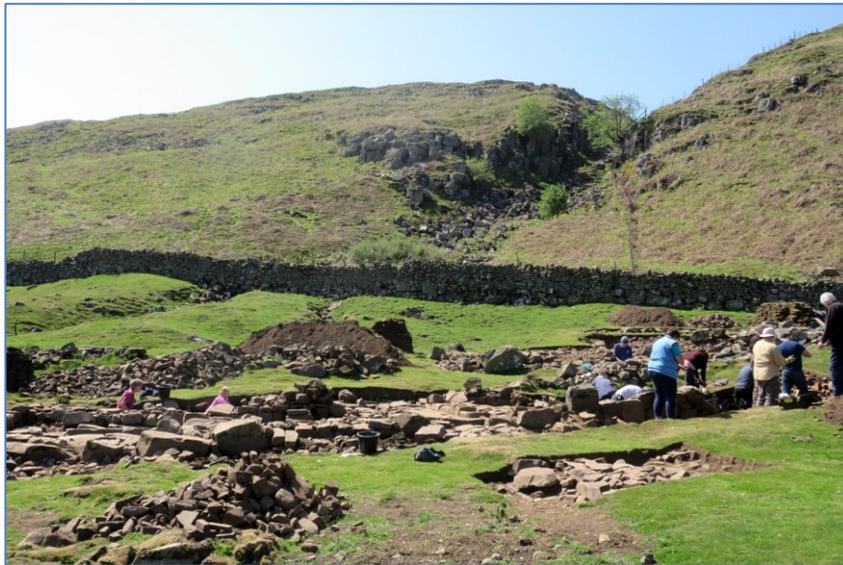
**Figure 45:** Well Head looking south-east. Trenches 3a (right foreground), 3 (centre) and 5 (right rear). Modern field-wall across centre of image with gully beyond draining water from moorland (resulting in flowing water across site after heavy rainfall).
