# WELL HEAD DESERTED SETTLEMENT Holwick, Teesdale

*Interim Report: 2018 (2nd season) Excavation*

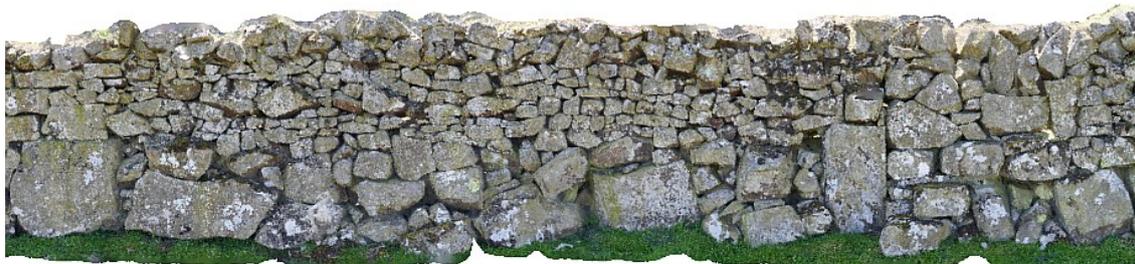
**Figure 46:** Photogrammetry image of modern field-wall adjacent to Trenches 5 and 5a, showing use of boulders, presumably robbed from site. *Photogrammetry by Stephen Eastmead.*

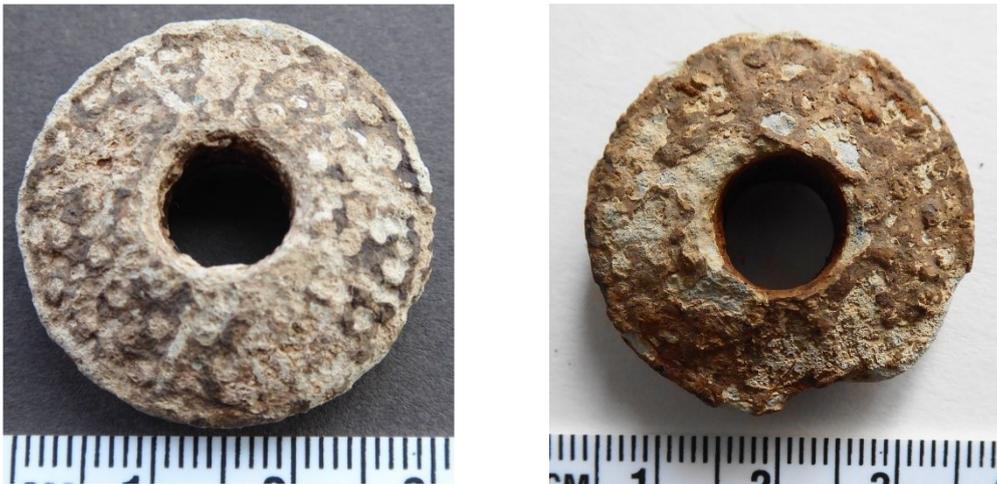
**Figure 47:** Lead spindle whorls, same mould, from (left) Trench 1, F8 and (right) Trench 3, F9.

Spindle whorls were found in both the 2017 and 2018 excavations, including a very similar pair, one from Trench 1 and one from Trench 3. These will be described in the final report.

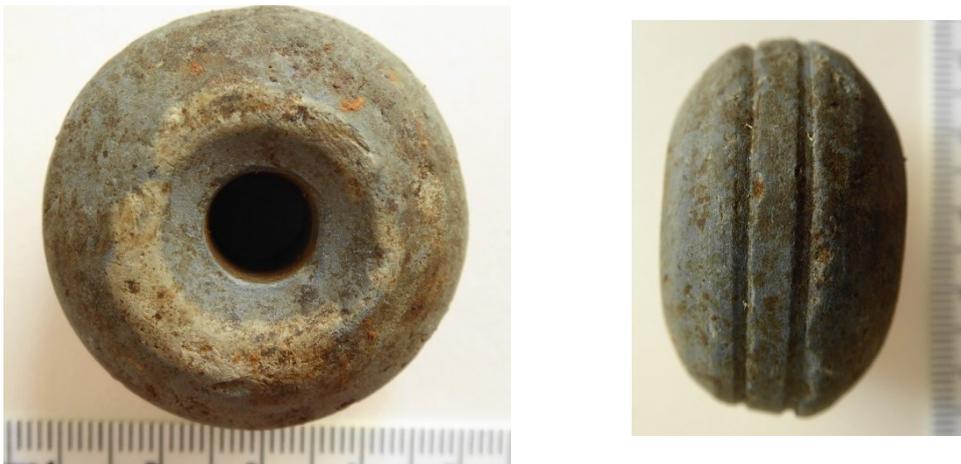
**Figure 48:** Stone spindle whorl from Trench 3, F9.

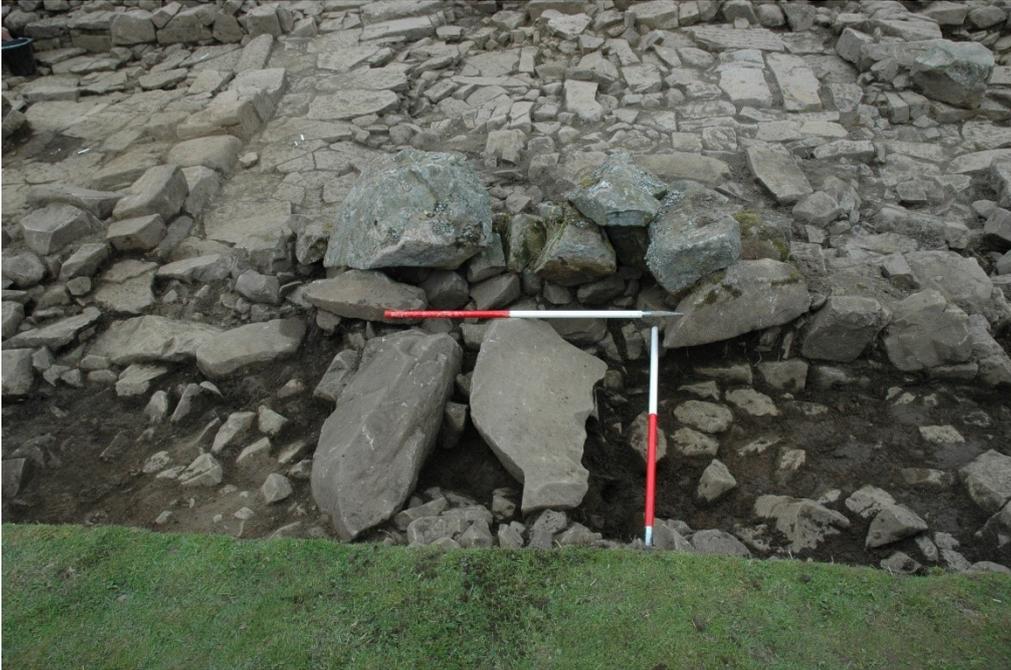
**Figure 49:** The incised stone in situ (the right-hand of the two stones framed by the ranging poles). It is lying face down over the drain outside the south entrance to building F9. View looking north.

An incised stone was found during the excavation, lying face down over the drain running along the outside of the south wall of building F9 in Trench 3. It was located about 1m to the east of the south entrance to the house. It is an irregular slab of whinstone, approximately 0.75m x 0.35m. It was removed to allow excavation of the drain underneath and only later, when turned over on the discard stone pile, was its incised pattern noted.

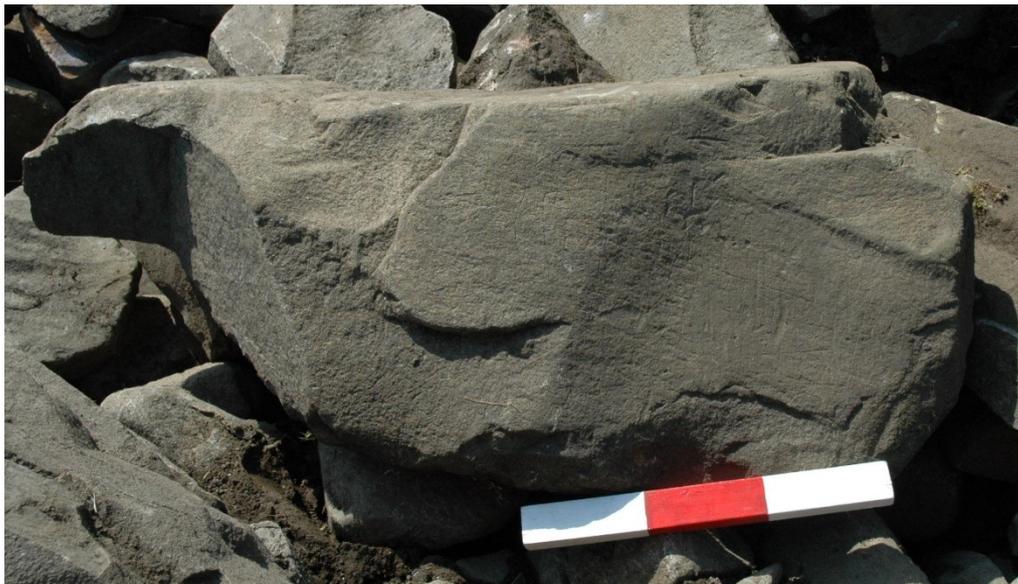
**Figure 50:** The incised stone, on discard stone heap, with incised pattern exposed.

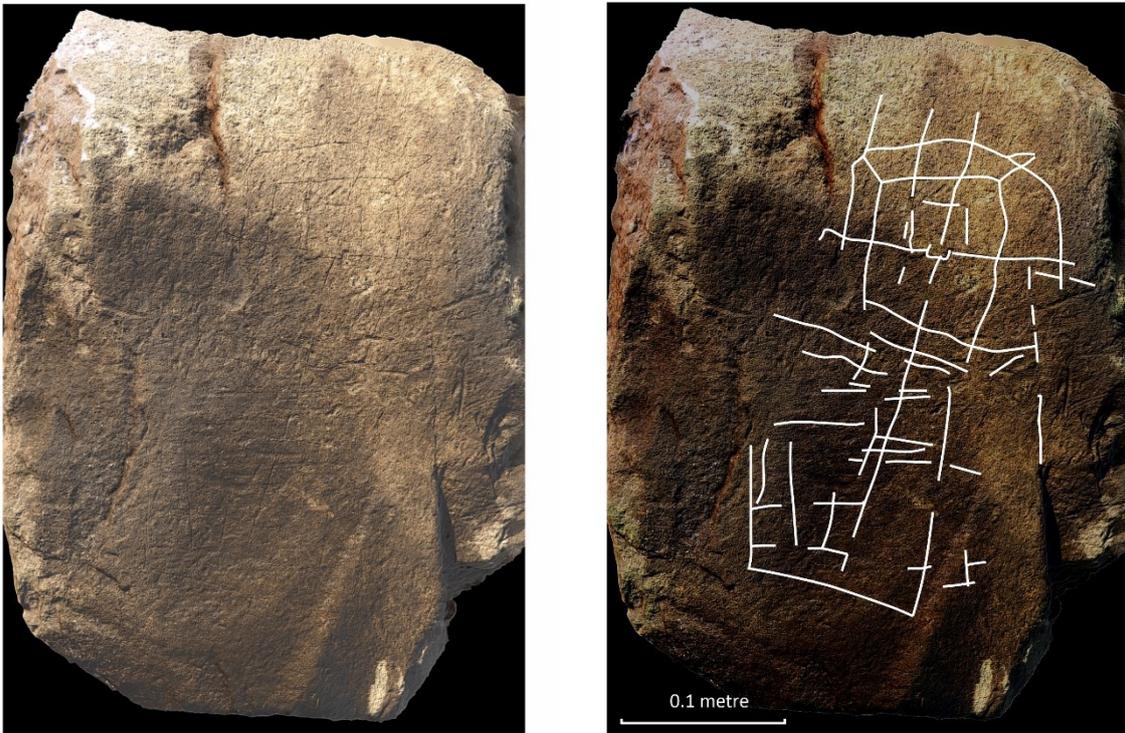
The incised pattern is very faint, probably because of the hardness of the stone: whinstone, a form of igneous dolerite, from the nearby crag. Hence the incised lines are very superficial. There were also broader linear “gouges”. To assist interpretation, a photogrammetry image was created of the face of the stone with the pattern. This allowed a tracing to be made of the pattern.

**Figure 51: The incised stone, photogrammetry image, with pattern of fine incisions annotated on right image. Note that broader lines/gouges are not annotated.**

The incised pattern includes rectangles within rectangles. The upper part of the design is reminiscent of a gaming board (Nine Men’s Morris). The transverse gouges are particularly noticeable in the central area. They overlie the incised lines.

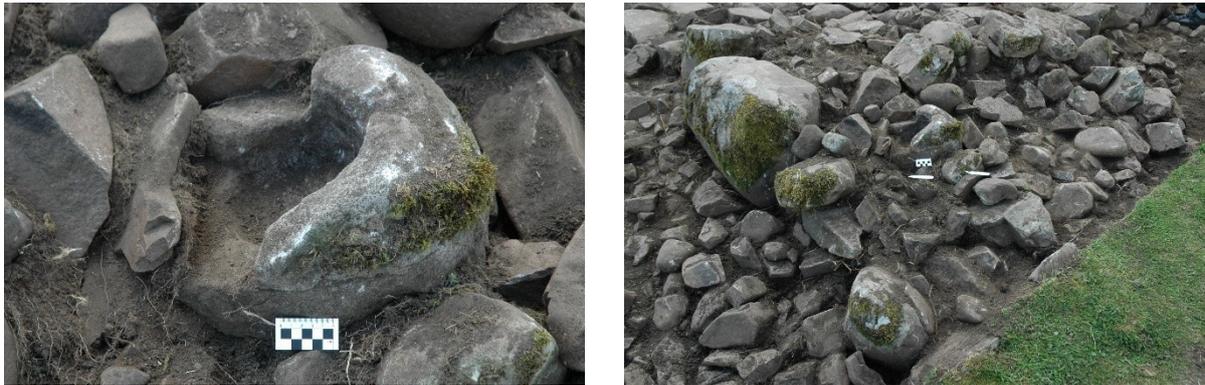
**Figure 54:** The creeing trough in situ before lifting from Trench 3. Views looking south-west.

A crudely carved sandstone basin was found in Trench 3, on top of a bank of rubble piled against the outer face of the east end of the north wall of F9. The basin is a rough octagon (a square with corners removed) about 35cm on its long axis and 30cm on its short axis. It is 27cm high. There is a horizontal crack through it, resulting in the loss of a section of the rim: This may have occurred during manufacture and have resulted in the discarding of the basin. It shows little sign of use. The trough internally is oval, 17cm on the long axis and 15cm on the short.

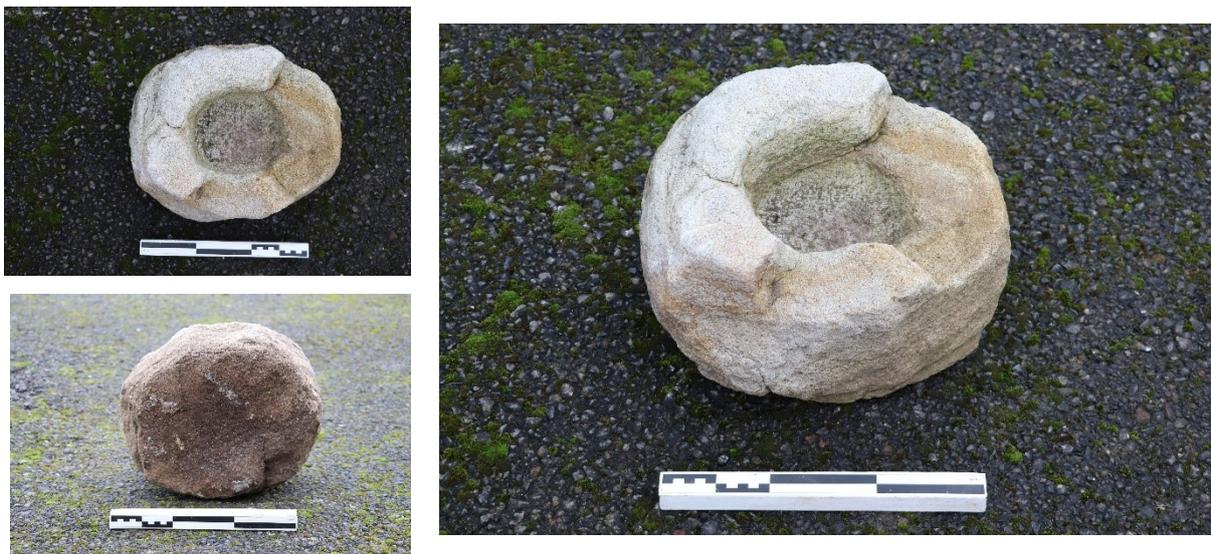
**Figure 55:** The creeing trough after lifting: top, bottom and oblique views.

The basin is a creeing-trough, a mortar used to prepare food for human (and sometimes animal) consumption. Grain was pounded in it to soften and de-husk before being boiled to make broth. No doubt they were also used to prepare other foods. Creeing troughs are fairly common findings on medieval occupation sites, but due to the lack of decoration and the likely long periods for which they could be in use, it isn't possible to assign close dates to them.

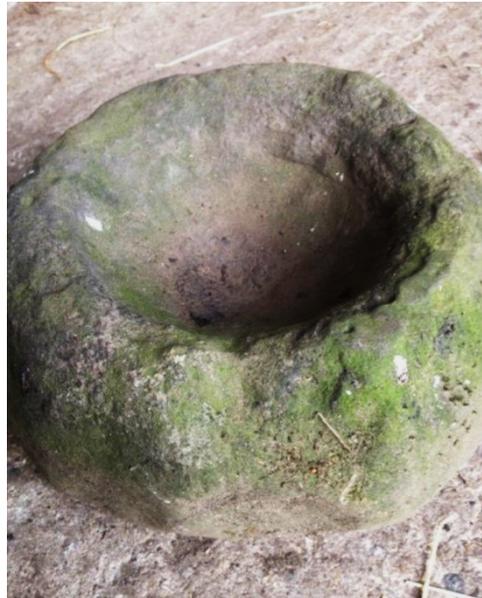
**Figure 57:** An example of an octagonal creeing trough from Yorkshire, 22cm in exterior diameter.

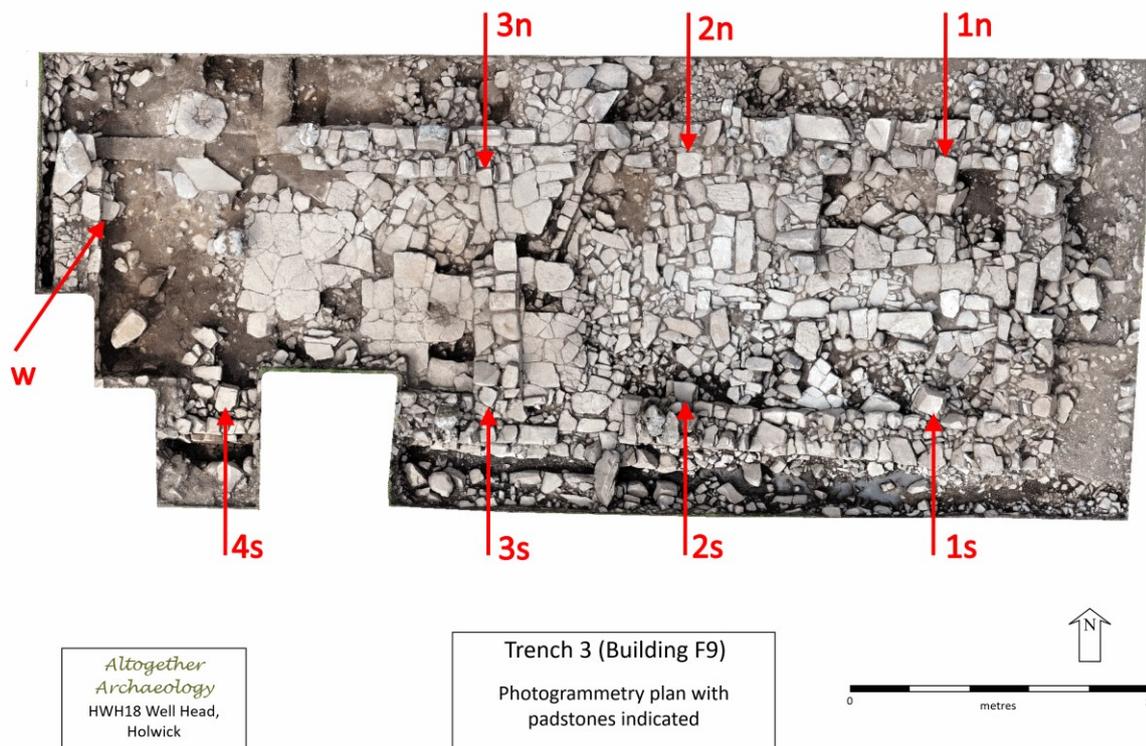
**Figure 58: Positions of the padstones of building F9.**

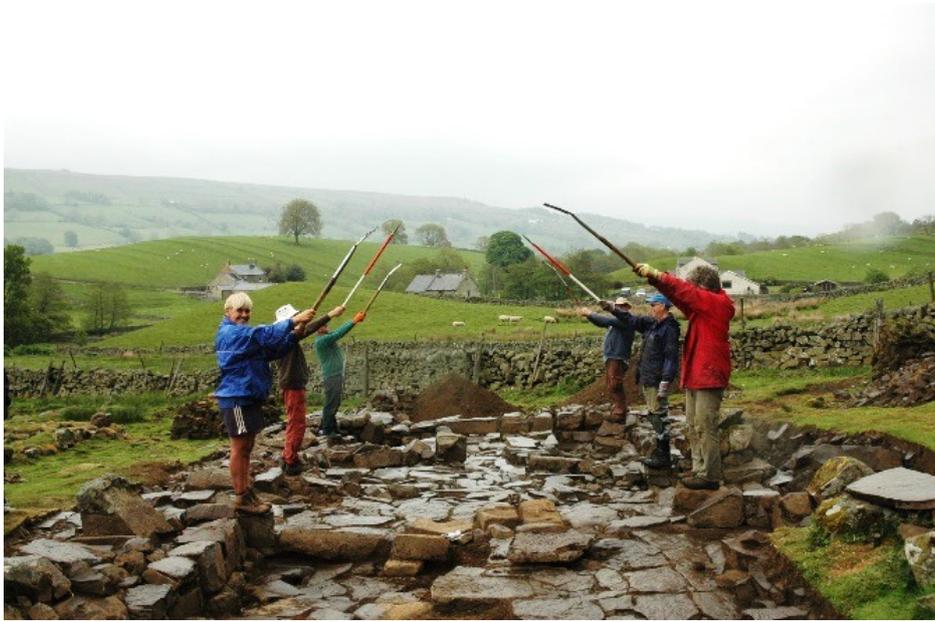
**Figure 59:** Members of AA standing on the padstones to demonstrate the crucks of building F9.

Cruck 1 had padstones in the animal pens at the east end of the building. Its northern padstone (1n) is in the line of stones dividing the main section of the northern pen from its small eastern compartment, the "dog kennel". Cruck 2 had both padstones in the lower "animal" cell of the building. Cruck 3 had both padstones built into the stone cross wall of the building; the northern padstone is adjacent to the threshold slab of the doorway through the cross-wall, so the cruck would have also served as a doorpost. Cruck 4 lies at the edge of the paved part of the upper "human" cell of the building. Although there are no post-holes or wall to confirm this, it suggests that there may at one time have been a partition across the building at this cruck, with the western 2m of the building being used for storage or workshop.

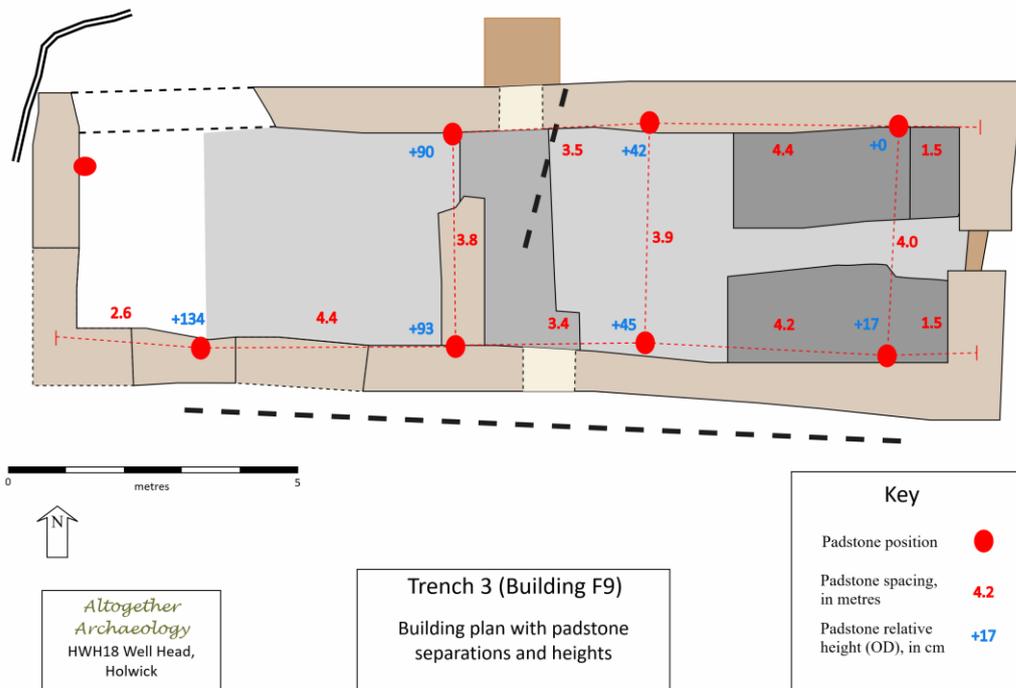
**Figure 60:** Cruck span dimensions and heights (ODs) of upper surface of padstones in F9.

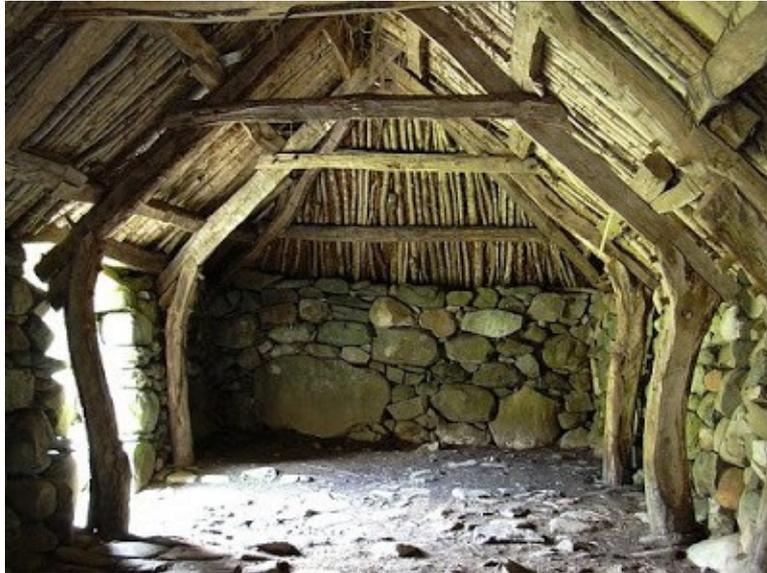
**Figure 61: Building at Auchindrain (Scotland) with a cruck frame and hipped roof. Note padstones.**  
Preserved at the Auchindrain Township Museum: <http://www.auchindrain.org.uk>.

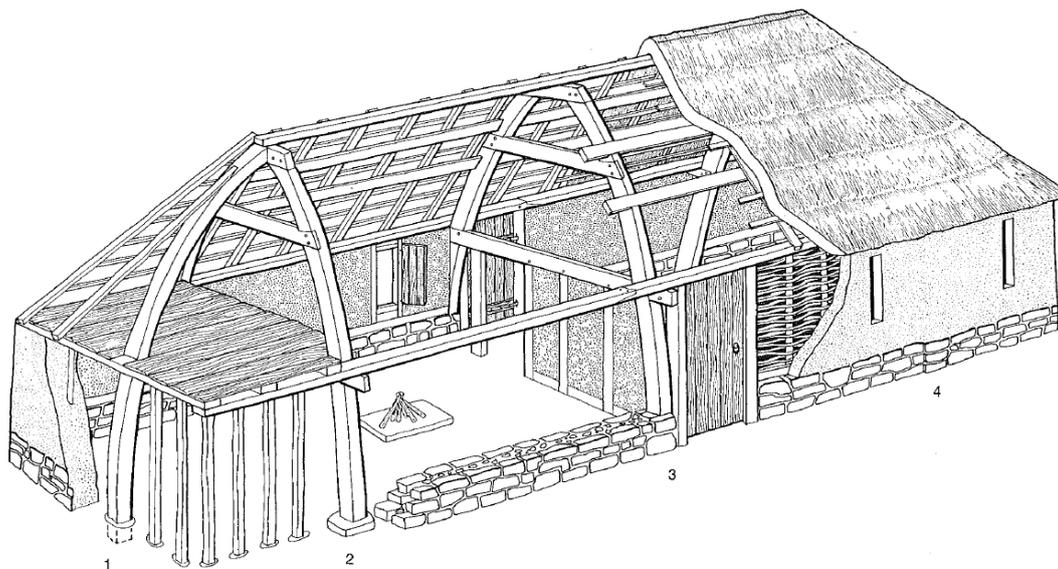
**Fig. 4.** Model of a medieval peasant house, showing the various possible relationships of superstructure to substructure: 1, cruck blade set in a posthole; 2, cruck set on a padstone; 3, cruck set within a groundwall. The discontinuity in wall alignment at 4 indicates another cruck-truss position.

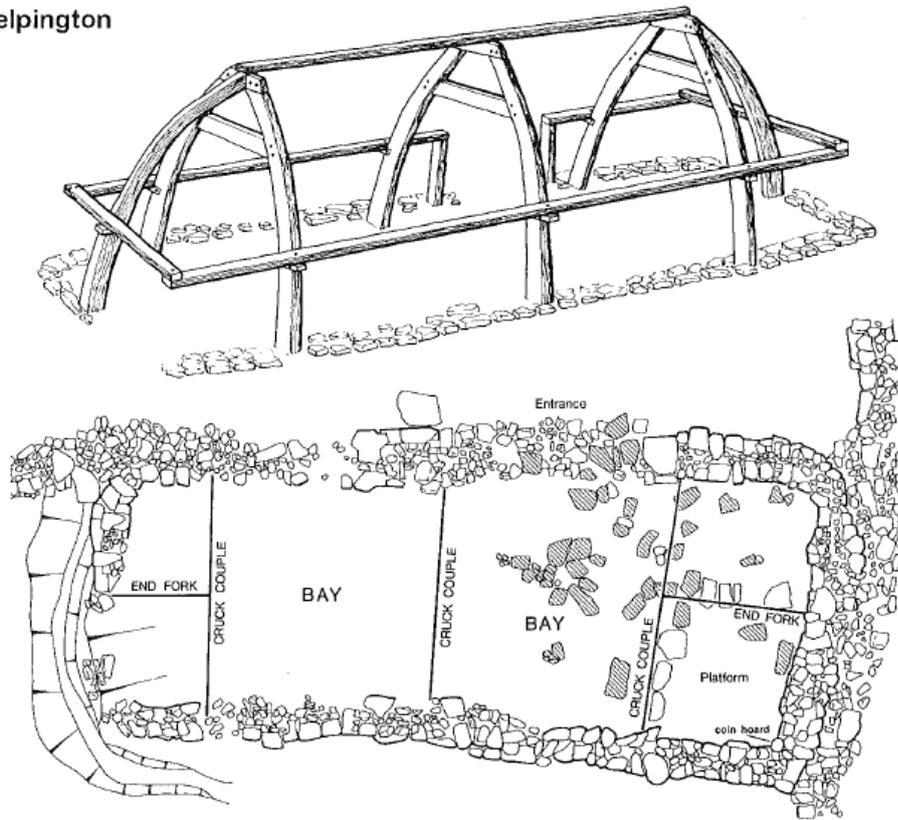
**Figure 63:** Excavated plan and suggested frame of a West Whelpington house.  
*From Wrathmell 2001.*

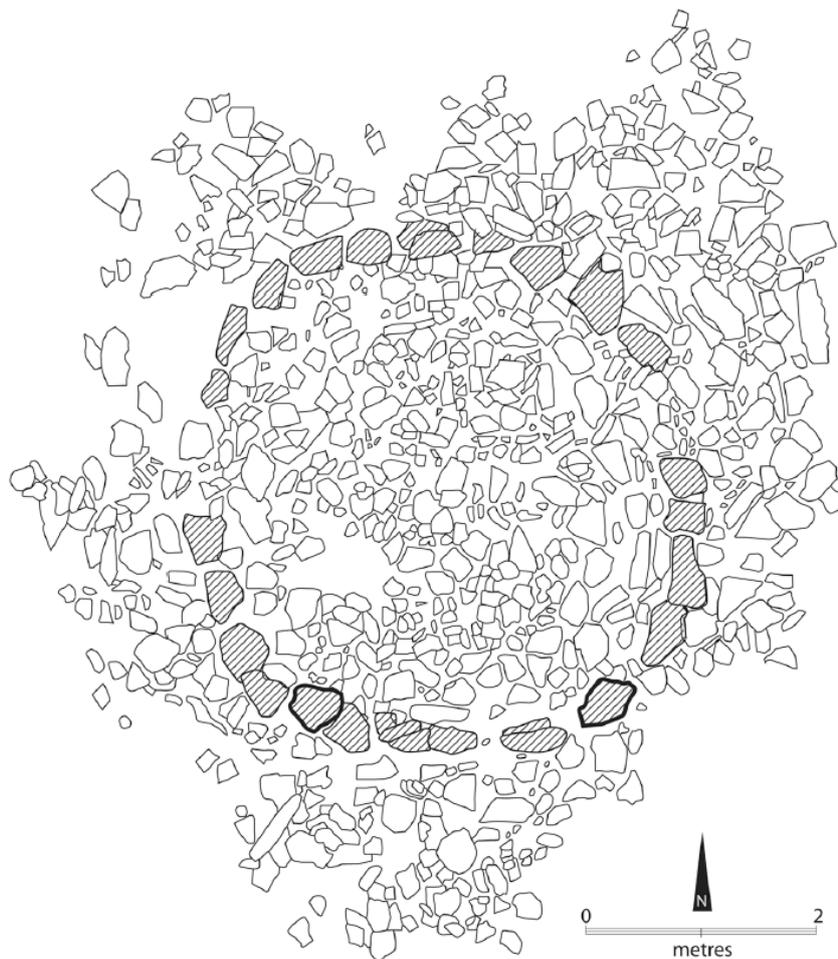
**Figure 65:** Plan of Birkside Fell ring cairn. *From Tolan-Smith 2005.*

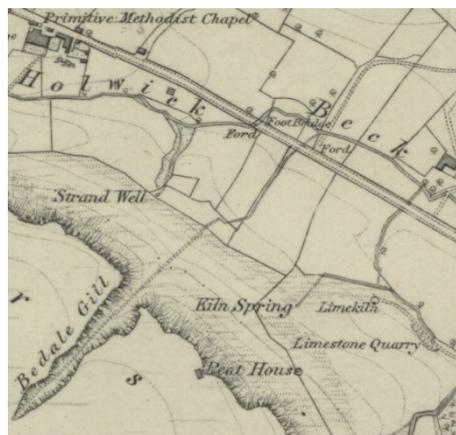
**Figure 66: First edition Ordnance Survey map, 1854, with “Peat House” bottom centre.**

- They are only about 200m away from the presumed “mother settlement” of Well Head.
- They are not near a good water supply: the nearby gully (Bedale Gill) is usually dry.
- They are on a steep hillside, with the nearest upland pasture out of sight over the brow of the hill.
- There are more buildings than would be necessary for herdsmen to occupy from a hamlet like Well Head.
- There are no livestock enclosures apparent.
- One of the huts is marked on the First edition OS map (circa 1860), labelled “Peat House”.

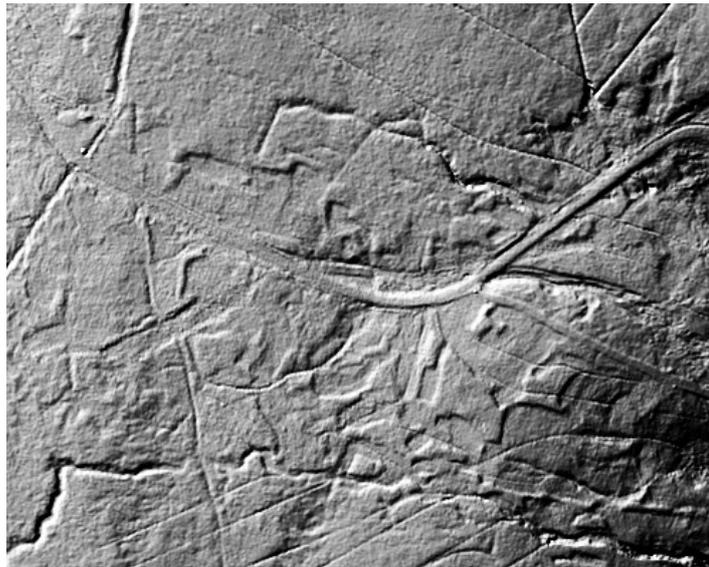
**Figure 68: Lidar image of North Pennine peat-cutting sites by Rookhope-Allenheads road. The summit of the road, altitude 538m, is at top left of image where the road crosses a fence.**

*Image size 500m x 400m, north at top.*

The location of peat cutting sites on the moorlands above Holwick have not been mapped, so the distance that peat had to be transported to the peat scales is unknown. Lidar has proved successful at detecting peat-cutting sites, but the Environment Agency lidar imaging programme has not yet covered the moors above Holwick.

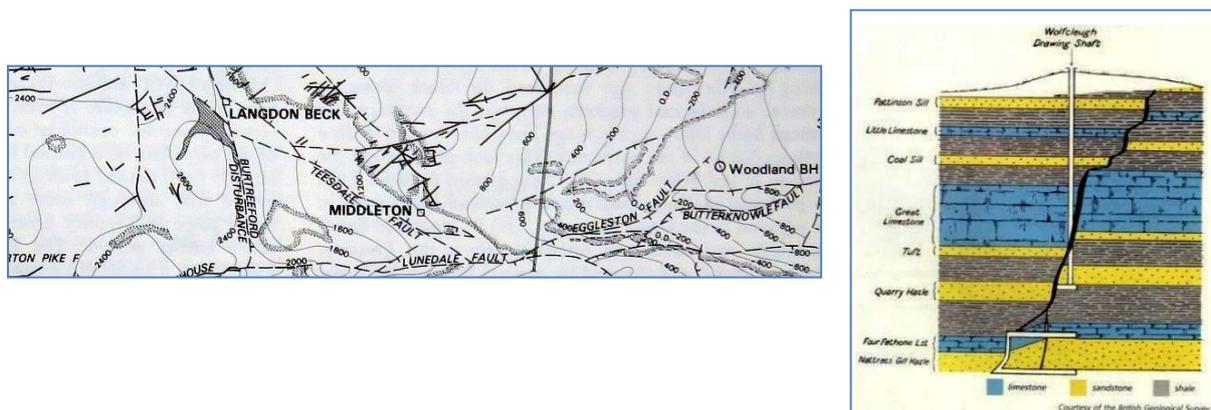
Figure 70: Veins and faults of Teesdale, and (on left) schematic section of a typical mineral vein. From Dunham 1990 and British Geological Survey.

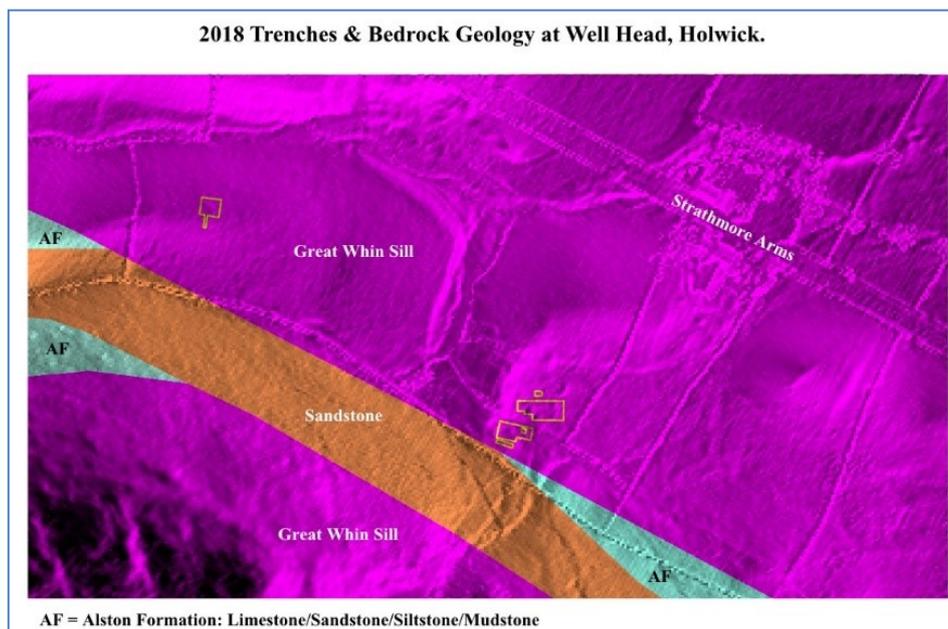
**Figure 71: Bedrock geology map of Well Head: 2018 trenches are marked.**

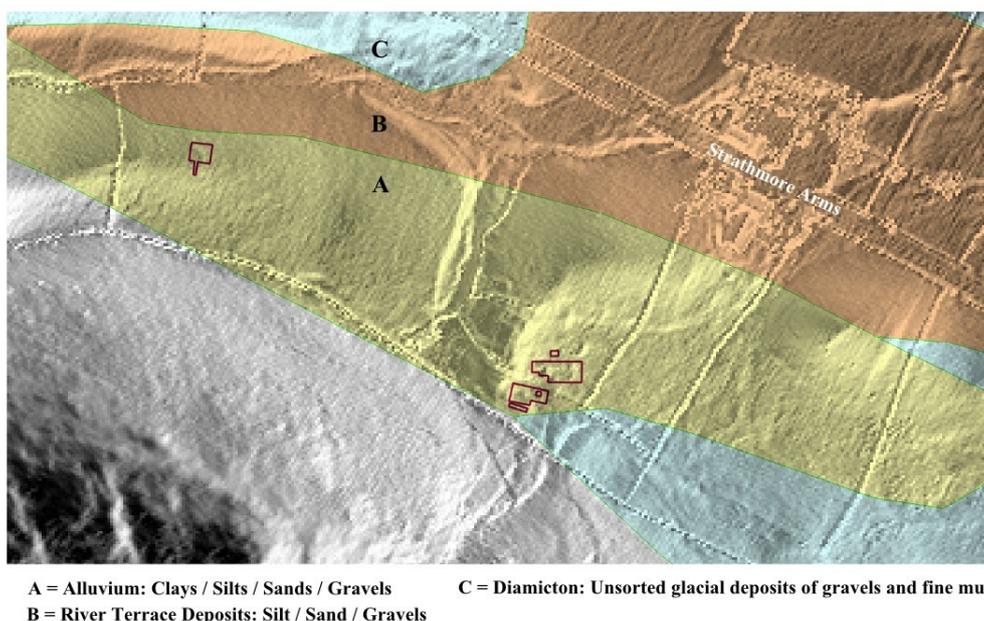
**Figure 72: Superficial geology map of Well Head: 2018 trenches are marked.**

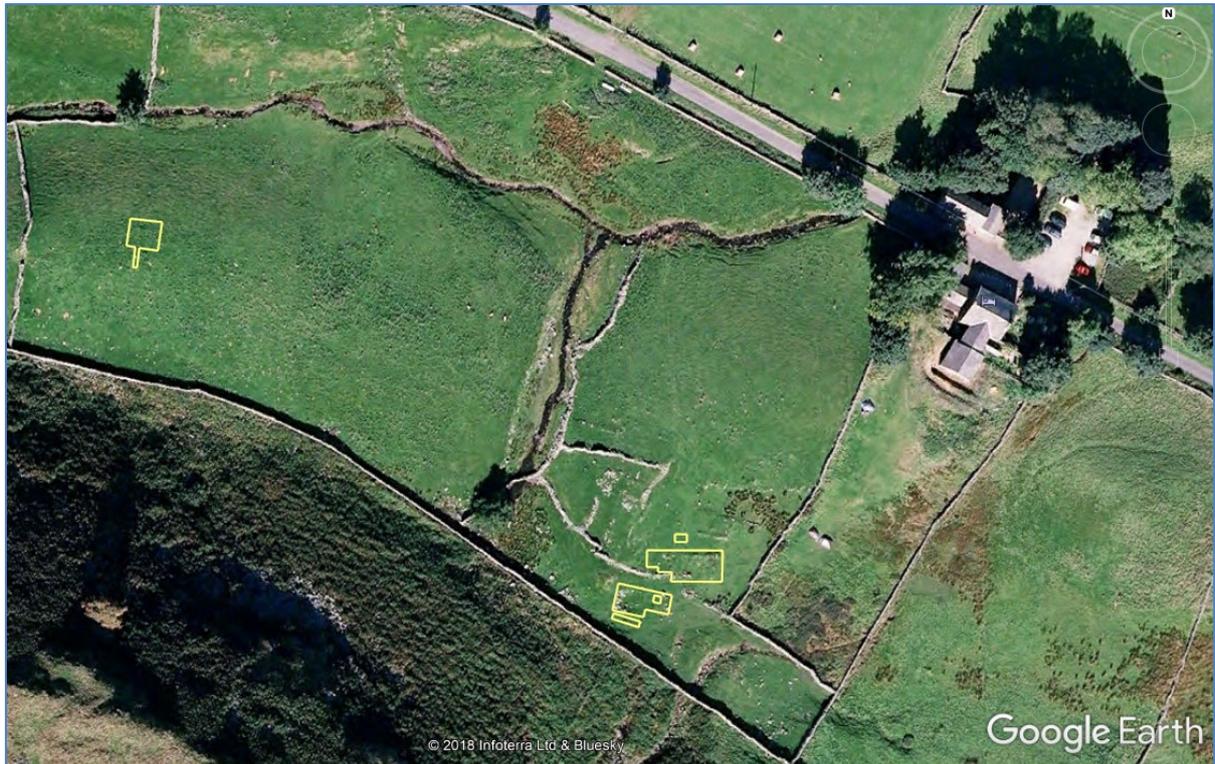
**2018 Trench positions plotted on Google Earth (top) and lidar (bottom).** *Images by Stephen Eastmead.*

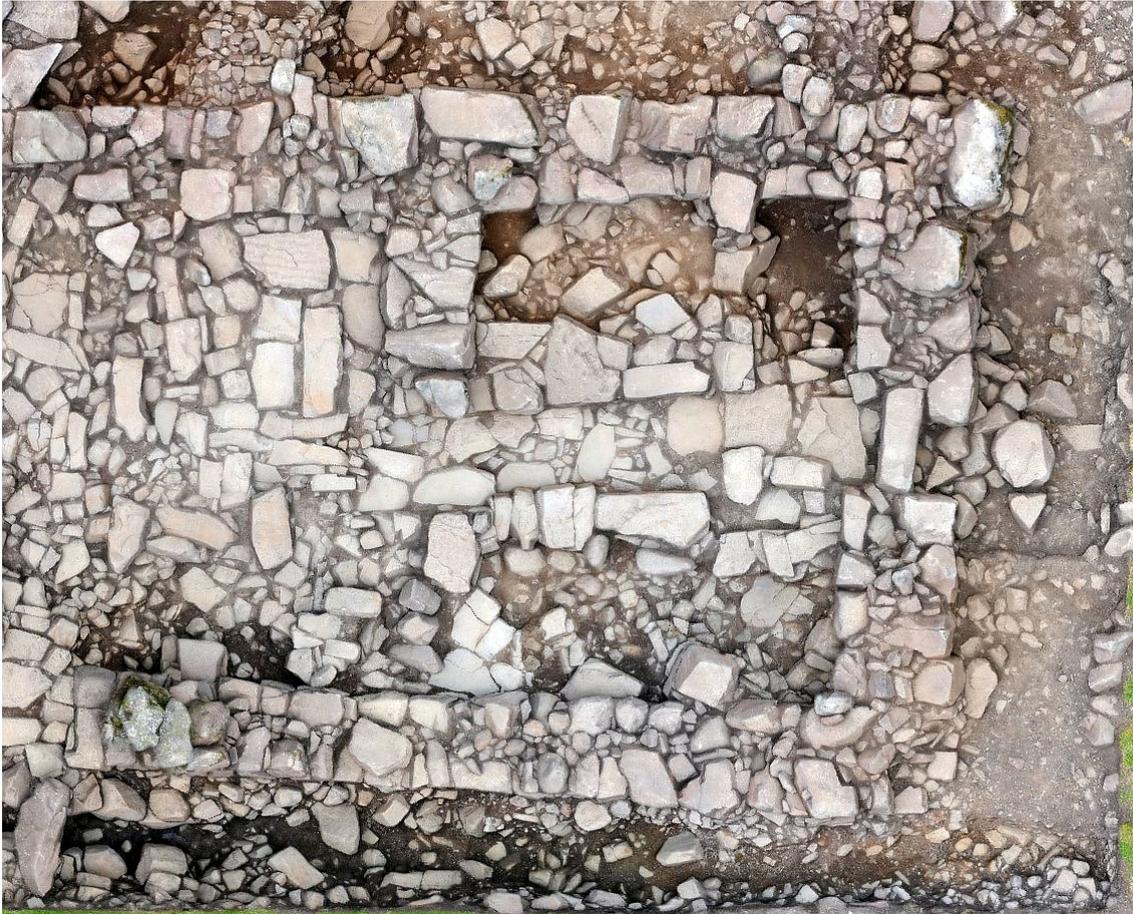
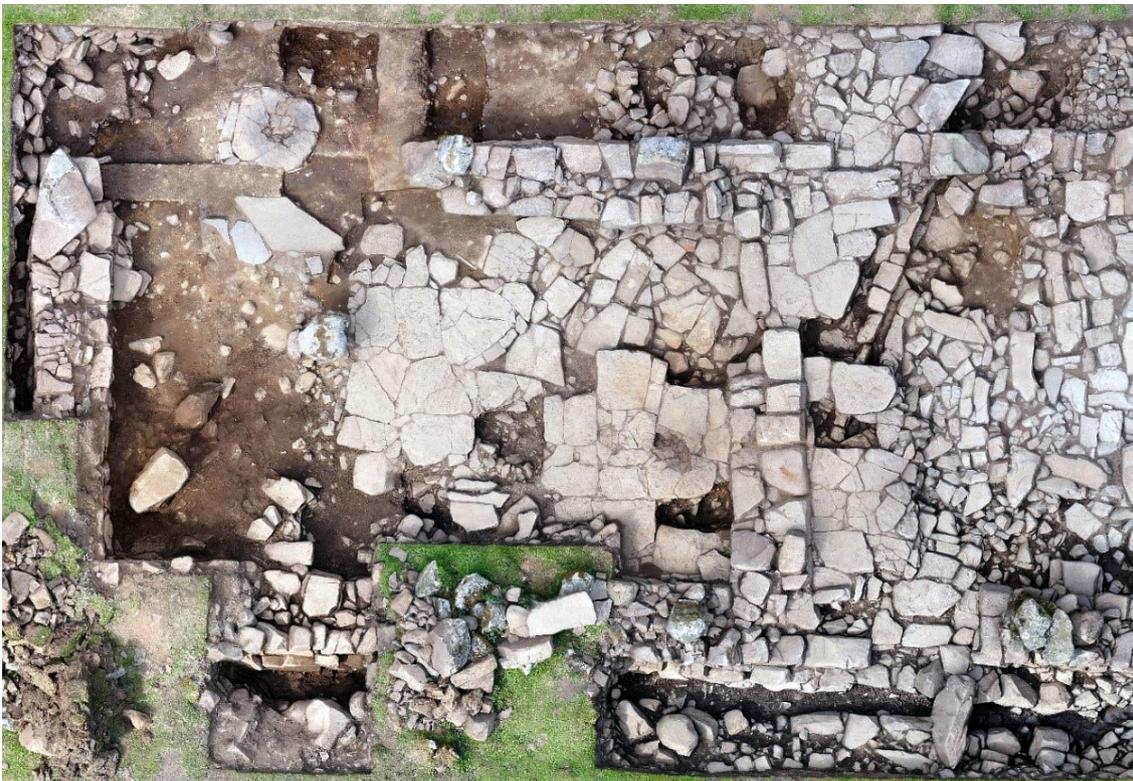
**Trench 3: Overlapping enlarged views of east (top) and west (bottom) ends of building F9. North is at the top. Final photogrammetry.**

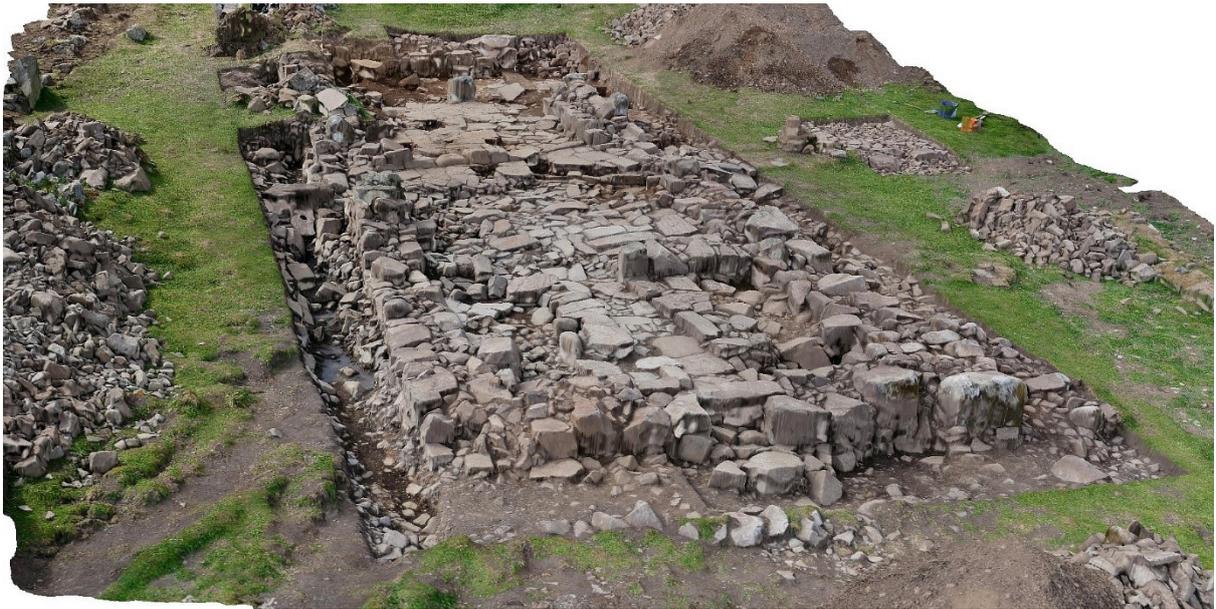
**Trench 3: Oblique photogrammetry image, looking north-west.**

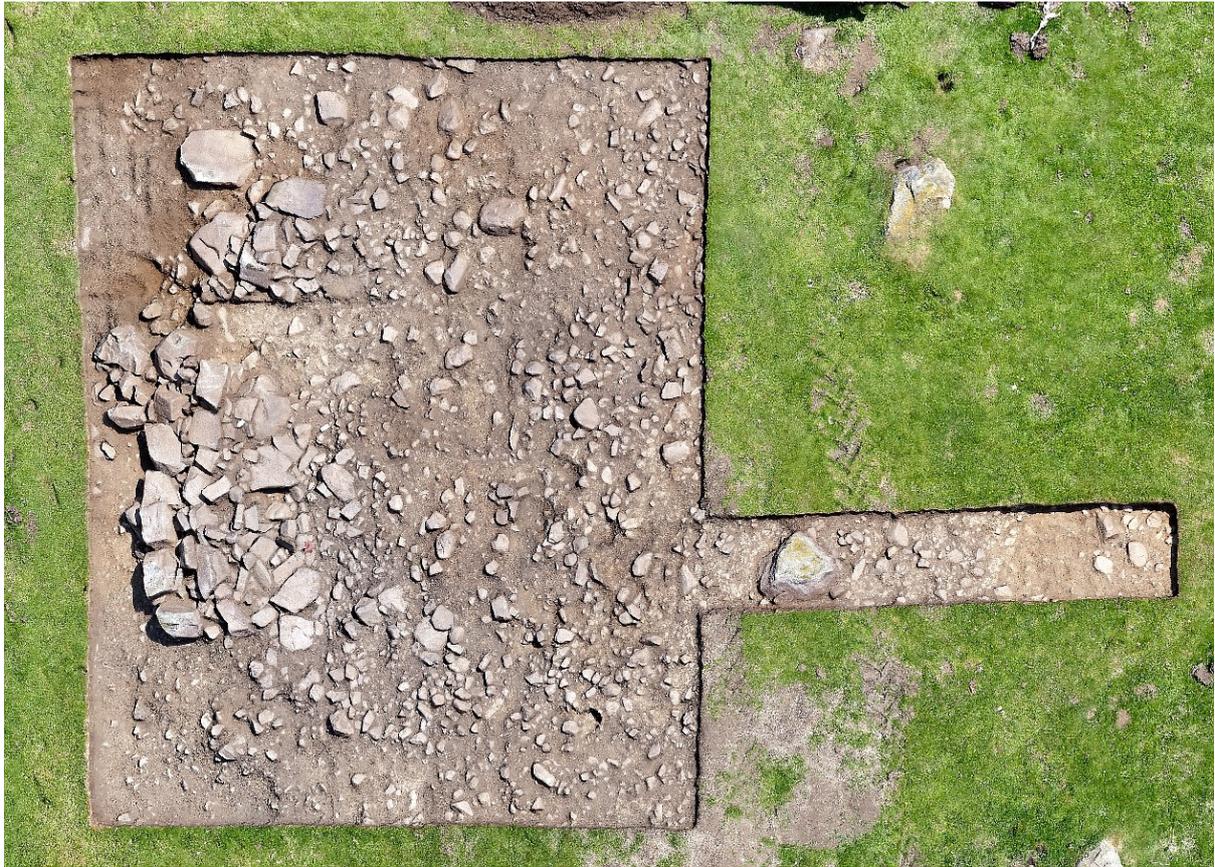
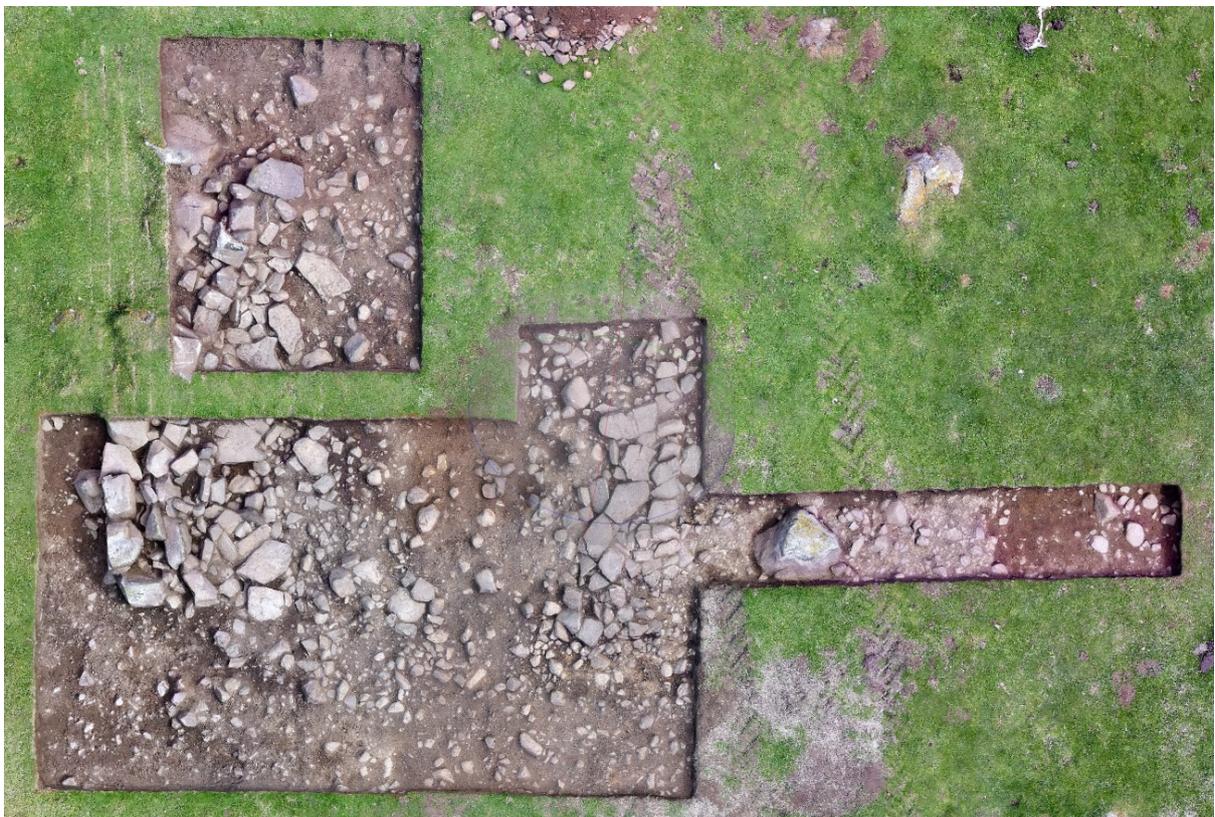
**Trench 4: At end of excavation (top). Before removal of flat stones (below). North to left.**

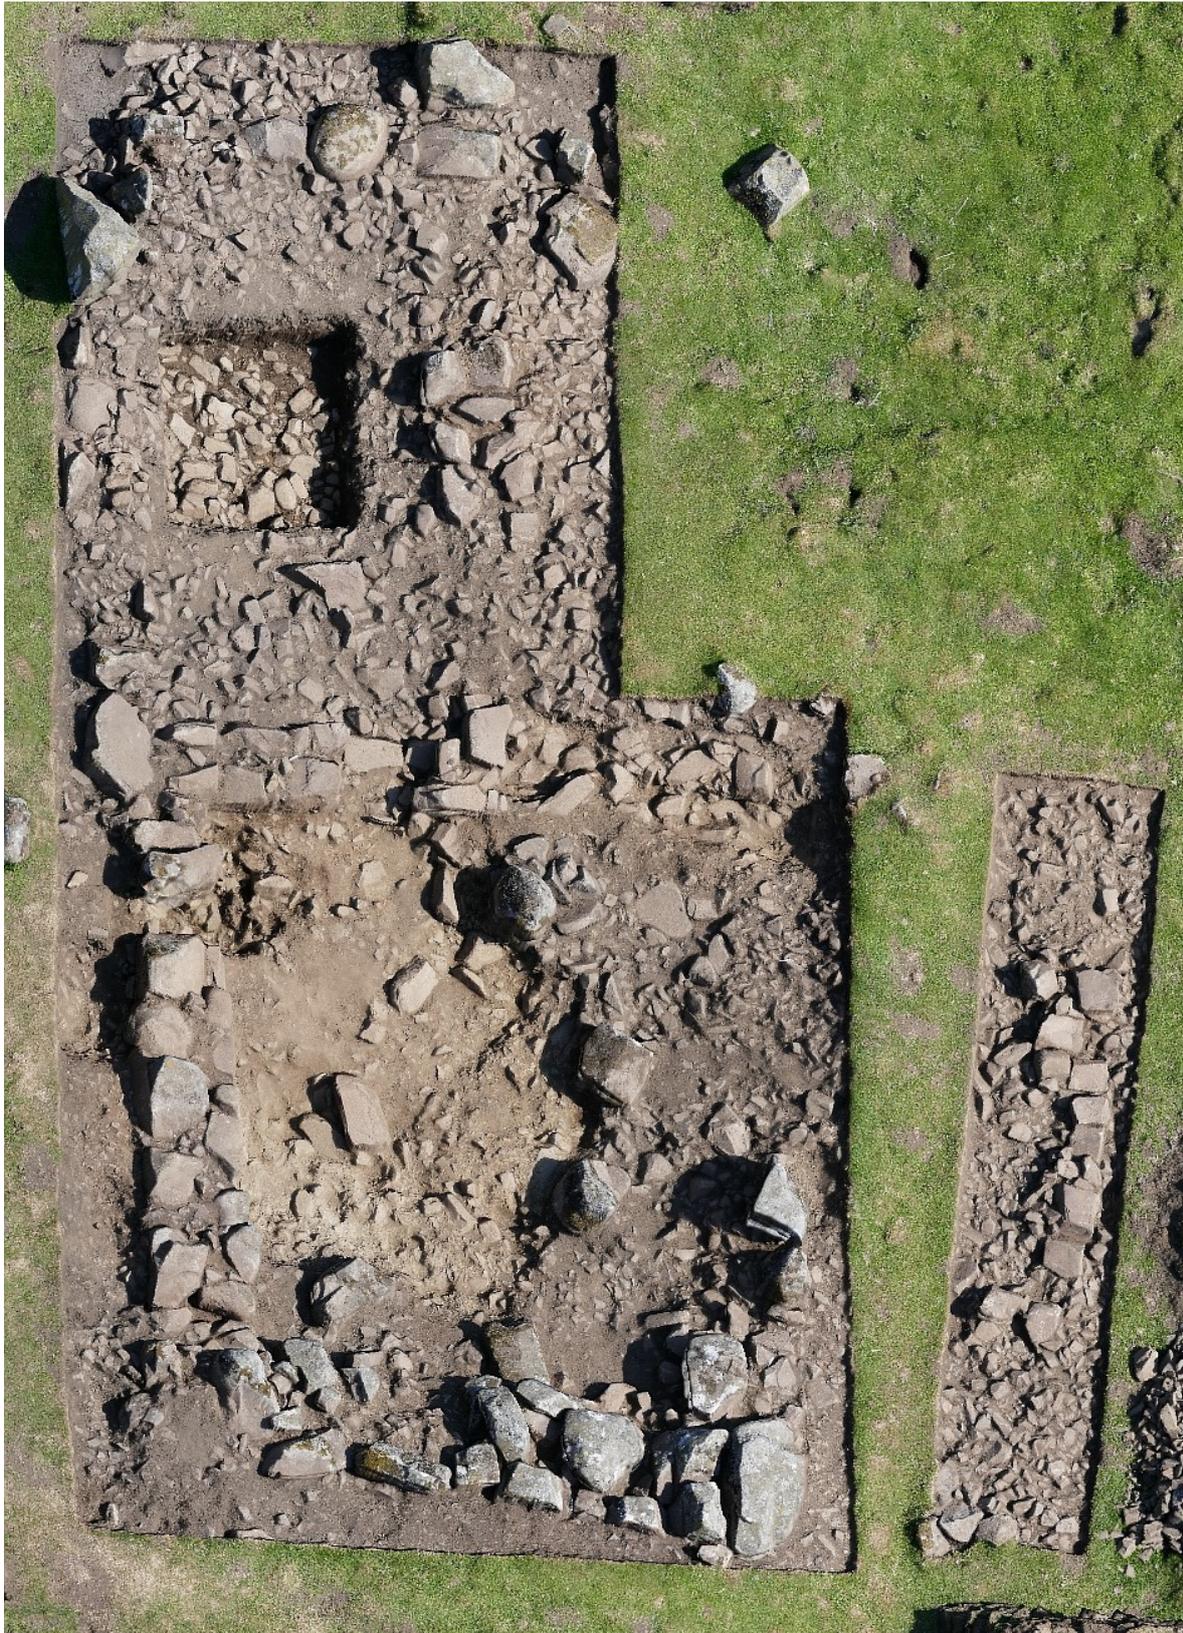
**Trench 5: Final image (enlarged version). North is to left.**

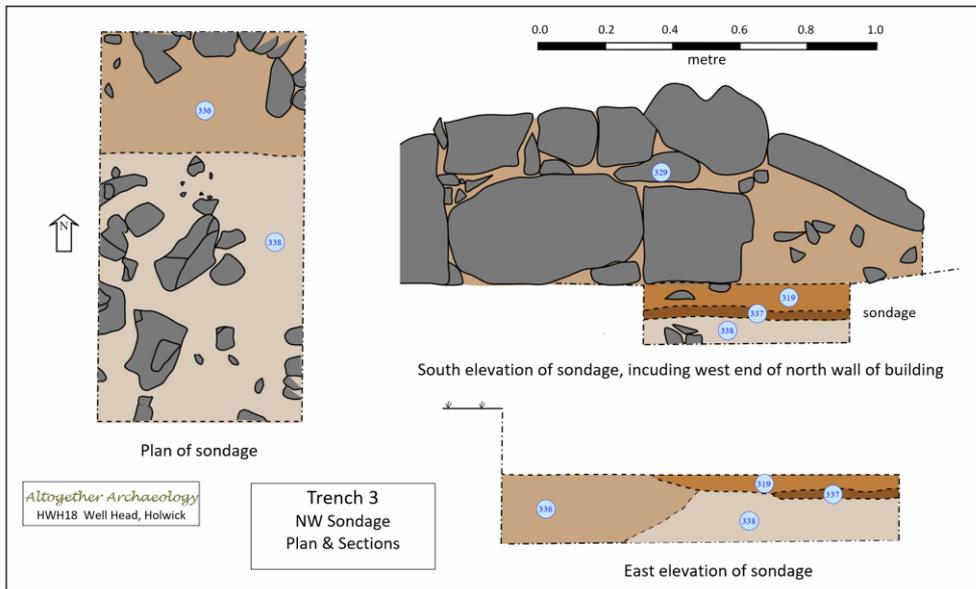
**Trench 3: Section and plan of sondage at external face of west end of north wall of F9.**

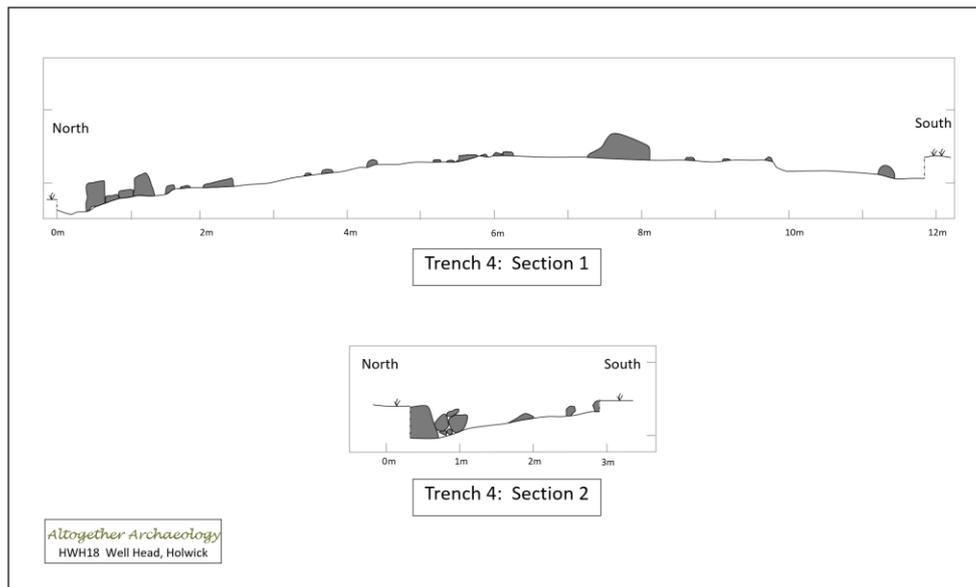
**Trench 4: Sections. Section 1 is north-south along diameter of monument. Lines of sections are shown on the levels and samples plan (Appendix 10).**

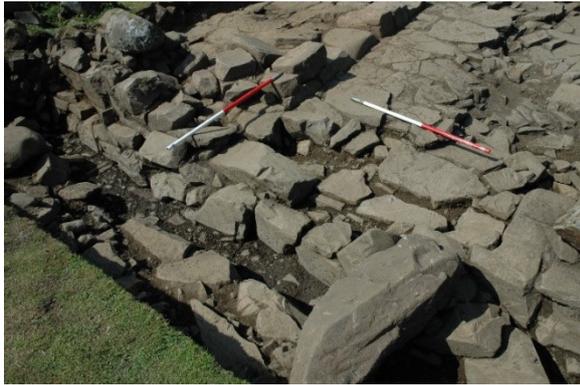
**Padstone 3s** looking NW. Padstone is to left of tip of left ranging pole.

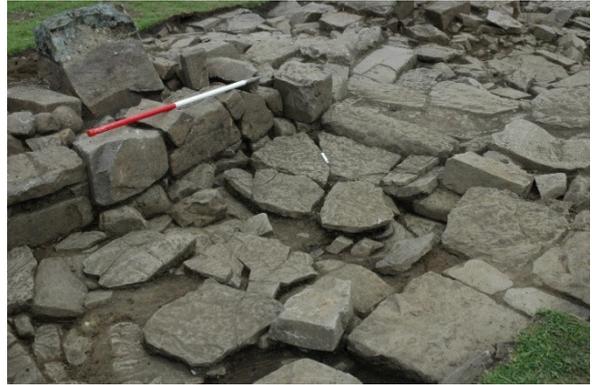
**Padstone 3n** looking NE. Padstone is to right of tip of ranging pole.
