# WELL HEAD DESERTED SETTLEMENT Holwick, Teesdale

*Interim Report: 2018 (2nd season) Excavation*

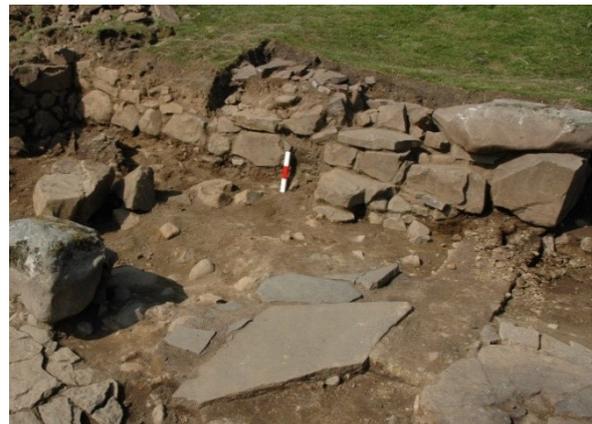
**Padstone w**, looking SW. Padstone is to right of 30cm scale. The diamond shaped slab in the foreground, although different to other padstones, may have supported **padstone 4n**.
