Muggleswick Grange

Priory Farm, Muggleswick, Co. Durham

Community Archaeology Project : March 2015

by Jenni Morrison, Tom Addyman and Sheila Newton

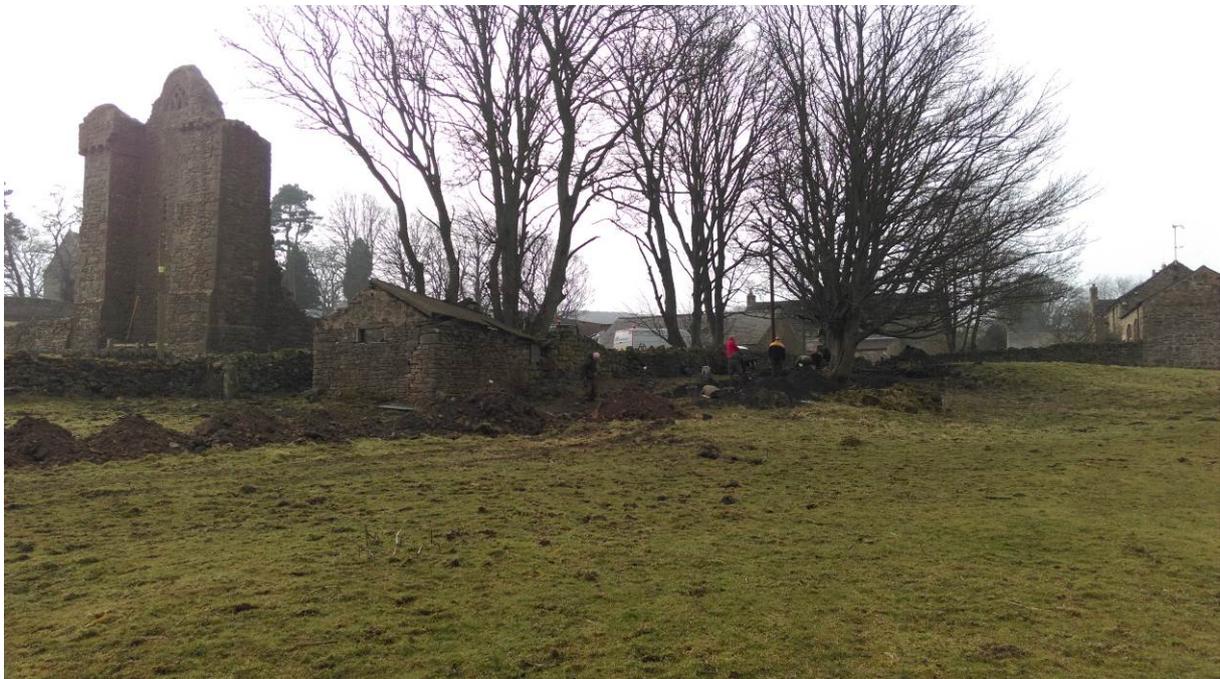
General view of the trench 5 area, with the grange ruin to left, looking west

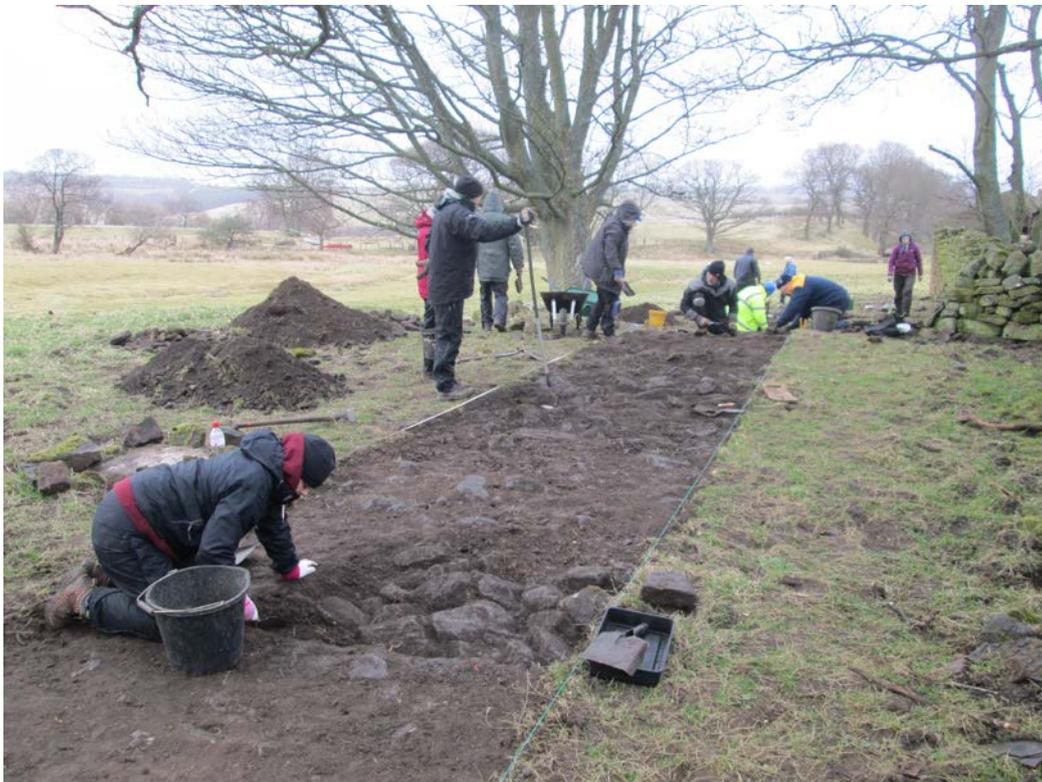
Plate 1 General view of the early stages of the excavation of trench 5, looking east

Immediately beneath the turf lay a substantial spread of large rubble stone (*plates 1 and 2*) (5010), this extended to the west to the break of slope where the top of wall {5011} was visible. In places a deposit of small compacted stones [5009] was visible where there was less rubble present. It is possible that this was an attempt to level the uneven surface created by the rubble. On excavation the rubble was found to overly walls {5014} and {5024}, and was presumably derived largely from the collapse of the building.

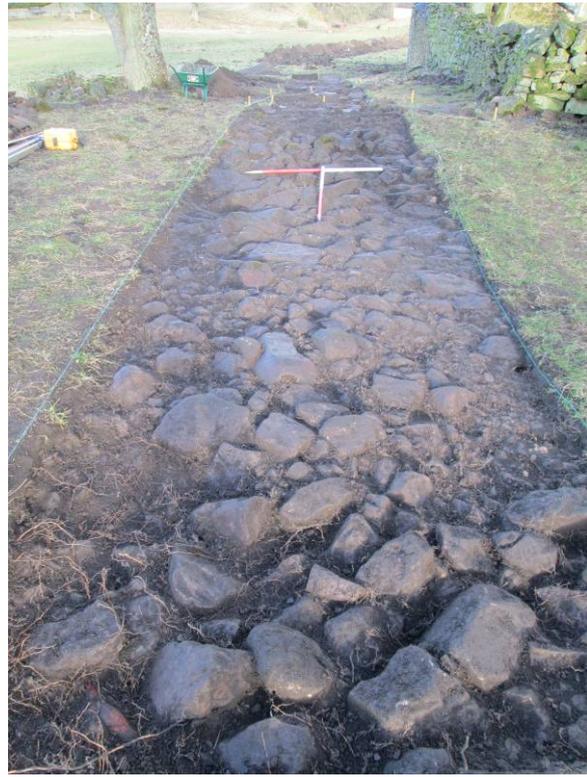
Plate 3 West end of Trench 5 looking east (569)

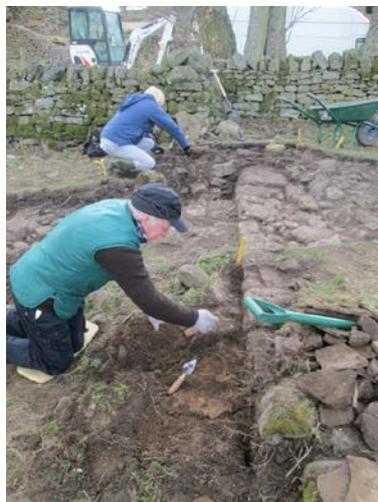
Plate 5 Volunteers exposing wall [5011] (548)

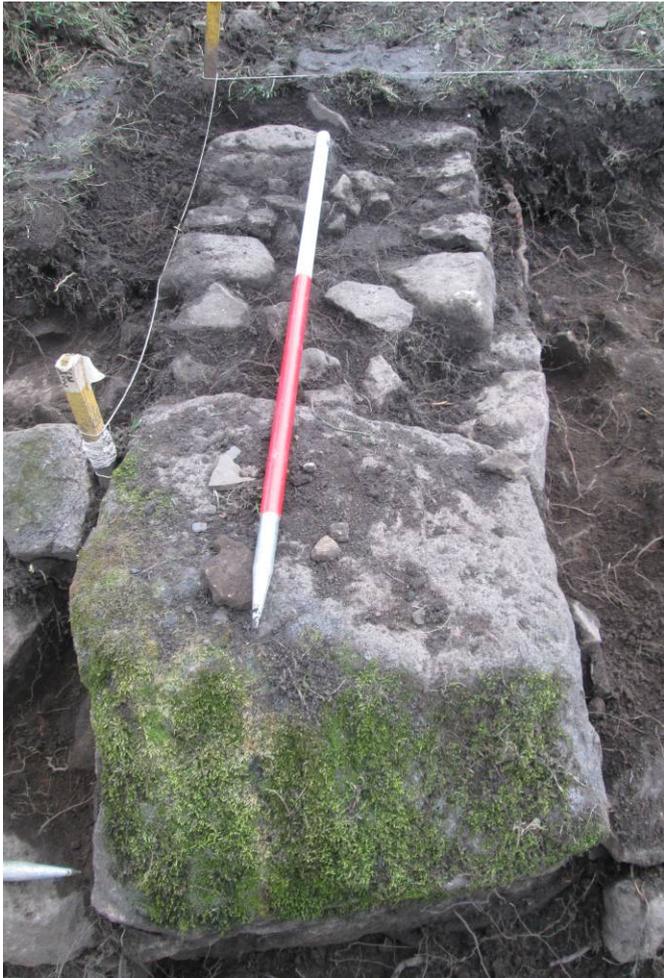
Plate 6 East end of North wall [5023] (602)

Additional excavations were carried out to determine the extent of the building. A small area was excavated to the west of the South East corner stone and a further 2 by 2 metre trench was excavated in order to locate the North West corner of the building. A short length of wall [5023], was uncovered for a metre running West from the North corner stone (Plate 5). A further short length of masonry [5028] was exposed at what was thought to be its West end (Plate 6). This appears to abutt a wall of similar dimensions [5024] thought to be the northern extension of wall [5024]. This may represent the North West corner of the building, though further excavation would be required to confirm this. This area is structurally different from the other corners of the building. Unlike the other three corners exposed, no large flat stone was uncovered and the West wall [5029] appeared to continue to the North.

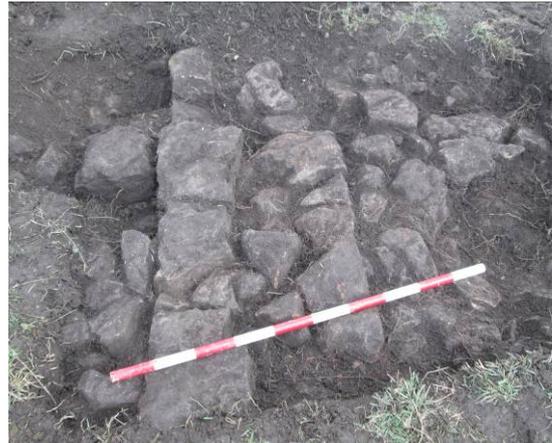
Plate 7 Junction of wall [5028] [5029] North West corner of building (618)

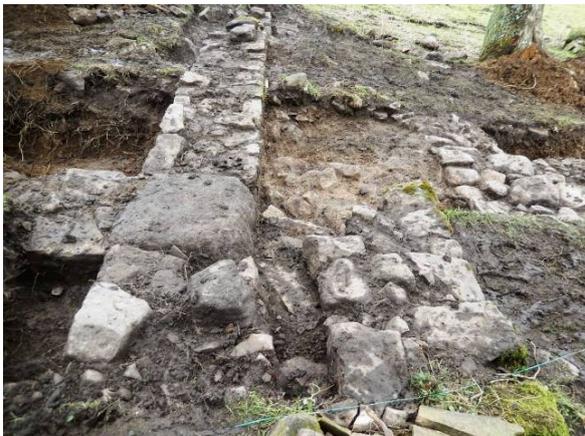
Plate 9 Looking N along walls [5030] and {5011} (780) by Stephen Eastmead

At the South East corner of the main building the trench was extended to the South in order to fully expose the large corner stone. In so doing the wall was found to continue South as previously discussed. In addition the remains of a second wall were uncovered [5030] running parallel to {5011} (Plate 8). There was only a very small gap between the two walls filled with rubble. The East (Plate 9) and the West faces were visible. The remains of the wall were uncovered for 1.4m, to the South it continued under the bulk, but to the North the wall terminated just within the main trench. There was no faced end suggesting the wall had been truncated. It was unclear how this wall related to the more complete building to the West. It may have represented an earlier phase that was robbed during the construction of the main building. Alternatively it may have been upstanding at the same time, but was more vulnerable to damage due to its location on the break of slope.

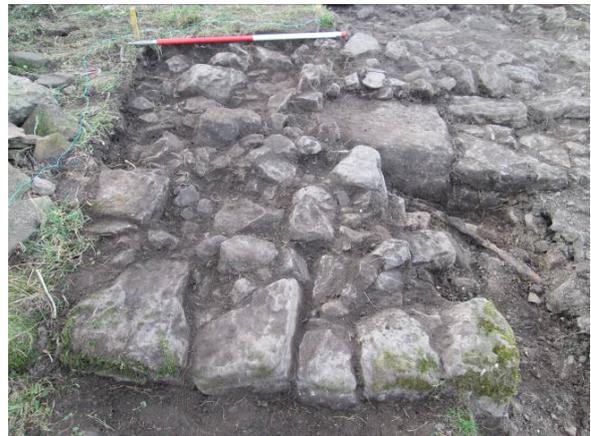
Plate 10 East face of wall [5030] showing with tumble obscuring the rest of the wall before excavation (552)

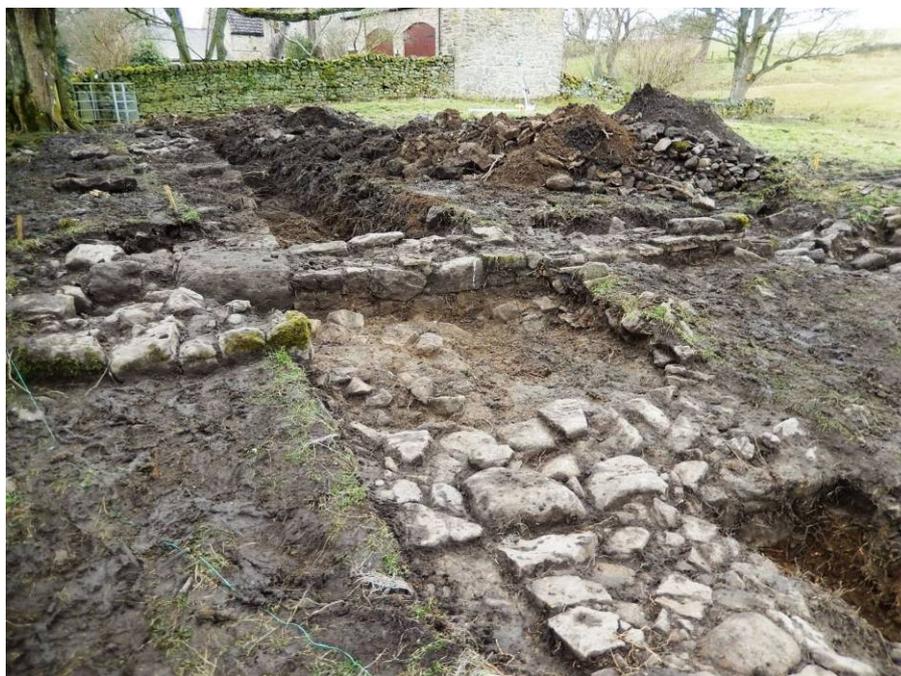
Plate 11 Walls {5013} and [5021] in the foreground (782) By Stephen Eastmead

Moving eastwards along the trench and down slope, a further parallel wall was exposed running across the width of the trench {5013}. This wall was wider, at 0.75m across, but otherwise very similar to those forming the main building. The face was cleaned down to natural showing a height of 0.43m surviving. It was abutted by a perpendicular wall [3021] (Plate 10). The only surviving face is on the South, and it has been eroded at its East end. It is assumed that the North face has been eroded. Due to the topography the East and North faces would be most vulnerable. It is not apparent from the results of the current excavation how this structure relates in terms of date and function to the main building to the west.

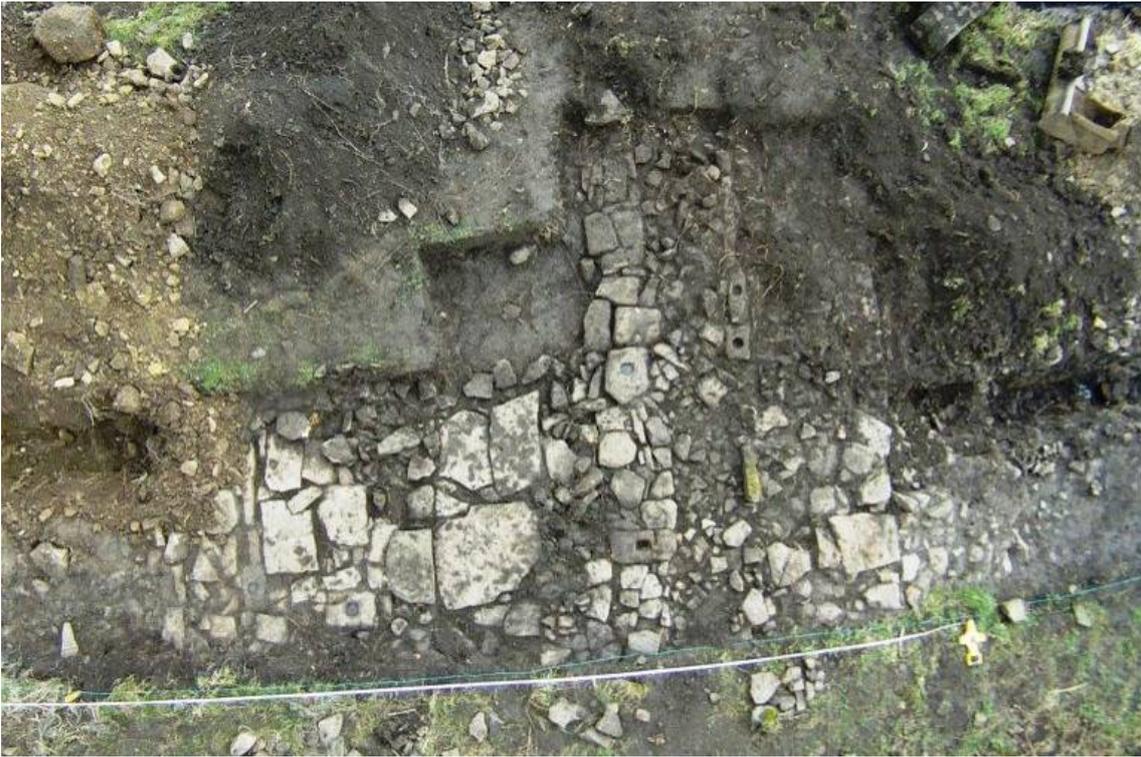
Plate 12 Byre area of the site looking North (813) By Stephen Eastmead

The trench was extended by 2 metres to the North by 3 metres wide. The stone features with sockets and associated vertical set slabs, and the path, were found to continue. It is thought that these features were located within a building, the East wall of which survives {5014}. The building appears to have been aligned North South, and is broadly parallel to the building to the East, this orientation would be largely dictated by the topography. The North and South walls lay outwith the excavated area, however it is possible that an element of the South wall survives within the upstanding field wall.

The internal arrangement of the building and the nature of the masonry suggest the building was for agricultural use, most probably housing livestock. It is possible that rather than stone walls the building was of timber, or at least the long walls, sat on stone footings, the easternmost of which survives.

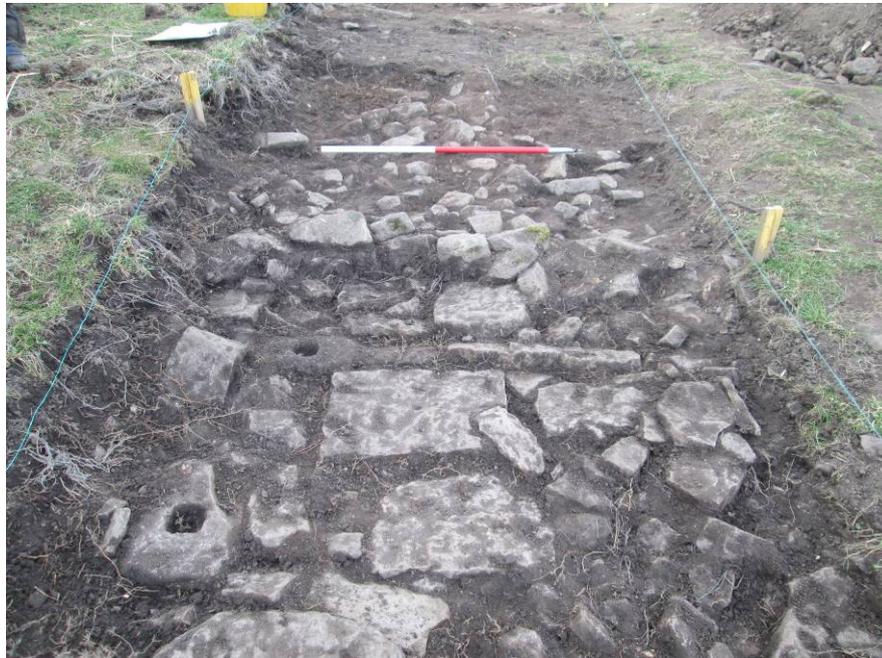
Plate 13 The Byre area looking West showing the different shaped sockets (559)

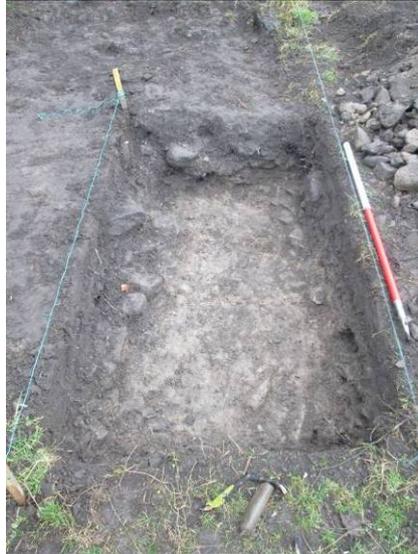
Plate 14 Natural subsoil at East end of trench (564)

The east end of the trench, covering 24m contained no archaeological features. Immediately below the turf there was a layer of small to medium angular stone, this was presumably tumble that had originated from the buildings upslope. The frequency of the rubble decreased towards the east end of the trench. A sondage was excavated through this rubble and the subsoil beneath down to

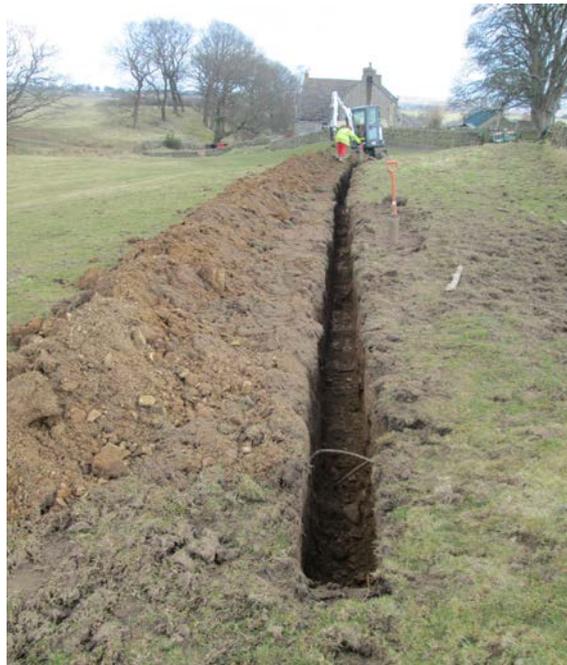
Plate 15 Services trench immediately to the east of the east end of trench 5, extending towards Grange Farm

Excavation of services trenching extended eastwards from the area of trench 5, along the south side of the field (parallel to the access road) and extending to the Grange Farm farmhouse, *plate x*. Monitored by Paul Frodsham, no archaeologically significant features or deposits were noted.

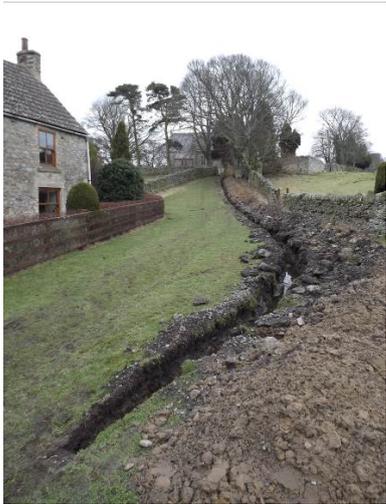
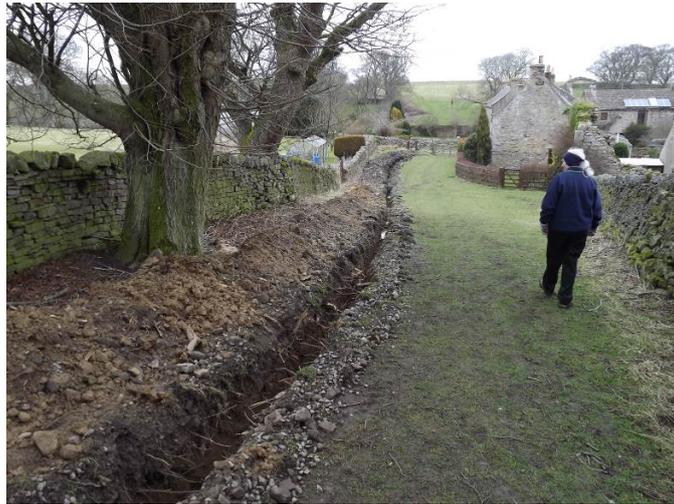
Plate 16 Trenching in Church Lane (left) – looking south towards the church;

Plate 17 (right) - looking north

The services trenching involved the laying of new cabling to the church. In this area the trench cut for the cabling route ran from the south side of the metalled road that runs through the Muggleswick settlement, southwards along the west side of the grassed lane that gently rises to the churchyard and through its main gate, an overall distance of about 61m. The excavation of all but the northern four metres was monitored by Paul Frodsham, the work carried out on 12 March.

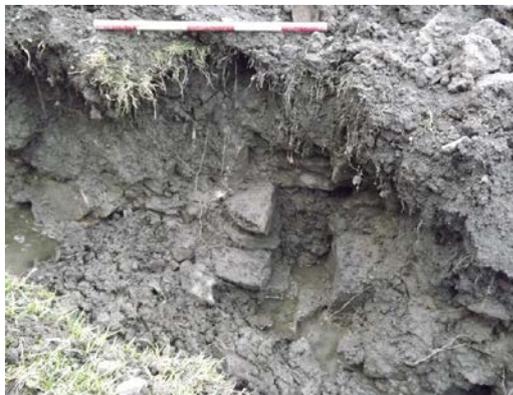
Plate 18 Trench 8 within in Church Lane – stone-lined drain, looking southwest

The ground surface of the lower, northern part of the church lane levelled out notably for its last 20m or so. In this area topsoil deposits overlay a make-up of rubble stone some 0.3-0.4m in depth that appeared to overlie natural clayey sub-soil. It was difficult to determine whether this had been intended as a base for metalling or a levelled platform relating to some structural feature though, given that this has long been the access to the church, probably the former. Finds recovered from the excavation spoil in this area, mainly ceramics, ranged in date from the 17th – 19th centuries. The only recorded feature was a well-constructed stone-lined drain running diagonally (south-west to northeast) across the trench approximately opposite the mid-point of Priory Cottage. This was detailed with stone slab base, dry-built walls of 2-3 courses of rubble and slab cap-stones defining a channel of about 0.15m by 0.25-0.30m. The lower 2/3 of the interior of the drain was silt-clogged; however there was still a moderate degree of water-flow within the remaining upper cavity.

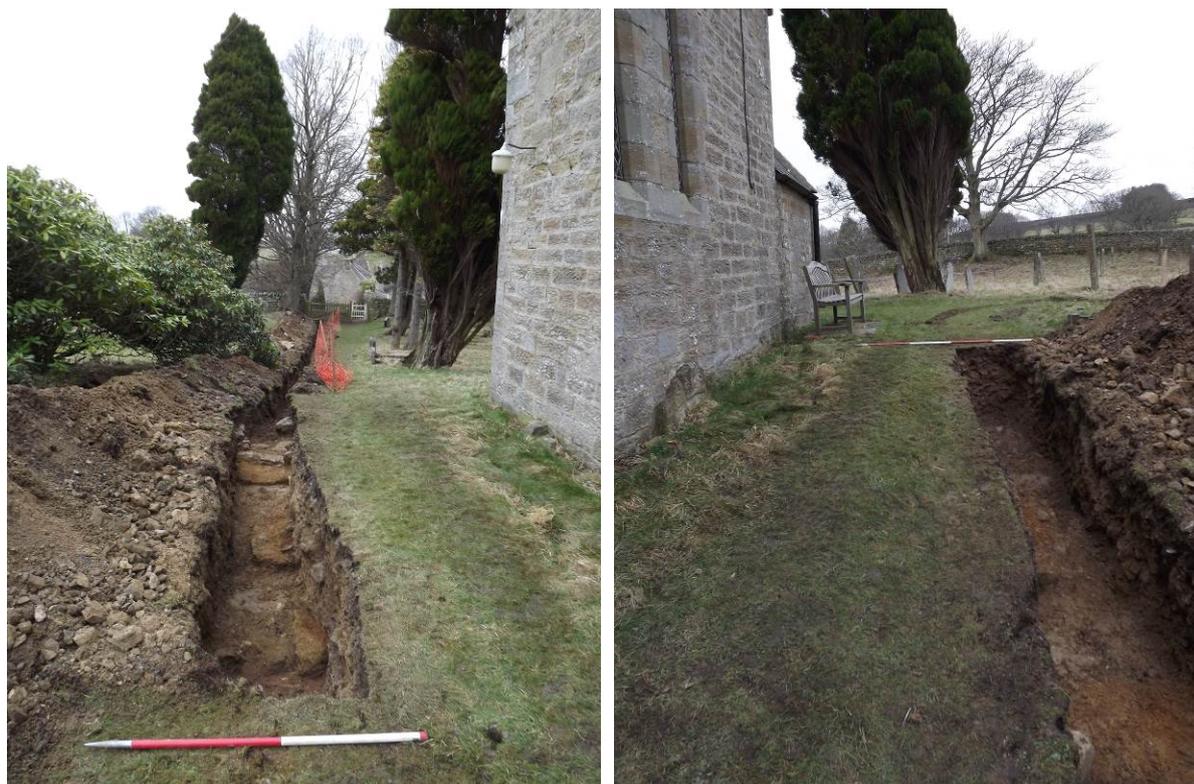
Plates 21 and 22 The southern extent of trench 8 in the vicinity of the west gable of the church, looking north (left) and south (right)

Significant archaeological remains were revealed along the last 6.5m of the trench, in the vicinity of the west gable of the present church. No features or deposits of note were seen along the path route further north, where natural subsoil was exposed along the length of the trench below the path make-up. The mechanical excavation was monitored by Paul Frodsham on Thursday 12th March; the remains in the vicinity of the church were investigated and recorded by Tom Addyman on 14th - 15th March.

In the area of the church an extensive make-up of deposits was recorded, these overlying a number of individual features that were found to be cutting down into the natural subsoil. Surviving areas of subsoil were encountered at a depth of 0.50m – 0.60m. Hand cleaning of the trench involved regularising of the section, and better defining the features revealed; some limited investigation of individual features was made in order to confirm their nature. A complex stratigraphic sequence was revealed that encompassed a number of episodes of construction activity, probable burials, a series of demolitions and finally, the laying of the existing path.

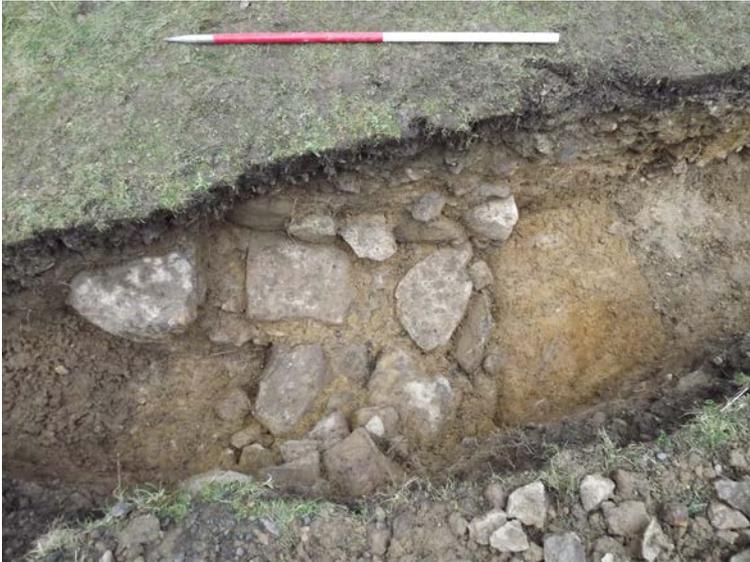
Plate 23 (left) The {8006}/{8028} wall footing as revealed, ESE to top

Upon cleaning the sections and trench base the remains of the wall were found to consist of 1-2 courses of its upstanding masonry {8006}, and a substantially formed footing structure {8028}. The footing structure had been built within a broad cut whose base was not located within the present trench, [8029]. The cut was near vertically-sided and measured 0.85m in width; it ran on a slight diagonal across the trench, from WNW to ESE. The cut was tightly packed with large and medium-sized generally angular blocks of mixed stone, including grit stone, sandstone and other field stone; a number of pieces were evidently very carefully flat-laid and so as to form a regular outward-looking face. The interstices between the larger stone were packed with medium-sized and some small stones, but also bonded with a thick orange-brown clay throughout. Some voids between stones were revealed lower down, indicating a somewhat looser structure though still tight-packed.

The first course of the wall itself was laid upon these but stepped out beyond the line of the footing trench cut by about 5cm both externally to the north and internally; the overall thickness of the lower part of the upstanding wall was thus about 0.95m. Remains of clay-bonding was also found amongst this walling. One large facing block, evidently fallen from the wall, was revealed immediately adjacent on its north side in the east section of the trench. Like the {8028} footing structure below the upstanding wall remains also clearly ran at a diagonal, this in notably different alignment to that of the existing church building - at a variance of 15° or more.

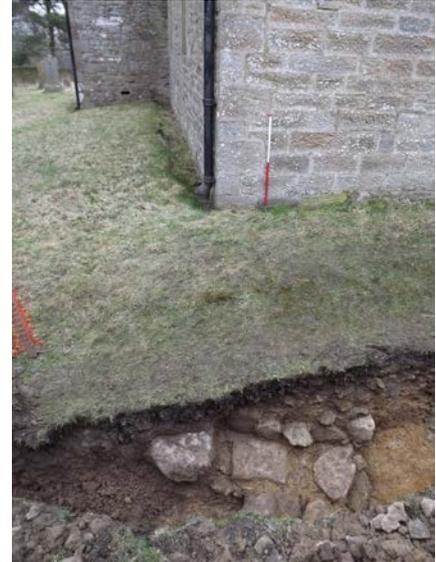
Plate 24 (right) The early footing shown in relation to the alignment of the existing All saints' Church, north side.

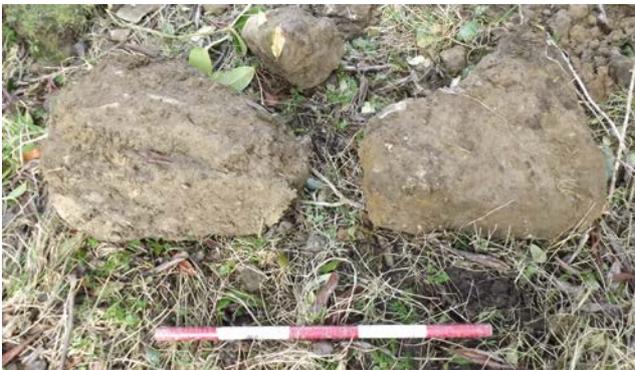
Plate 25 (left) Roughly squared facing stones dislodged from the [8006] wall footing

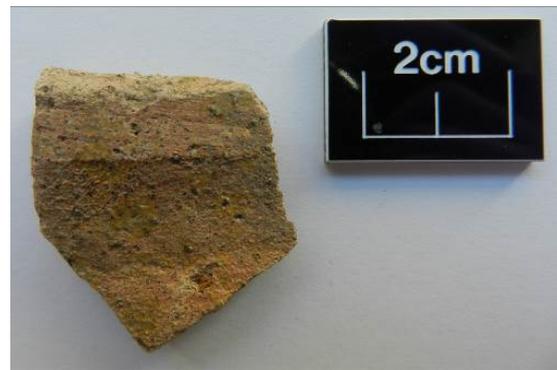
Plate 26 (right) Medieval pottery recovered from the matrix of the [8006] wall footing SF006

A single sherd of pottery was recovered from within the matrix of the wall; significantly this was a basal fragment of a thin-bodied gritty-ware vessel upon the exterior of which slight pale-green / green-yellow glaze spotting was evident. The sherd is probably consistent with a 13th or 14th century date, SF006.

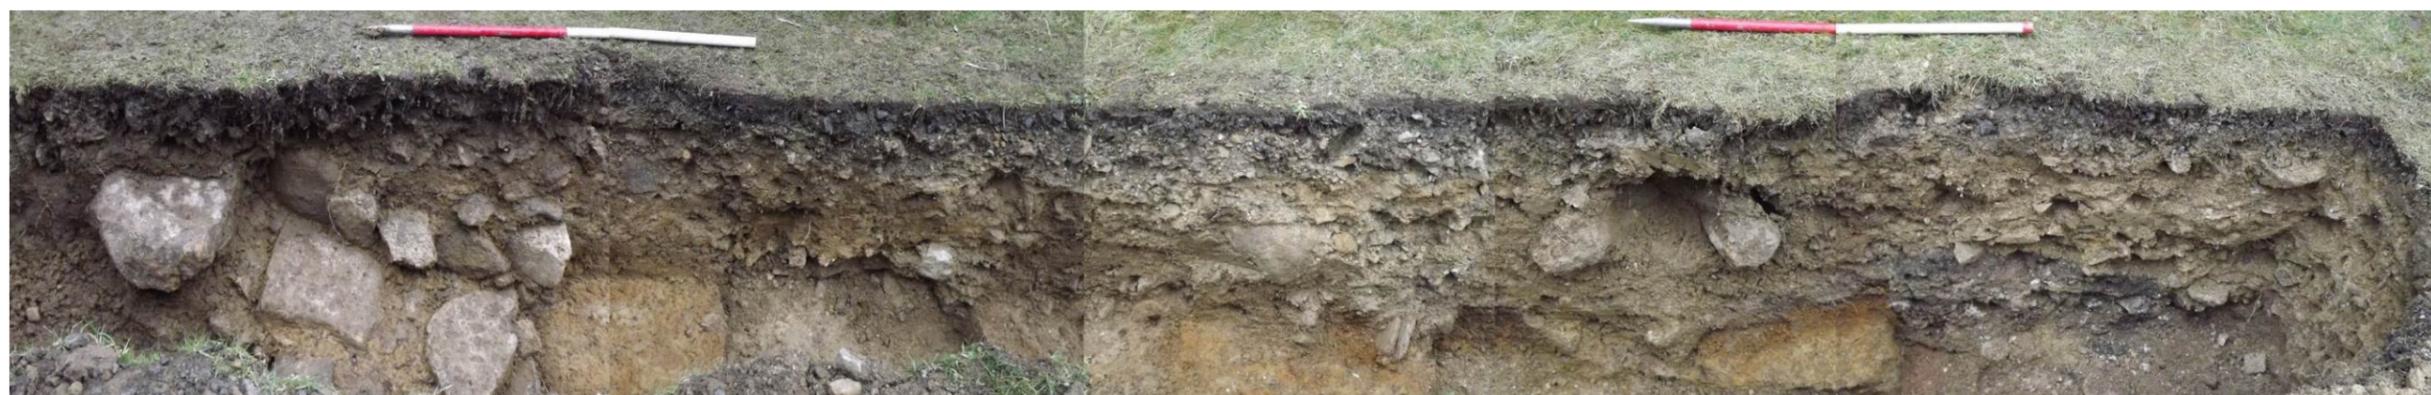
Plate 27 Composite photographic section of archaeological deposits at the south end of the church yard trench, Trench 8

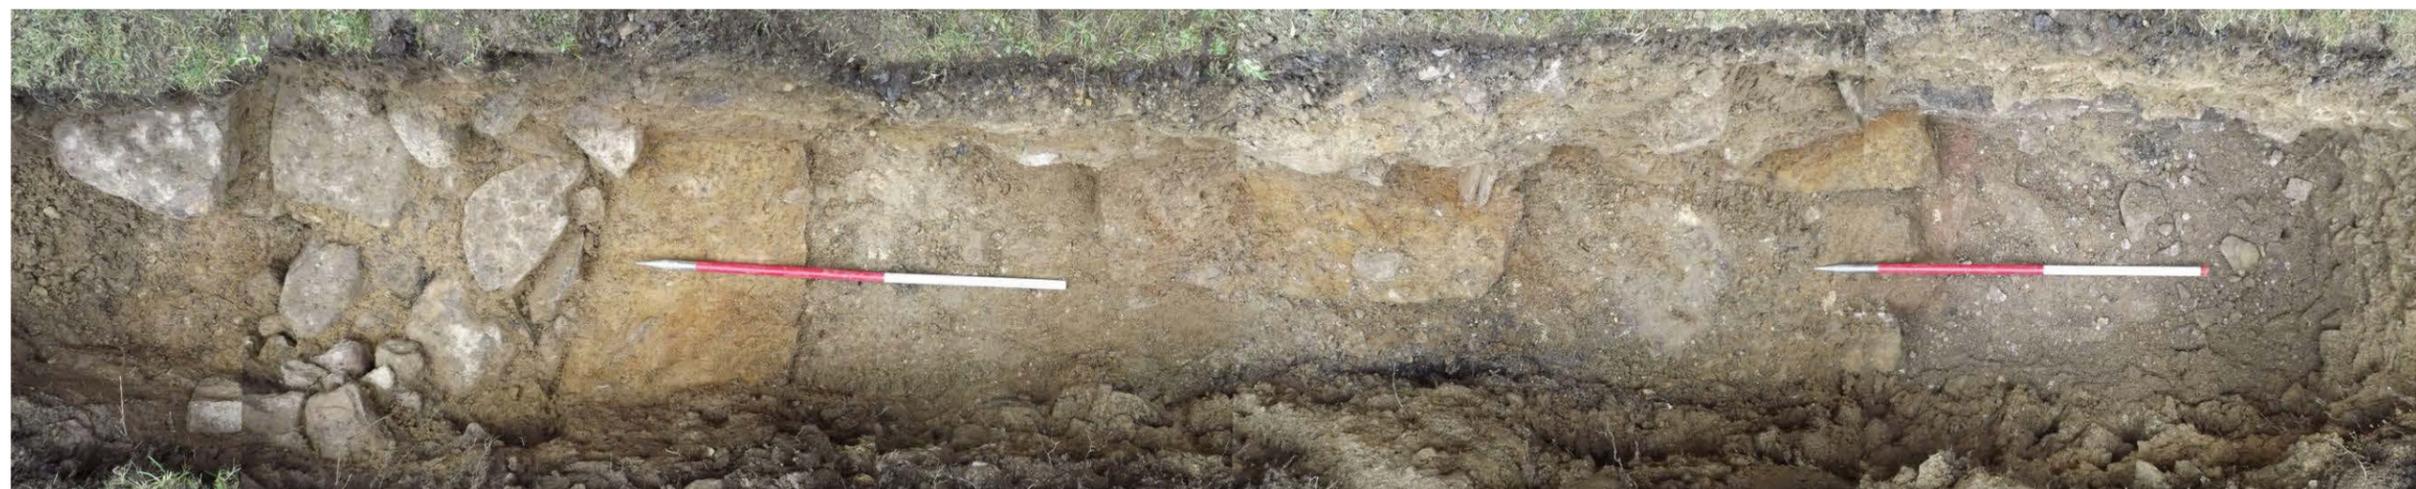
Plate 28 Composite photographic plan of archaeological deposits at the south end of the church yard trench, Trench 8

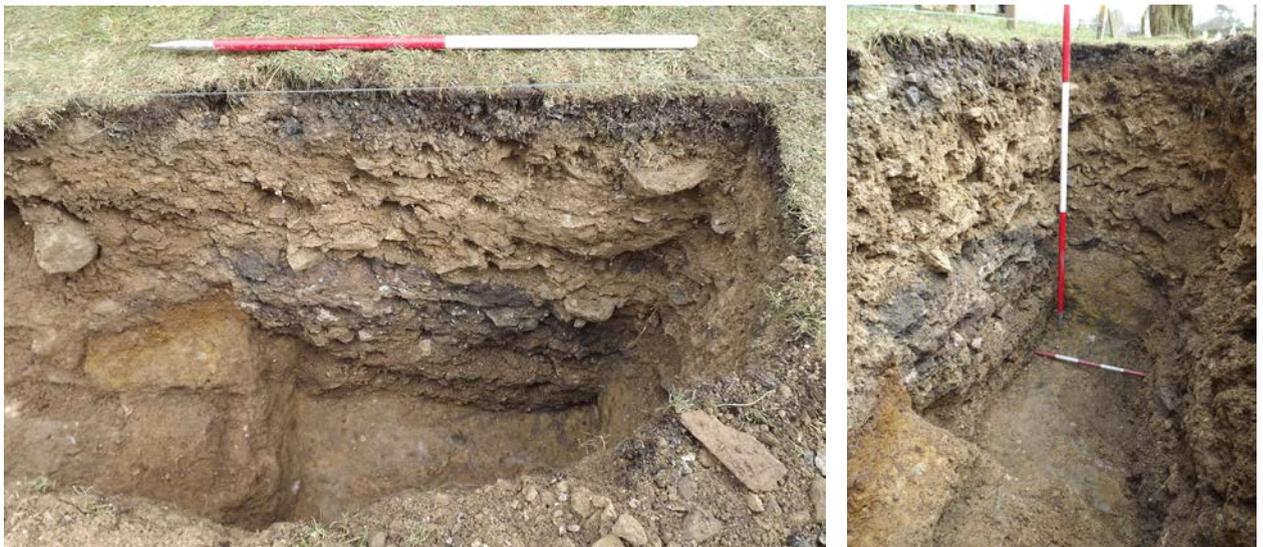
Plate 29 (left) The south end of trench 8 showing the [8015] cut with its various fills ((8010) – (8014)) showing in the section; east to top

Further south the [8026] trench cut was found to run in to the side of a further apparent footing cut, [8015]. From their junction it was unclear which was the earlier cut – it is possible that they may have been coeval; cut [8015] appears to be on a similar east-west alignment and on this basis seems likely to have been.

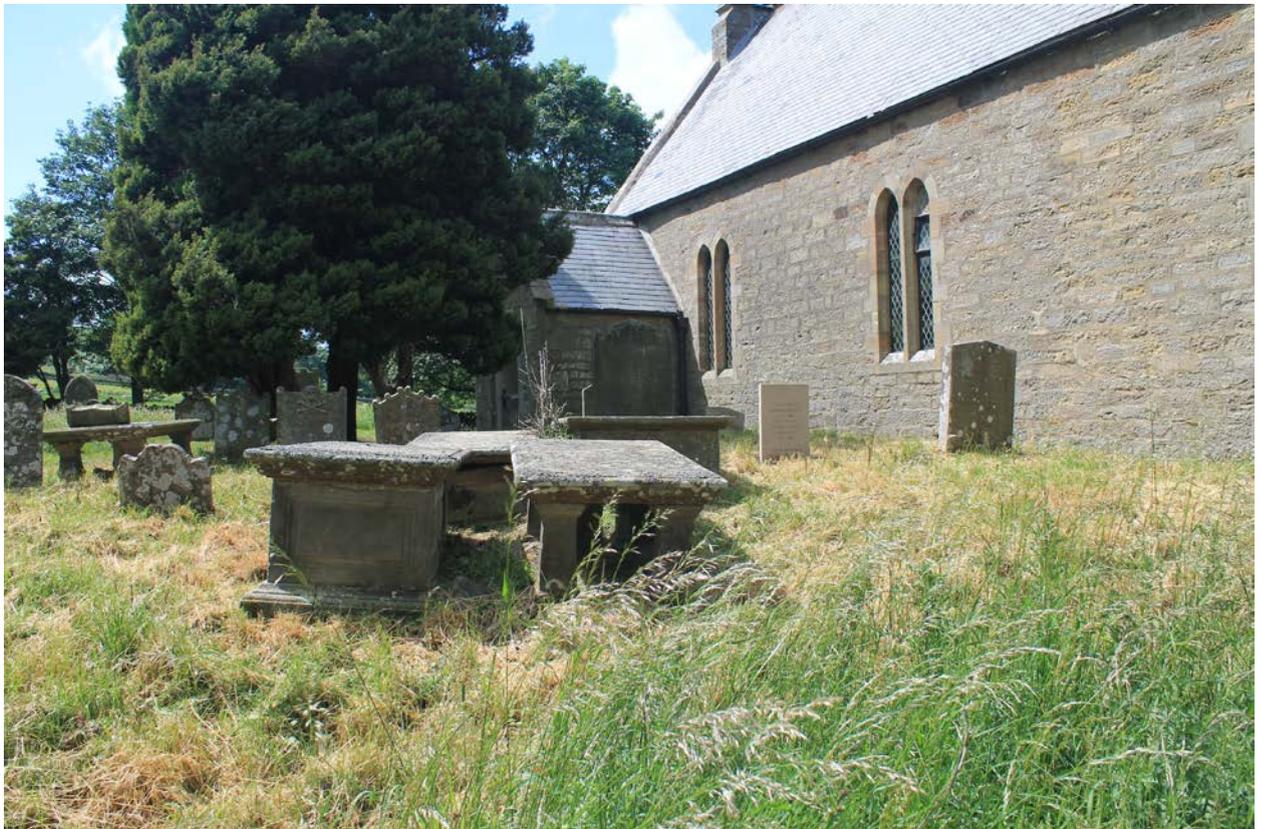
Plate 31 Table and chest tombs within the churchyard that display a very marked difference of alignment to the axes of the existing All Saints’ Church.

The alignment of the early footing is also notably different to that of the existing building. However it is very close to the alignment of earlier graveyard monuments, particularly some of those on the south side of the church, see *plate 30*.

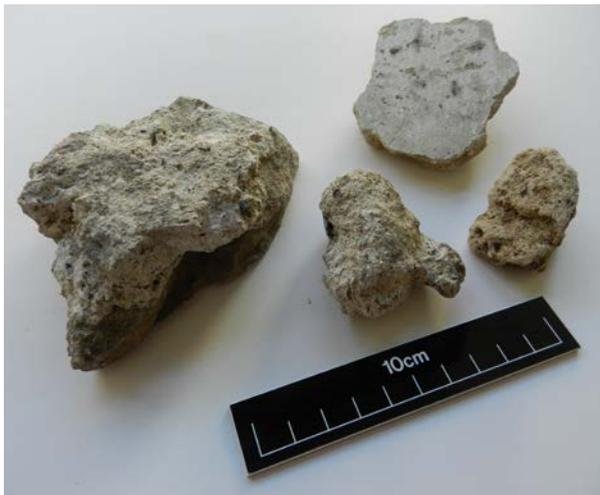
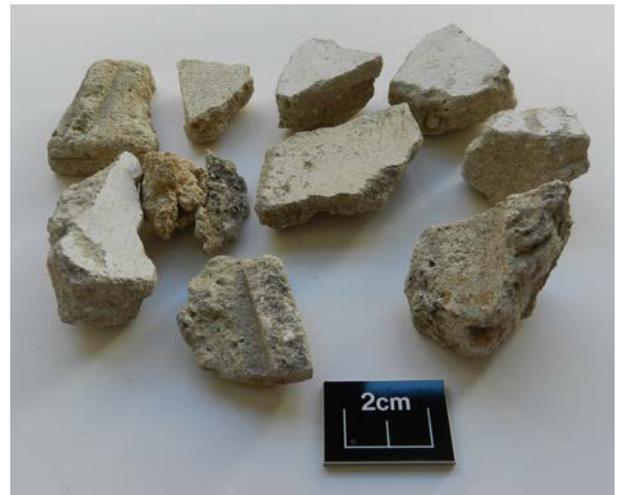
Plate 32 Building debris – from the back-fill of footing cut [8015] - SF859 and SF855; mortars and plasters of varying date; the yellowish pieces are likely to be medieval

From within the fills of each cut was recovered similar materials, including large lumps of coarse mass masonry mortar of yellowish-cream hue – likely of early date (probably medieval) intermixed with lumps of mortar and faced plaster of much later character – finer mixes of slightly browner hue that are more typical of the 18th and 19th centuries. Some occasional finds included roofing nails, some corroded iron and one copper, and some pieces of cream brick of early-mid 19th century character.

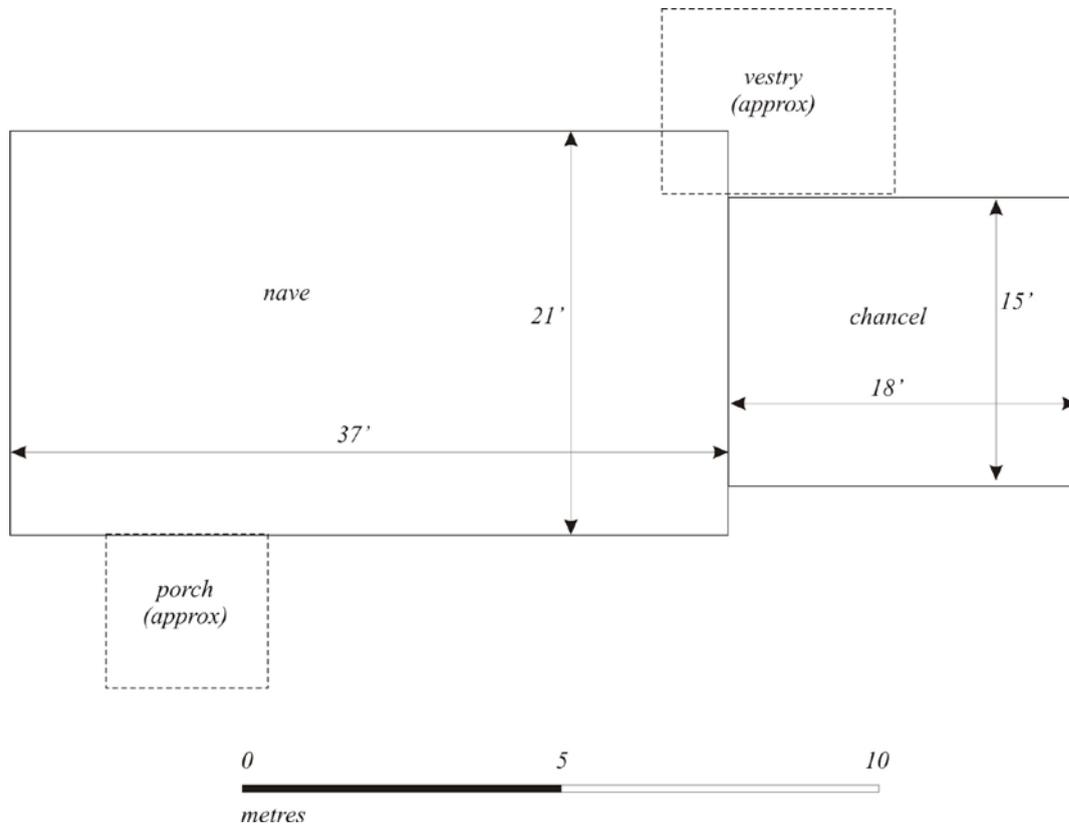
Figure 7 Block plan of the church of c.1728, based on dimensions given in 1787

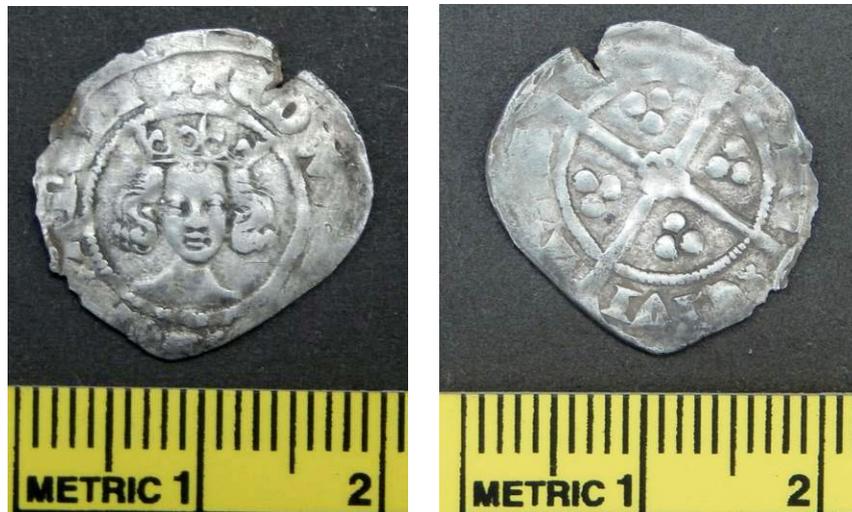
Plate 35 *Silver long cross penny of Edward III (possibly York mint), recovered from trench 8 in the vicinity of the church (SF043)*

Recovered from the excavated spoil in the immediate vicinity of the early wall footing revealed in trench 8 close to All Saints' church was a 14th century silver coin (SF043), plate 35.

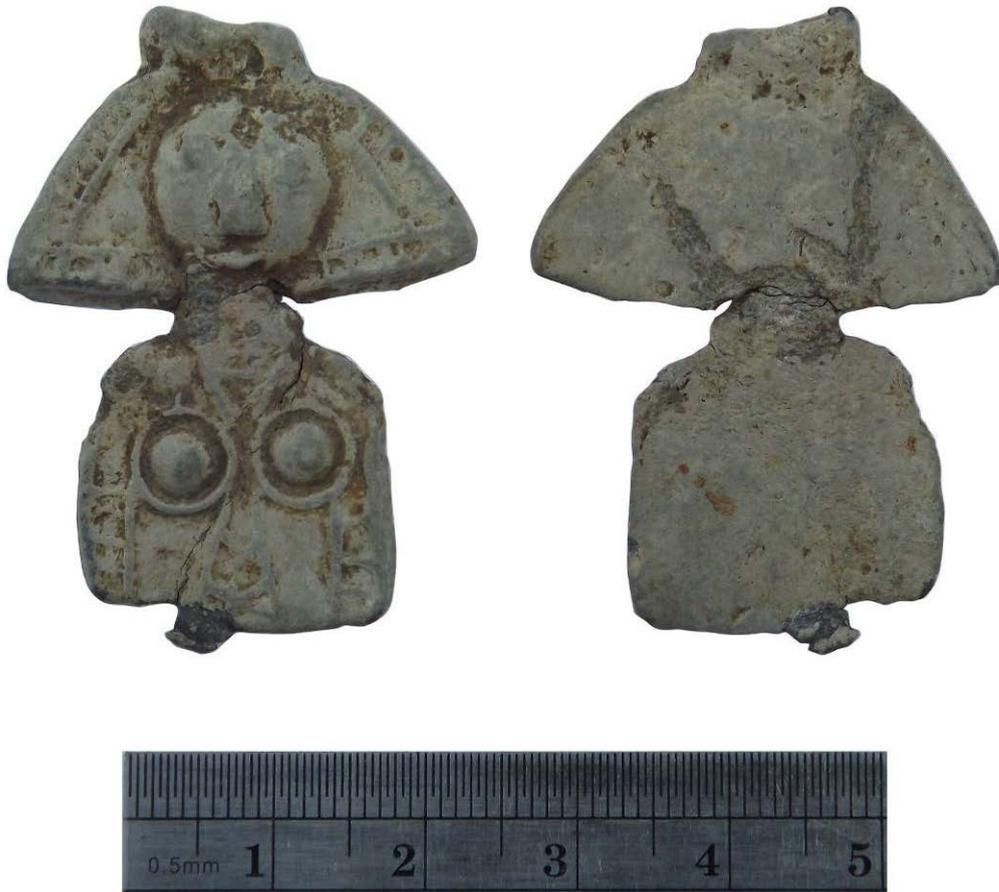
Plate 36 SF043

Flat-backed cast lead toy / figurine of a female with head, neck, and torso surviving. Circular convex face with eyes, nose, and lips in relief. Face and head are framed by fan-shaped collar edged by square panels and topped by a tuft of curled hair. Thin moulded neck wearing a globular necklace separates the head from the torso. The torso is squared, with a strip of square panels down each side in the same ladder motif as the collar. The pattern is replicated down the centreline of the torso, flaring out towards the head and lower torso and constricted between two domed and haloed breasts.

Evidence of arm attachments are present at the upper left and right sides of the torso. A breakage at the base of the torso likely indicates the former presence of a skirt completing the figure. Visible cracks are present along the obverse and reverse of the neck, and also diagonally down the front of the torso.

A further find of particular interest, found within the field close to the churchyard boundary immediately to the west of the church, was a crudely cast lead figurine of female form, (SF043), plate 35. This was lightheartedly dubbed the 'Muggleswick Madonna' at the time of the excavation.

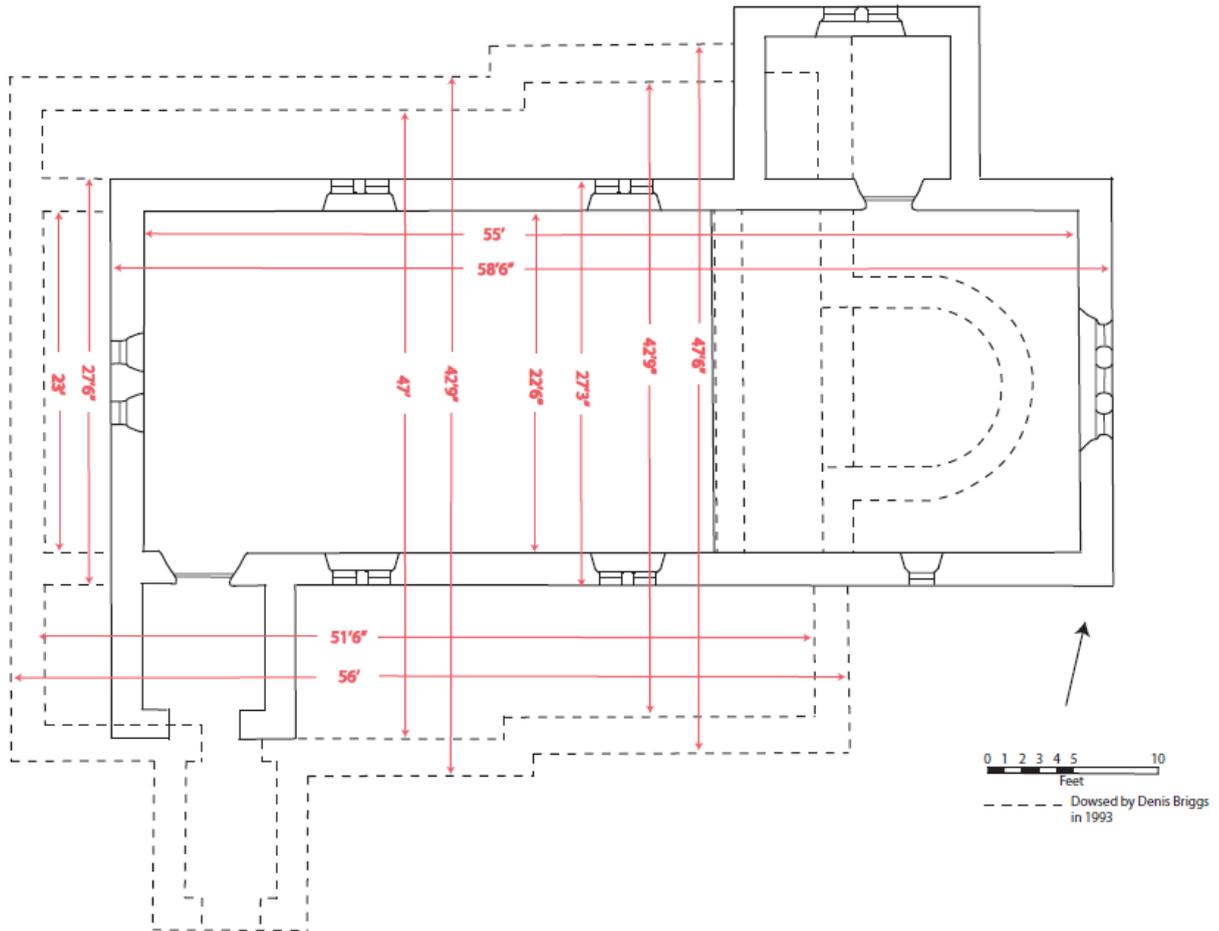
Figure 8 Plan of All Saints Church after Denis Briggs, showing the extent of possible wall footings as suggested by dowsing – dashed lines

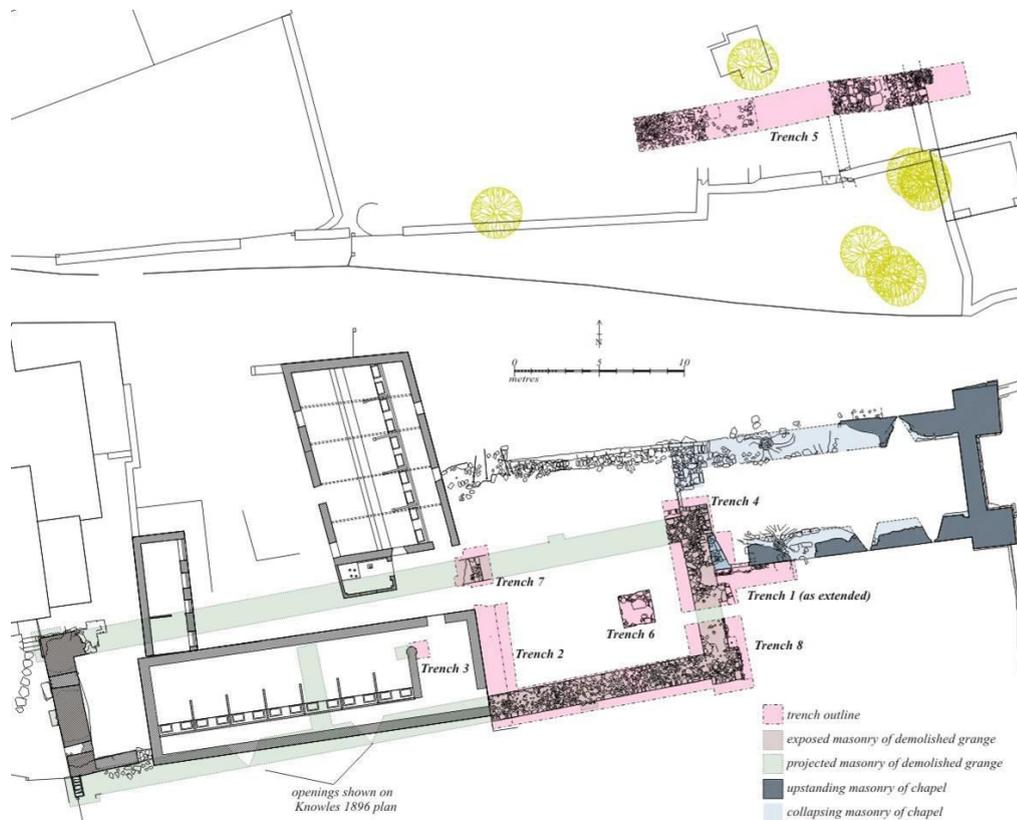
Site plan showing the locations of previous Altogether Archaeology excavation trenches at Muggleswick. the current project will focus on the complete excavation of Trench 5, which will be extended to the west as far as the stile in the corner of the field.
