Westgate Castle  
Weardale  
County Durham

archaeological investigations

report 2804  
January 2012

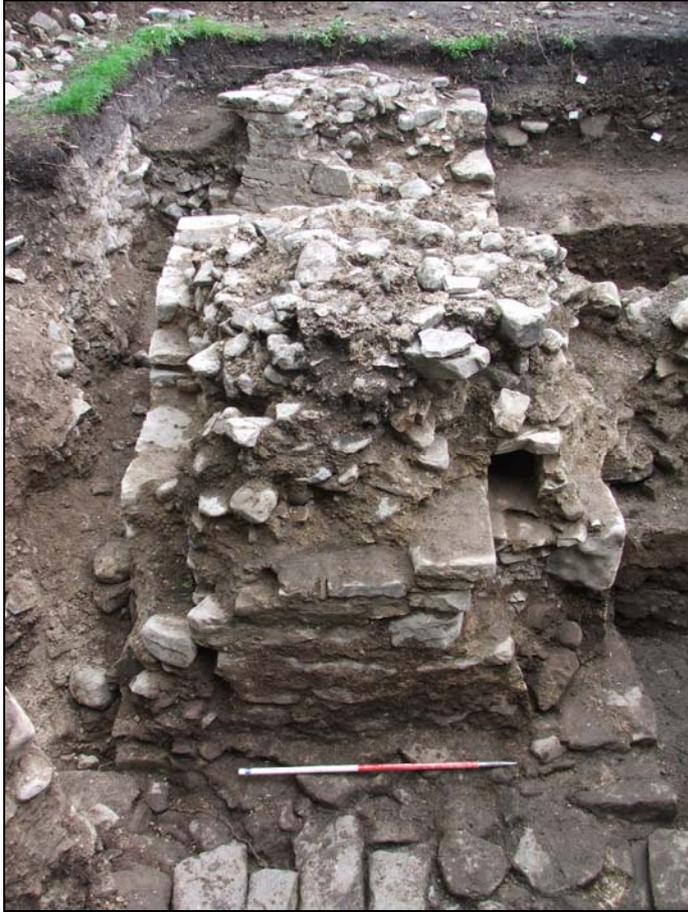
Figure 10: Wall [F15], facing north. The robbed outer faces of the surviving masonry are clear

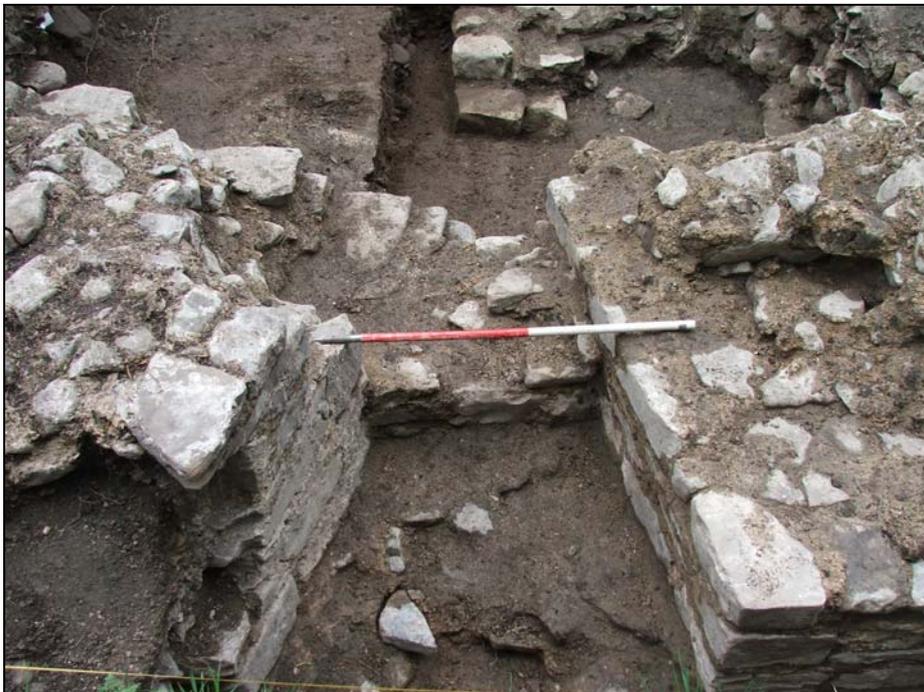
Figure 11: The narrowing embrasure of window [F65], facing east

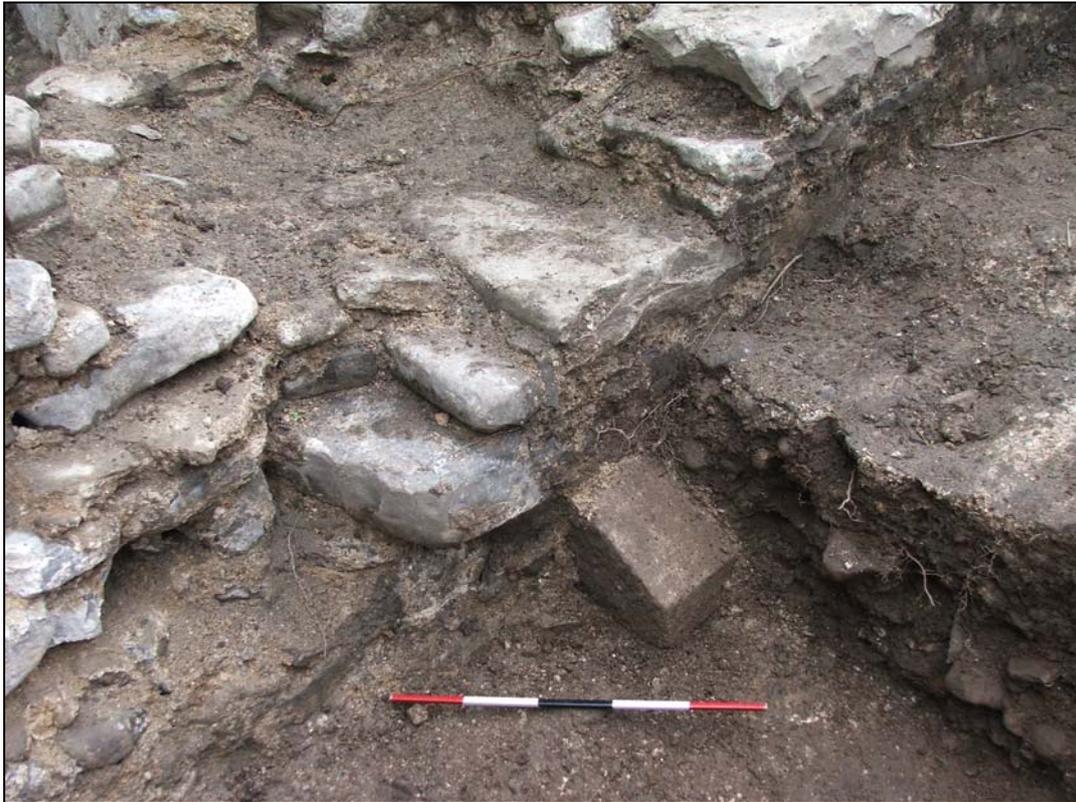
Figure 12: Shaped, chamfered block at the base of the east face of wall [F15]. Facing northwest

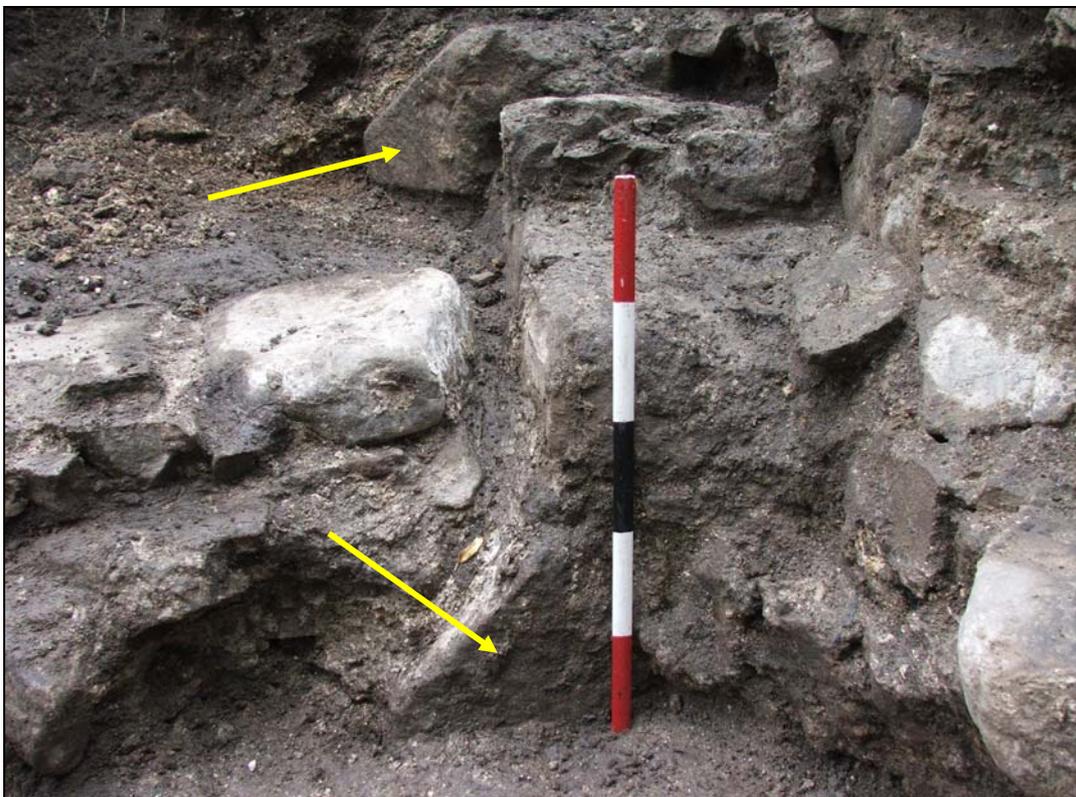
Figure 13: Chamfered blocks (indicated) at the base of wall [F29]. The rising course is evident. Facing east

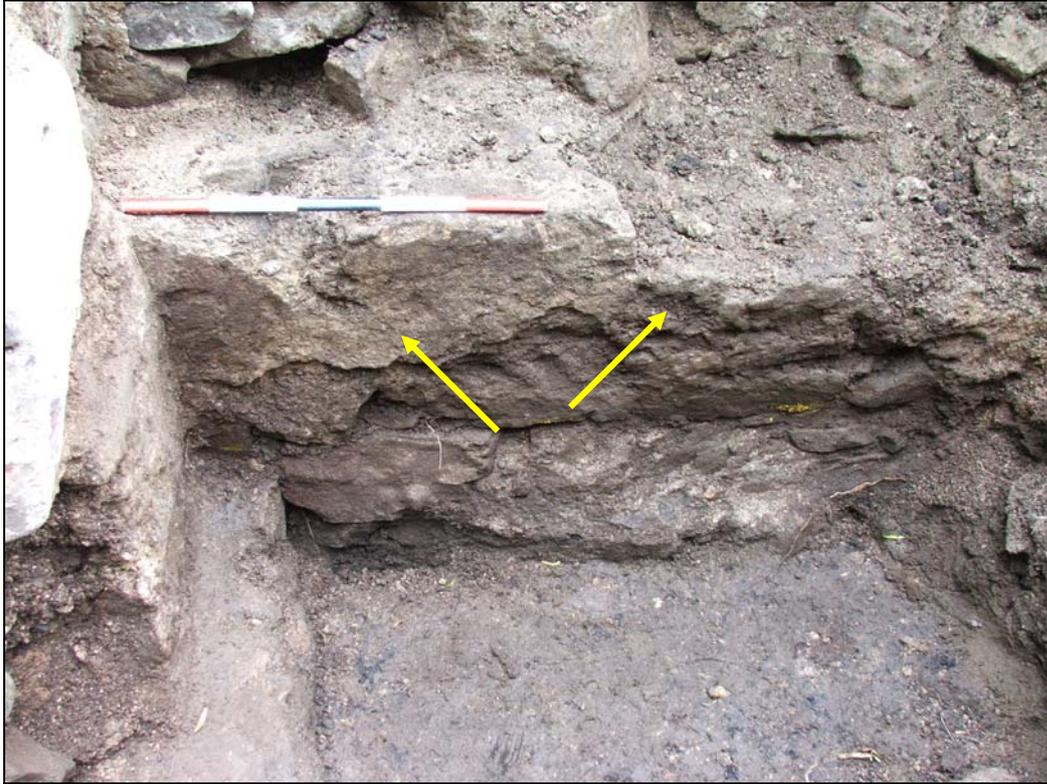
Figure 14: Dressed stone at the base of the southwest end of [F29], facing north. The remains of the mortar rendering are indicated

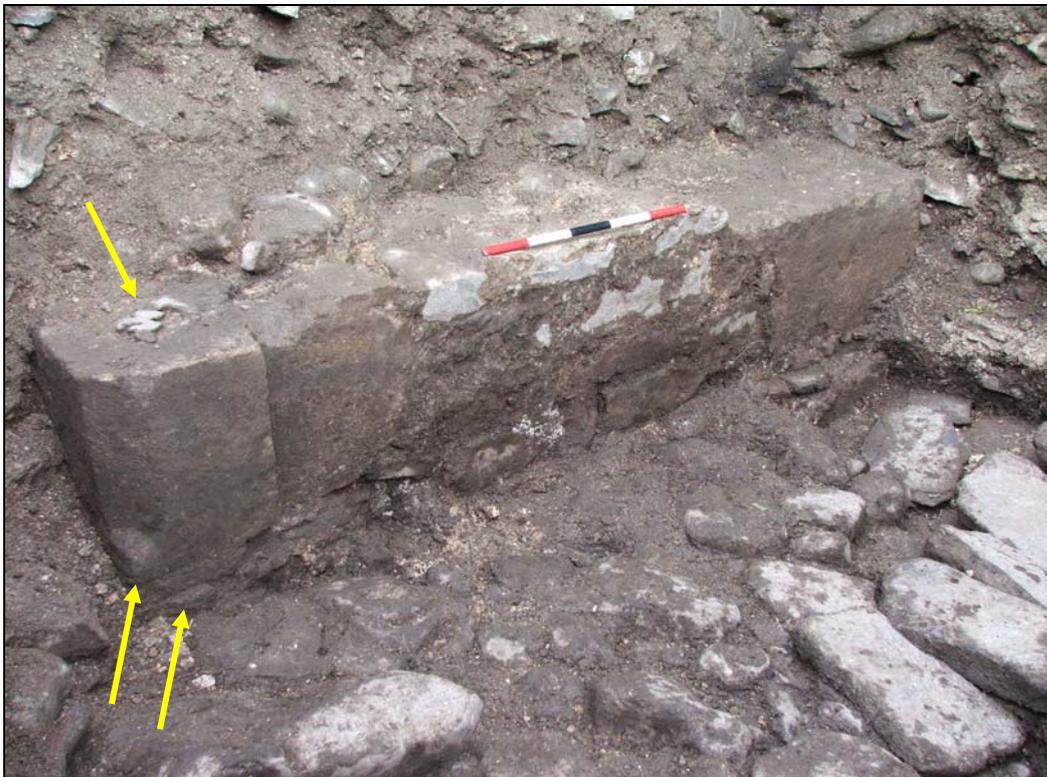
Figure 15: Wall footing [F14], facing southwest. The shaped block of the door jam is to the left of frame. The attached lead casting is indicated top, while the score marks of possible paving are indicated below

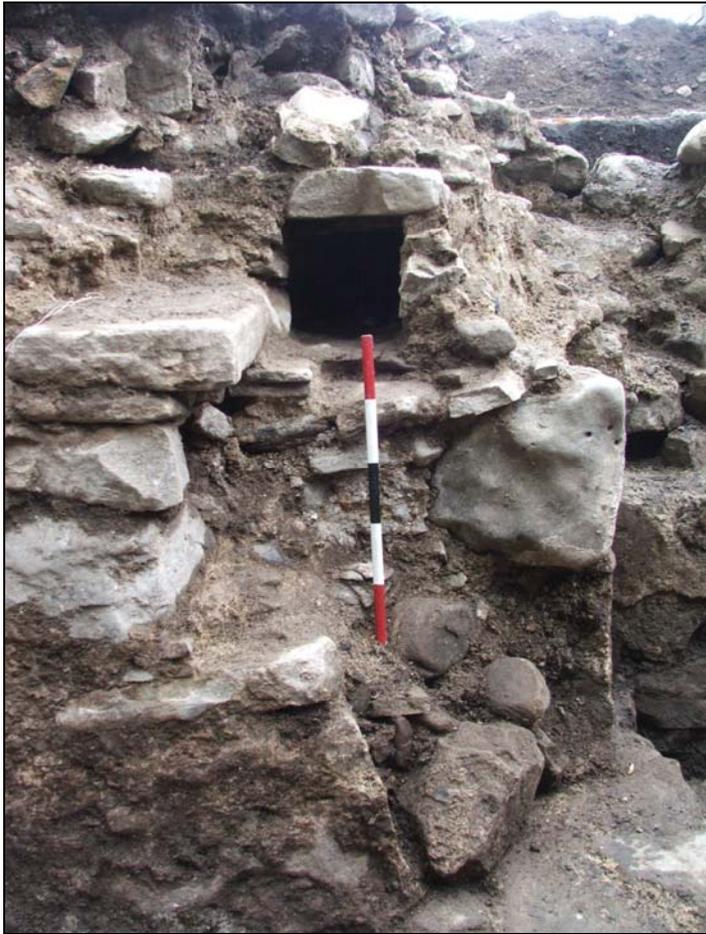
Figure 16: The south face of wall [F15], facing north, and showing the rebate for the draw-bar [F93]

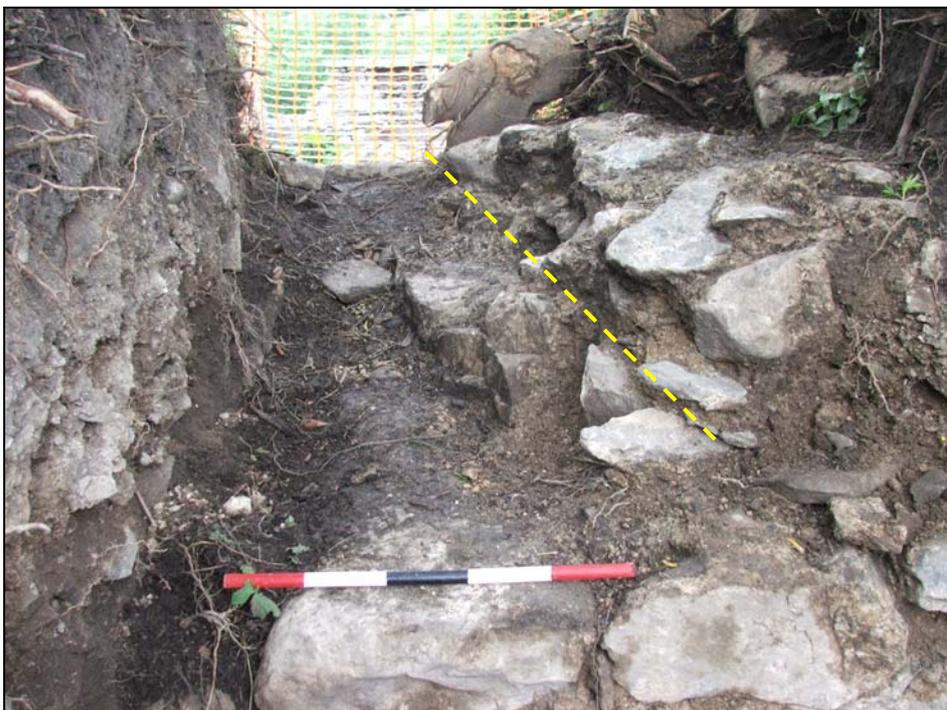
Figure 17: Wall [F66], facing west. The line of the north side of window [F55] is indicated

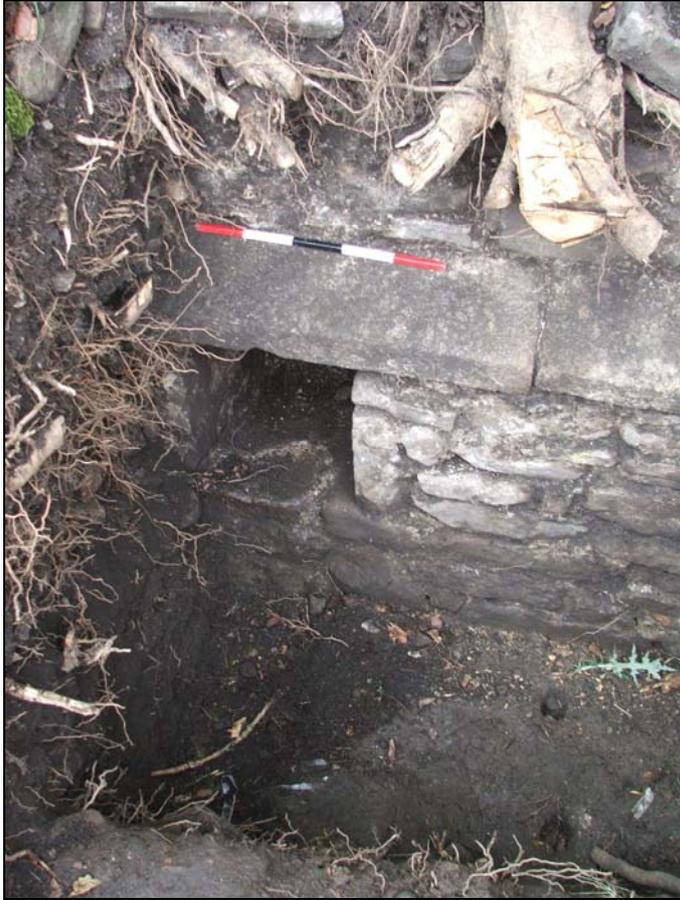
Figure 18: The west face of wall [F66], showing string course [41] and the exit of the garderobe chute [F42]

- 6.8 On the west side of [F66], three chamfered blocks extended along the wall, forming a 'plinth' string course comparable to the remains observed on the external faces of walls [F15] and [F29] to the east. This course [41: 0.28m wide] again served to widen the wall, with [F66] extended 0.12m to the west beneath it. The west face of the wall was exposed to a height of 1.55m. On the north side of the excavated face, a square hole in the masonry was exposed directly underneath string course [41]. This hole [F42] was roughly 0.3m in diameter, capped with one on the shaped blocks of [41] as a lintel but with no other framing evident (Figure 18). It extended horizontally eastward into the thickness of the wall for roughly 0.5m before angling sharply upward: tracing the exact course of the feature was made difficult by the presence of roots growing along the gap it formed in the masonry. This hole was most probably the exit chute of a garderobe, running from the first floor of the building and discharging onto the low ground to the west. The base of the feature was filled with a deposit of dark greyish-brown sandy silt [37].

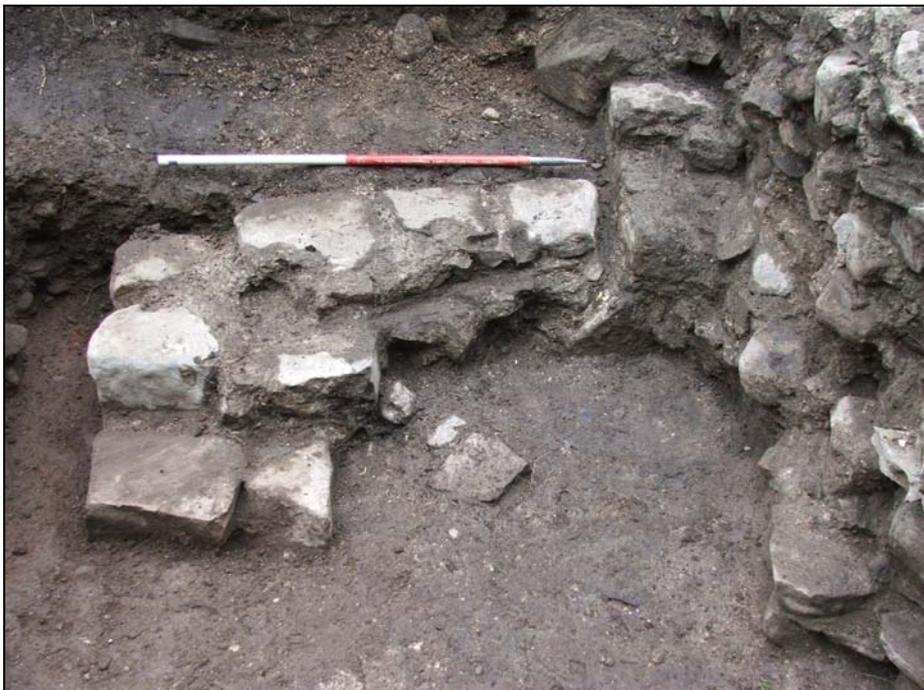
Figure 19: The base of probable staircase [F68], north of wall [F29]. Facing east

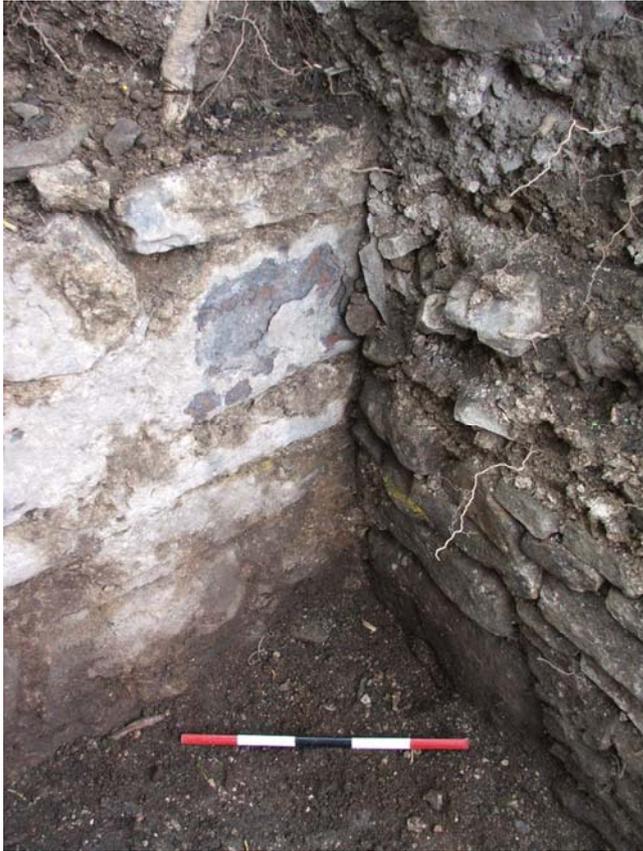
Figure 20: The junction of walls [F66] and [F67], facing northwest. It can be clearly seen that [F67] at the right of frame is a later addition

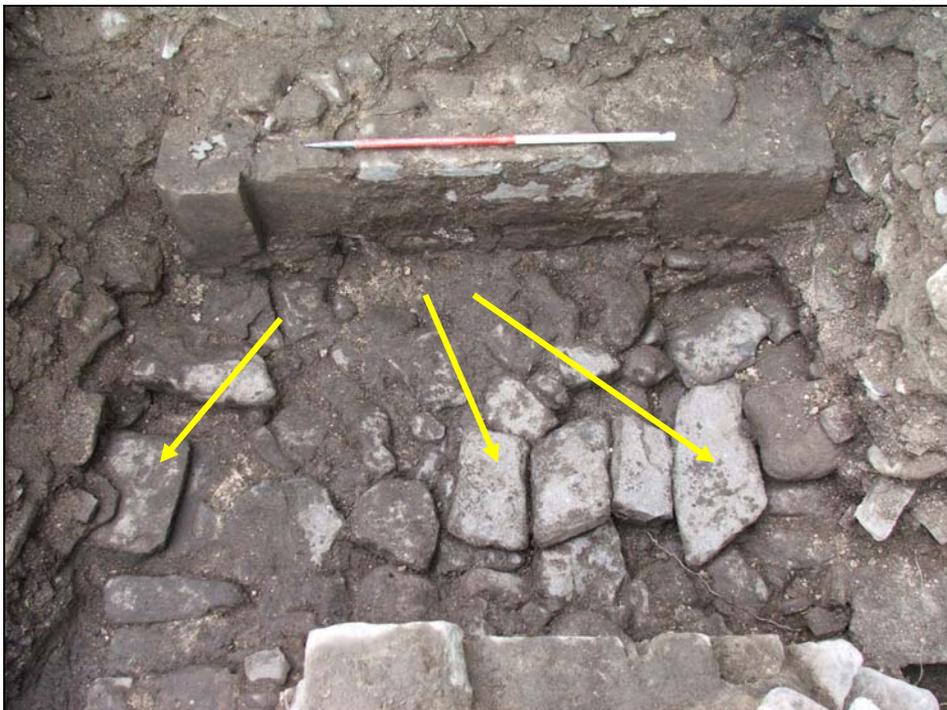
Figure 21: Stone surface [63] in doorway [F90], facing south. The slabs of possible drain [91] are indicated

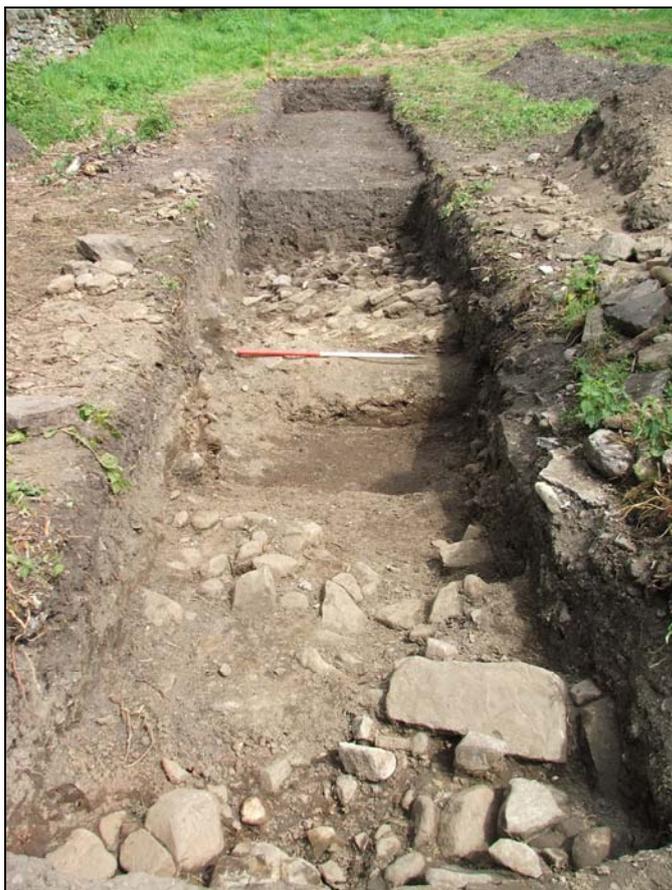
Figure 22: Cobble surface [F24] exposed in the centre of Trench 2. Sloping ground and the thick soil build-up of layer [3] can be seen at the top of frame, on the east of the trench

contained occasional small, rounded gravel but frequent irregular lenses of grey-brown silt, suggesting that it may have been formed partly by water action. This might have been the result of flooding from the Middlehope Burn to the west of the site, or may have been due to waterlogging of the area. To the east, layer [23] was covered by a homogenous, dark greyish-brown deposit of sandy silt [3: 0.6m thick]. This had the look of an imported soil, used to build up the area, with the layer thickening significantly to the east and appearing to form the main body of the steeply-rising bank which divided the site. Due to the depth of the deposit, only the west end of the layer was excavated (Figure 22).

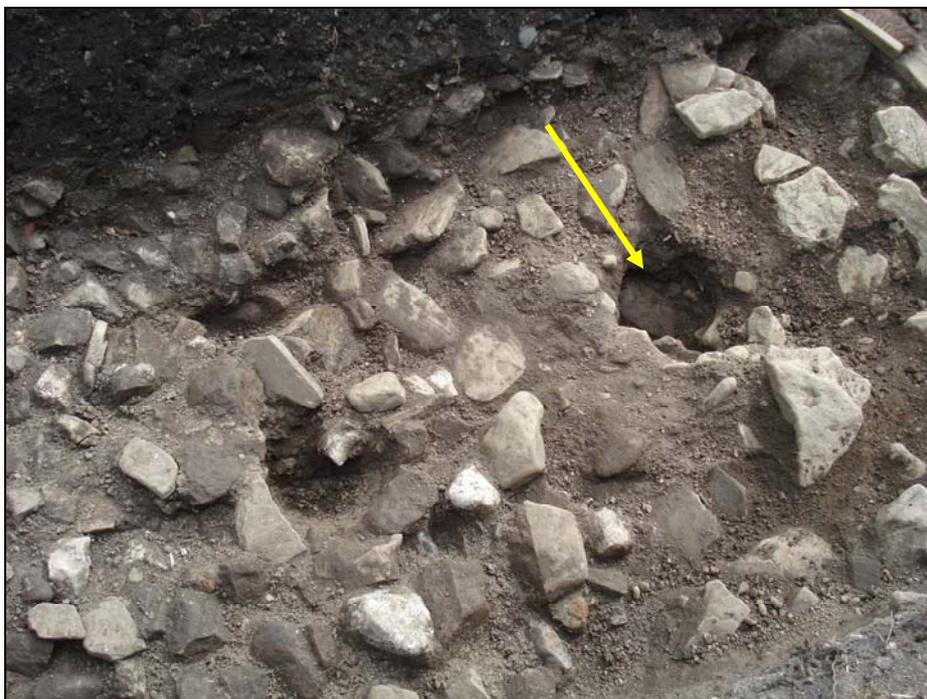
Figure 23: Posthole [77] (indicated) and possible postholes [79] and [81] (left of frame) on the east side of surface [F24]. Facing south

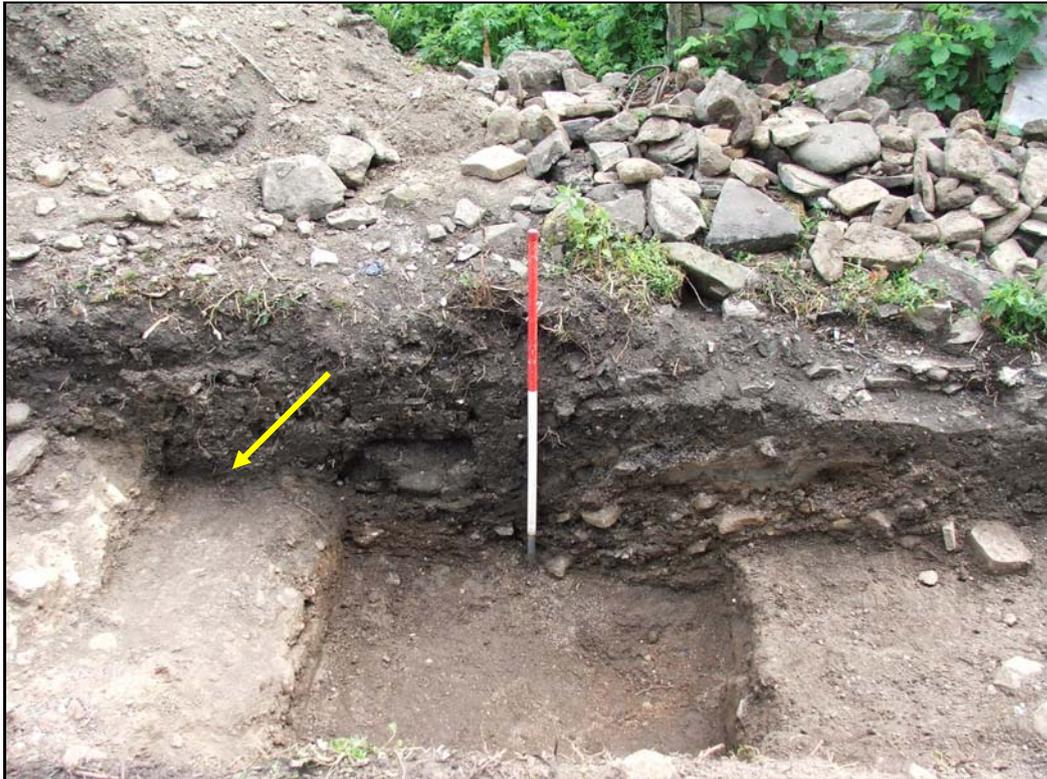
Figure 24: Leat channel [F75], facing south. The cut of dog burial [F70] is indicated to the left of frame

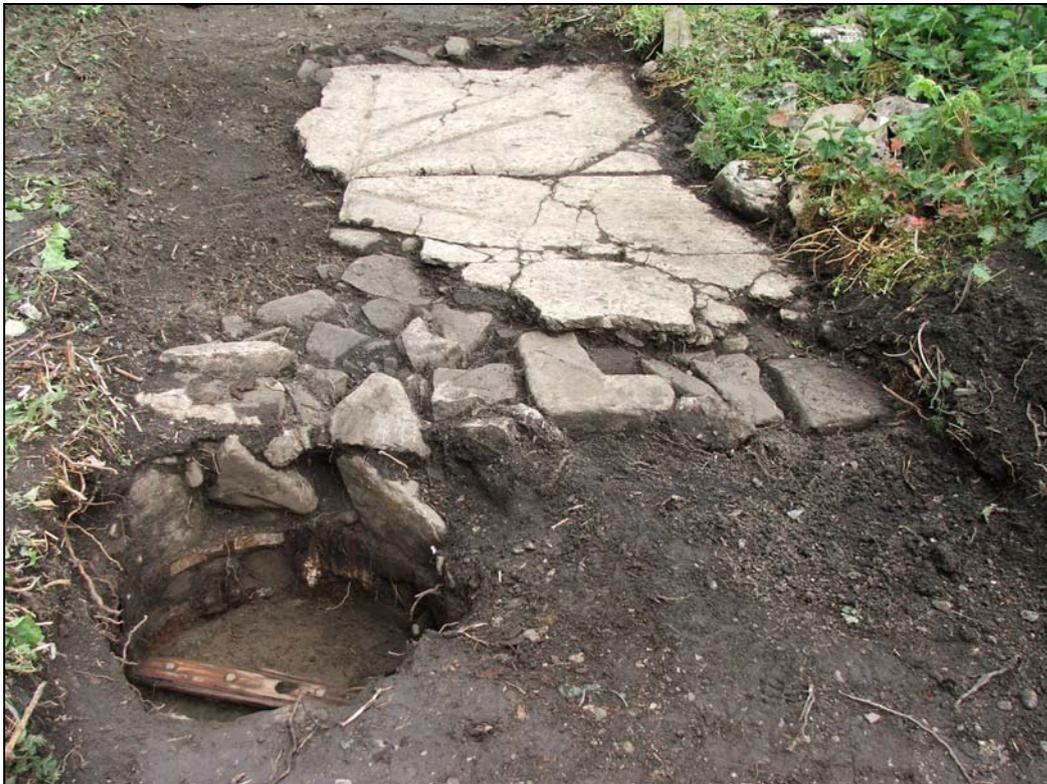
Figure 25: The floor and west wall of the demolished shed, facing east. The remains of barrel [9] are visible at the bottom left of frame

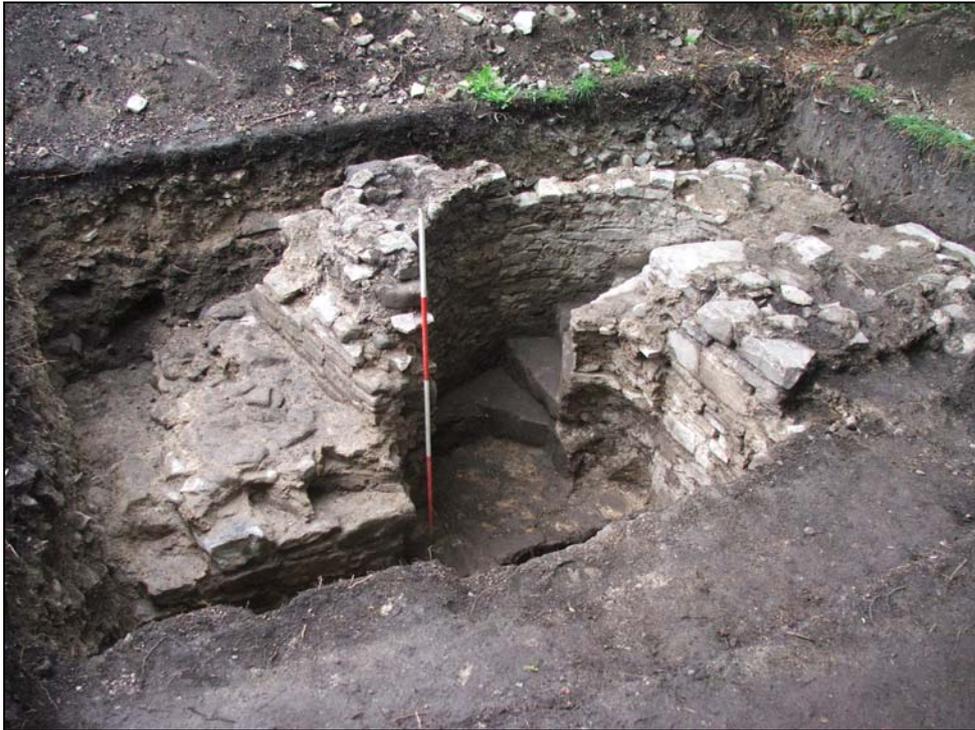
Figure 26: Trench 3, facing southeast, showing the southeast corner of the castle

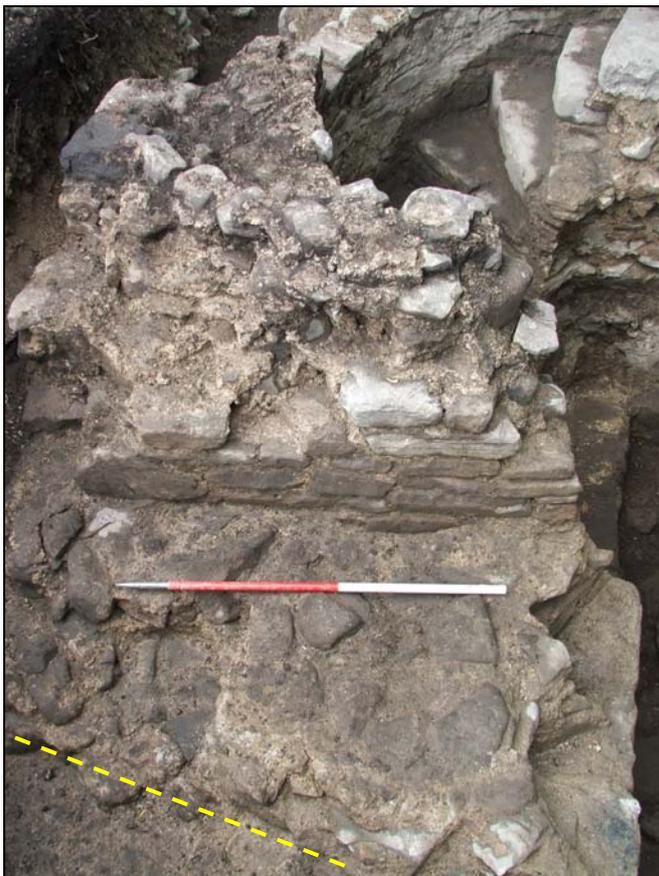
Figure 27: Window embrasure [F84], showing the surviving dressed face and the line where the opposite face has been removed (indicated). Facing south

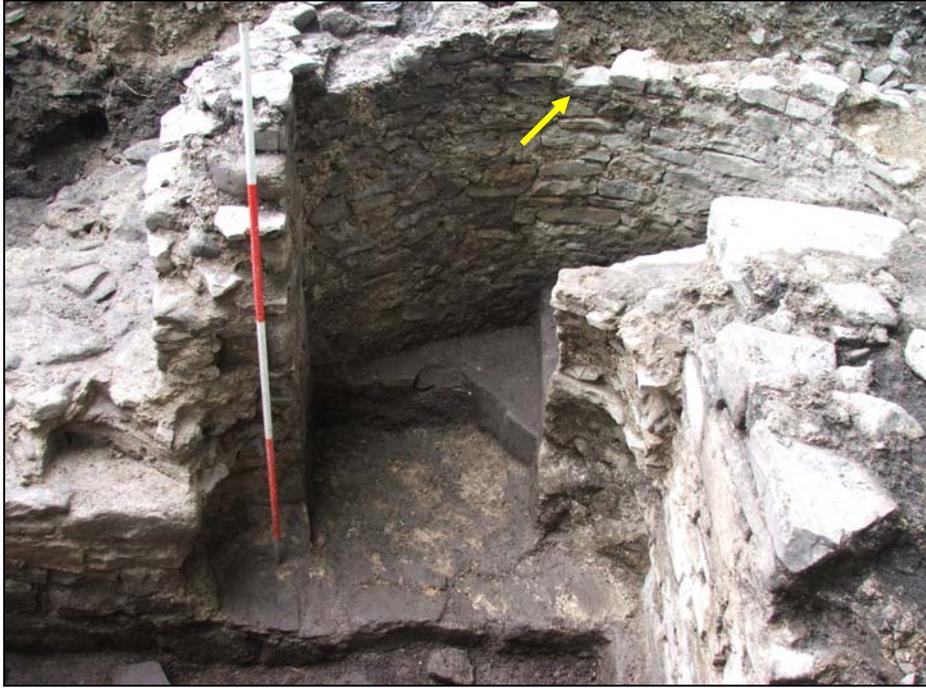
Figure 28: The west-facing doorway of staircase [F83], facing east. The scars of the robbed frame can be clearly seen, as can the broken lower step at the rear of the doorway. The possible niche or window light is indicated at the top of frame

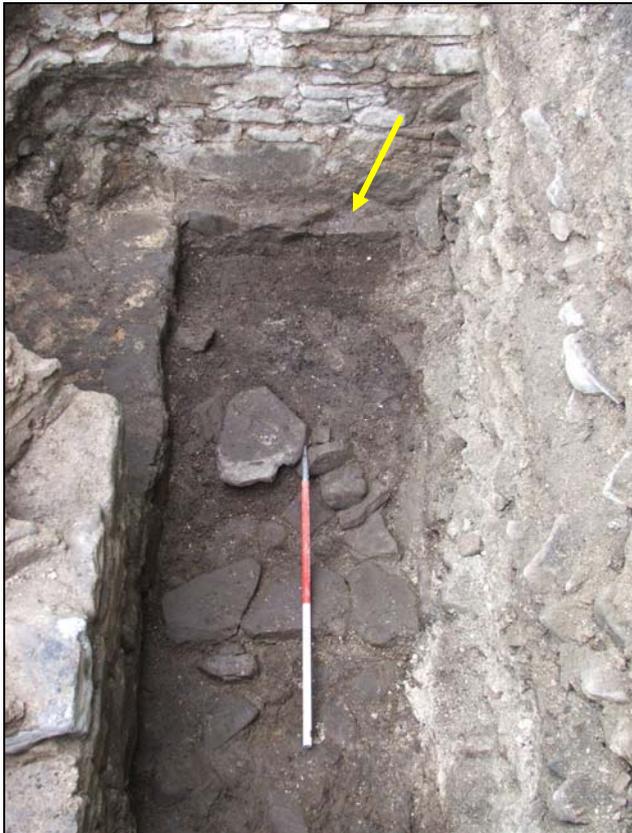
Figure 29: Flagstone drain [F51] crossing cobble surface [54], facing south. The stepped base course of wall [F82] is indicated at the top of frame

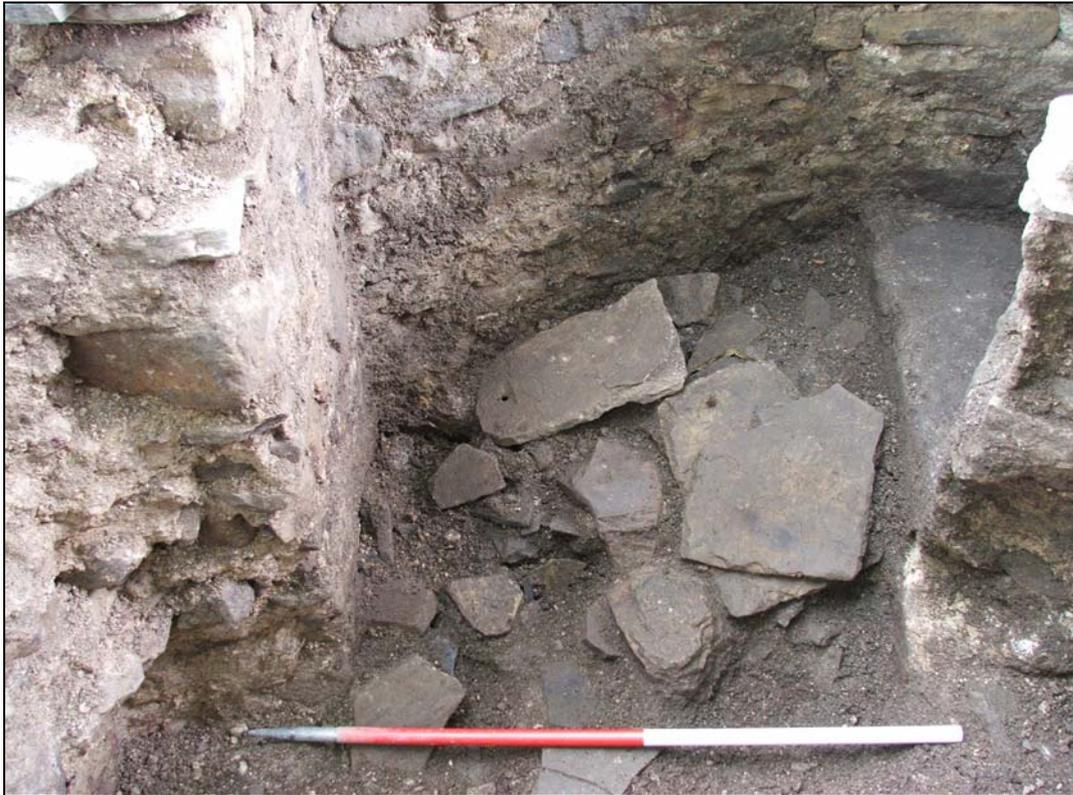
Figure 30: Roofing tile dump [30], exposed during the excavation of stairwell [F83]

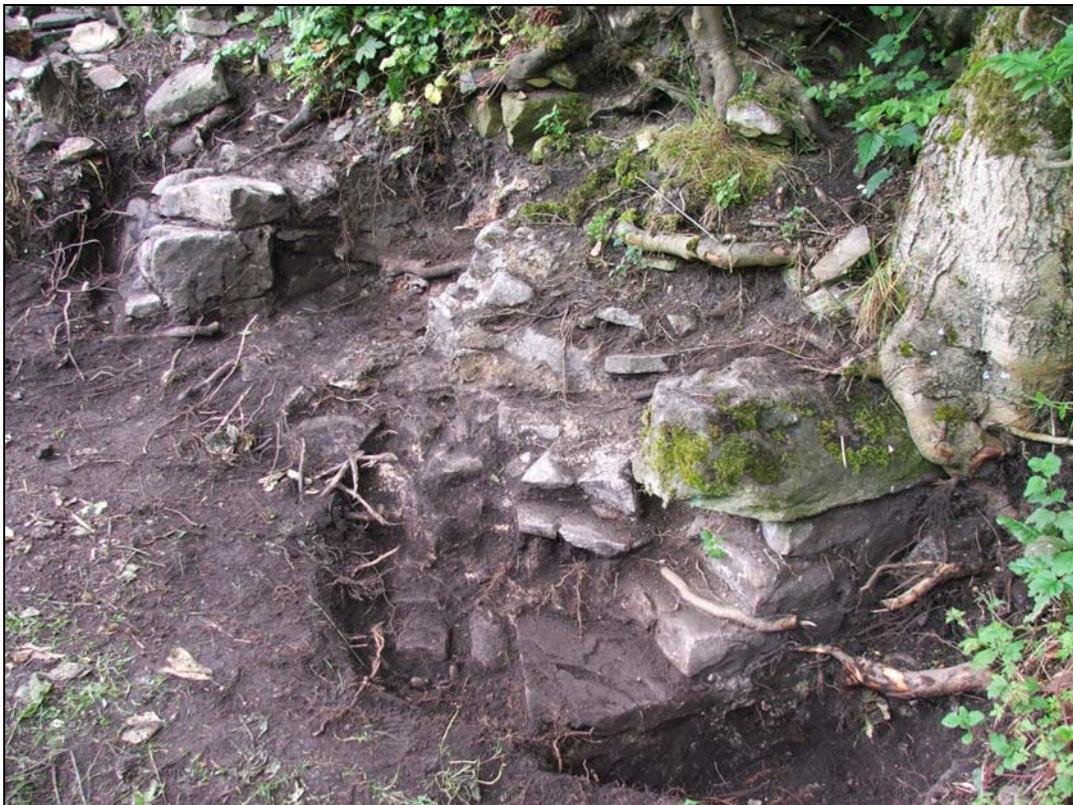
Figure 31: Masonry exposed at the base of the bank of the northern boundary lane, facing east

- 6.26 Elements of two masonry walls were recorded, set onto a rubble and mortar base (Figure 31). This base [87] was comprised of medium sub-rounded stone and dense, heavily-compacted mortar, possibly intended to form a building platform. On the west side, the remains of a substantial north-south orientated wall [F85, 1.3m x 1.45, 0.8m high] were exposed (Figure 32). This had a fair dressed face to the west, with six courses of stonework exposed. The west side of the wall was capped with a heavily-eroded chamfered `plinth' stone, identical in form to those found in Trench 1 to the south, and set at the same level as the similar plinth course [41] on the west side of [F66] (Figure 18). On the east side, the wall appeared to narrow. The dressed face of the masonry here was aligned roughly northwest-southeast as it extended northward from the bank, with an angled block marking the return to a parallel-sided wall 1.1m wide. This face of wall [F85] was poorly preserved, with only two courses of stone surviving at the greatest extent.

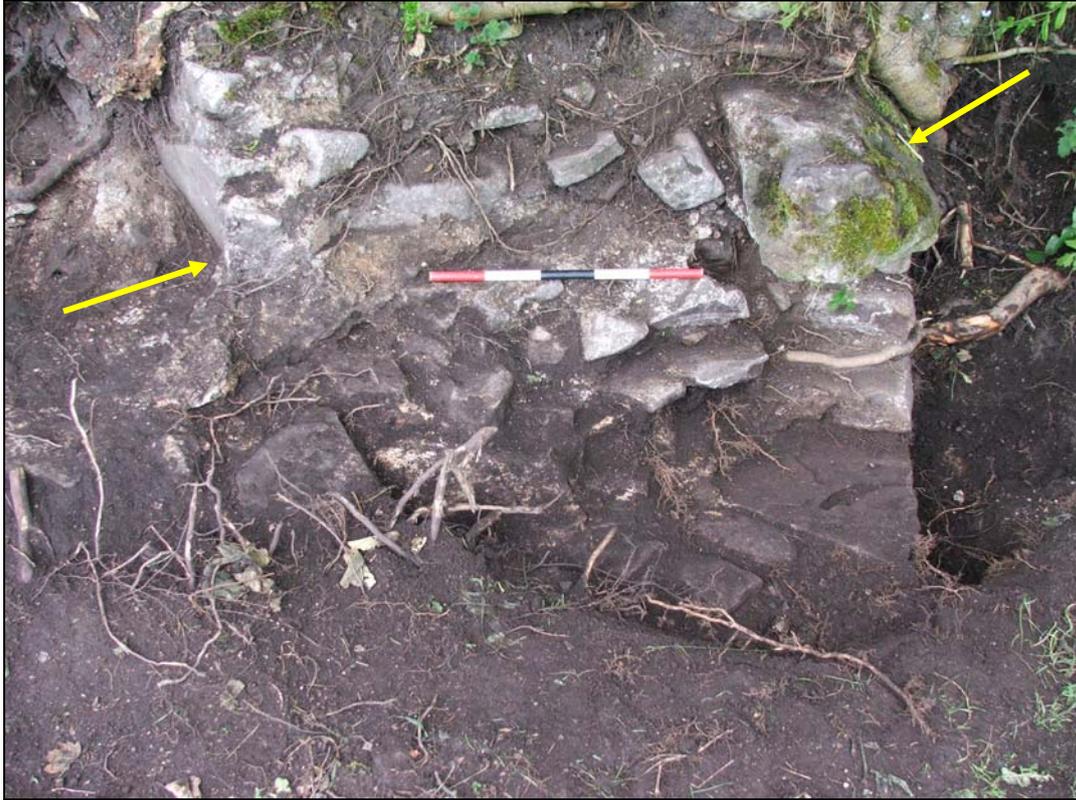
Figure 32: Wall [F85], facing south. The chamfered plinth stone is indicated on the right of frame, and the angled block narrowing the wall face on the left

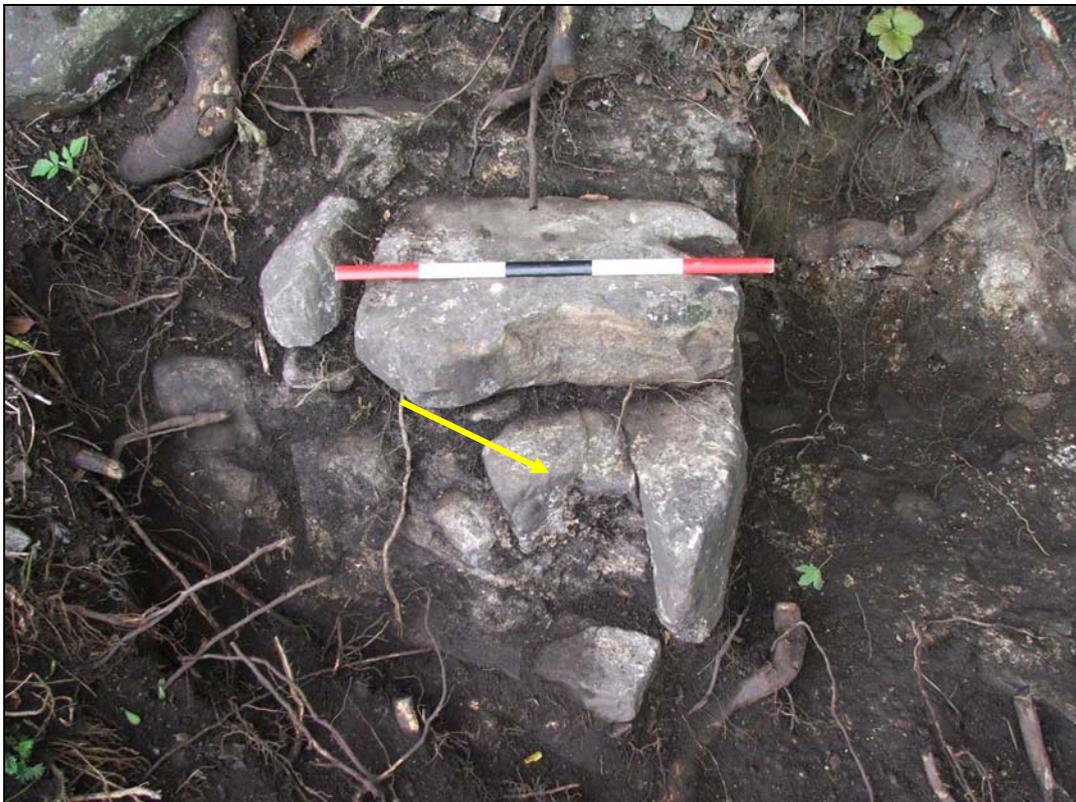
Figure 33: Wall [F86], facing south. The surviving dressed face is on the right of frame, and the possible socket is indicated

- 6.27 To the east, the base of a narrower wall was observed. This feature [F86: 0.9m x 0.75m, 0.4m high] was recorded mainly from the surviving west face: the east side of the masonry was fragmentary, and heavily disturbed by root activity. The face as exposed was aligned roughly north-northwest – south-southeast, with three courses of stone set in a fair face. At the north end of the wall, the remains of a broken, shaped block were recorded (Figure 33). This appeared to form part of a socket, with southern half of a well-worn cylinder evident in the stone. The orientation of both walls would indicate that they originally intersected, north of the recorded area. It seems probable that they were constructed at the same time, as both were set onto deposit [87], which also formed a worn surface between them. Each wall was again comprised of an uncoursed rubble-and-mortar core with dressed, smoothed faces, matching the construction observed to the south. The west face of [F86] clearly formed a continuation of the west wall of the castle [F66]. However, the narrowing

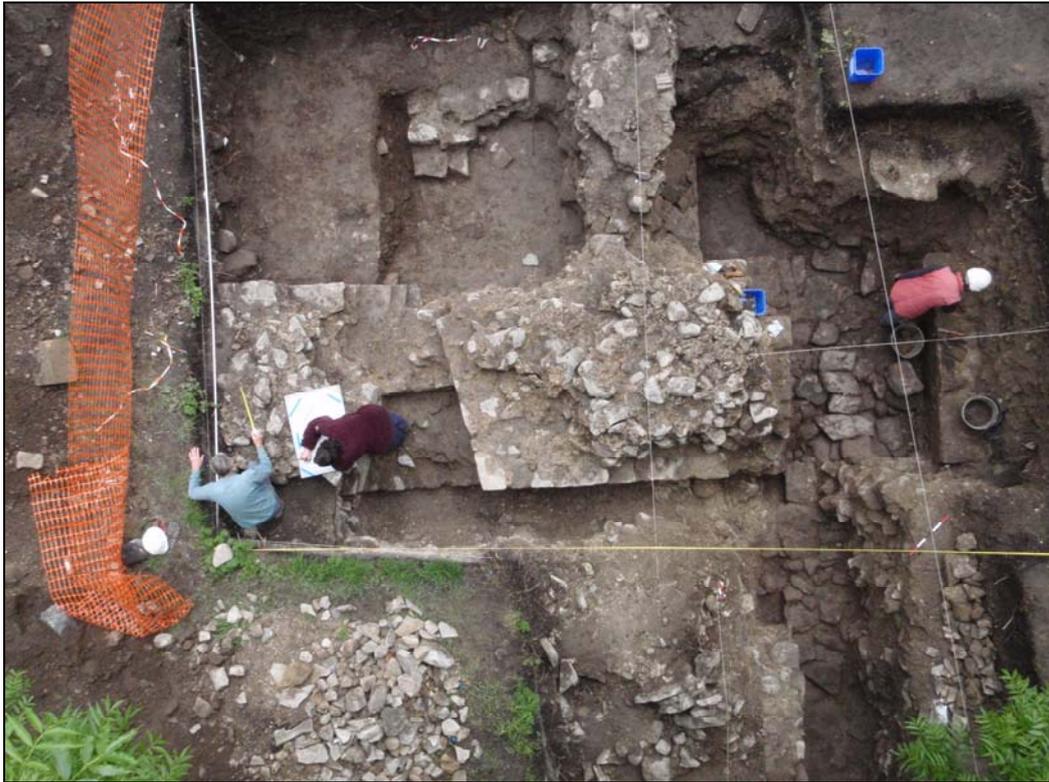
Figure 34: Overhead view of work in Trench 1, showing part of the east side of the castle with walls [F15] and [F29]. The sheer scale of the masonry remains can be easily appreciated. North is to the left of frame (aerial photograph taken by Mark Household)

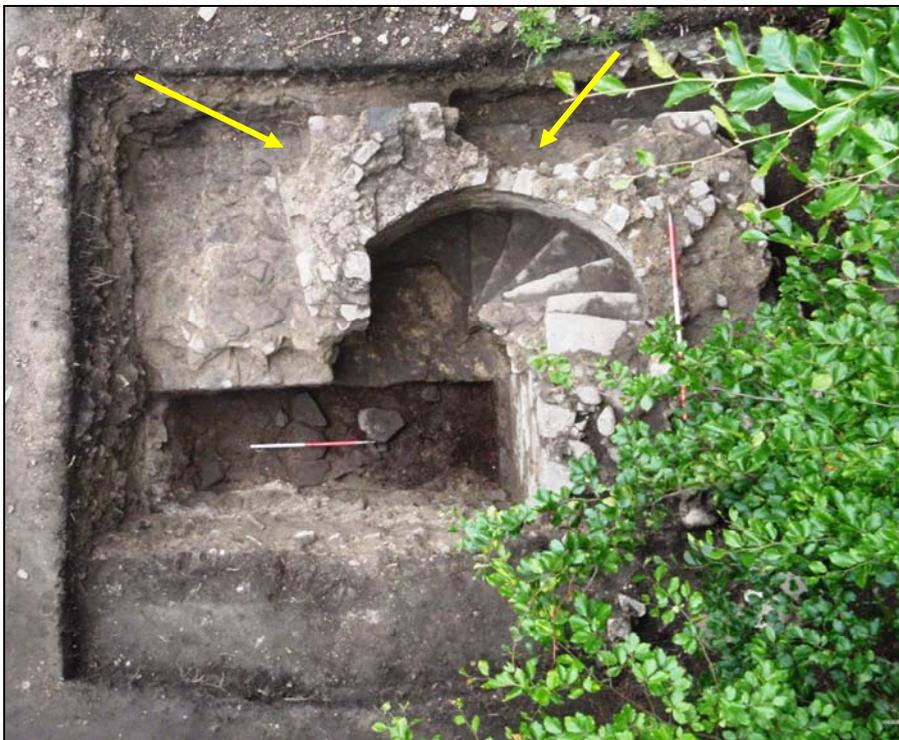
Figure 35: Overhead view of Trench 3, with wall [F82] and stairwell [F83]. Robbing pits can be clearly seen on the east wall (indicated). North is to the left of frame (aerial photograph taken by Mark Household)

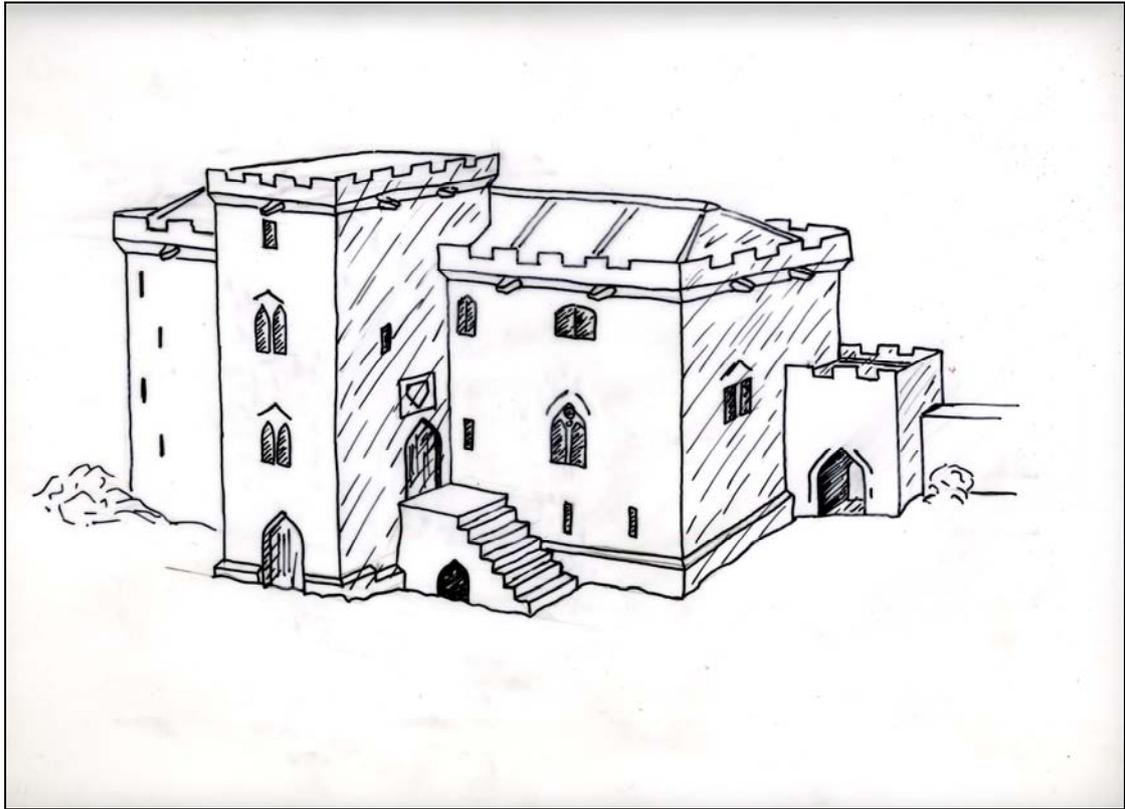
Figure 36: A suggested reconstruction of the castle during the initial phase of occupation, viewed from the northeast. Redrawn from a sketch made on site by Peter Ryder, based on structural remains and masonry fragments found during the excavation works (Randerson, after Ryder, 2012)

- 9.2 The main walls of the castle are immensely thick, and very solidly constructed. This raises the question of the original height of the building. Drury suggests that the structure must have stood two-storeys high, as the damages listed in court in 1590-91 mention only one wooden floor (Drury 1978b, 32), and her proposition was followed in Manchester's reconstructions of the building (Manchester 2001, 27 & 30-31). However, the walls as exposed would have been capable of supporting a further storey (Ryder 2011, *pers comm*). It is difficult to see why such massive walls, involving considerable labour, would have been constructed for a two-storey building, and therefore it seems more probable that the castle originally stood three storeys high. A suggested reconstruction of the castle is illustrated in Figure 34.
